## SELLER'S REAL PROPERTY DISCLOSURE FORM

Property Address: 8605 Eaglesnest Rd Sparks NV 89436

## Sparks, Nevada 89436

Prepared exclusively for:  
Mike Fredenburg

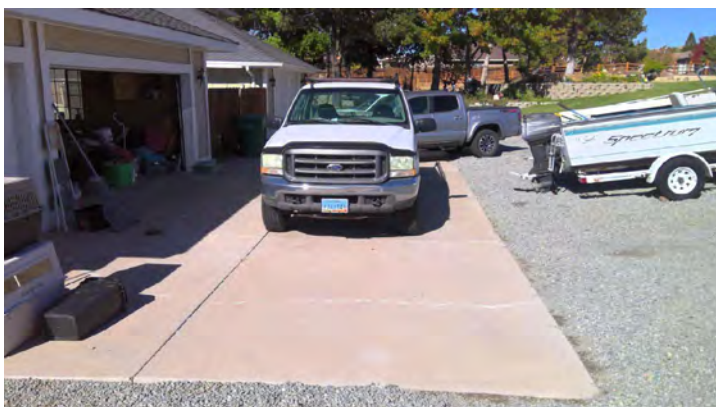
1. ☐ ☐ ☐ ☒ ☐ Driveway: Concrete: Negative grade - Cracks and light surface spalling noted in the driveway appears as is generally common for the material type. Correction to seal the cracks may prevent frost wedging or further cracking of the material.

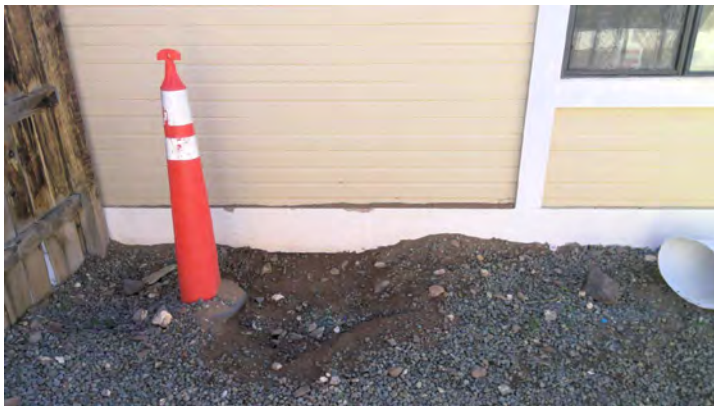
8. ☐☐☐☒☐ Grading: Minor slope - Earth is in contact with the siding where pictured at the 2nd garage. Correction of the grade to reduce contact is recommended to improve drainage and prevent deterioration.

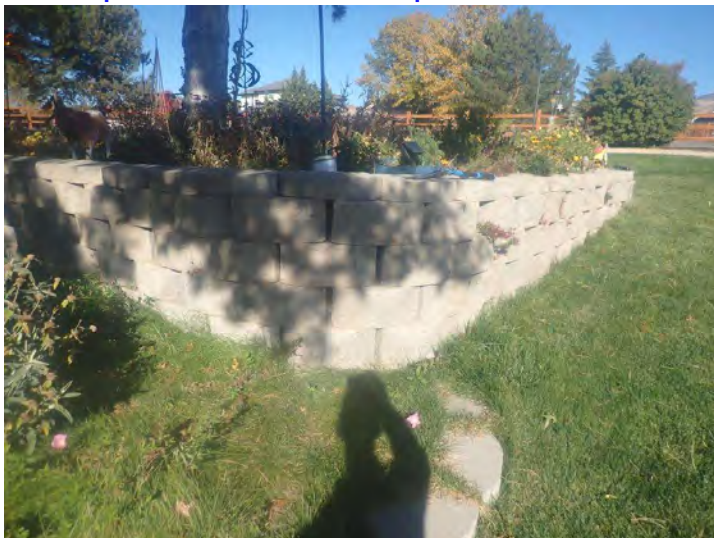
9. ☒☐☐☐☐ Vegetation: Trees & Shrubbery
10. ☐☒☐☐☐ Window Wells:
11. ☐☐☐☒☐ Retaining Walls: Block - Front retaining wall appears out of square. Adjustment by a qualified landscaper is recommended for preservation.

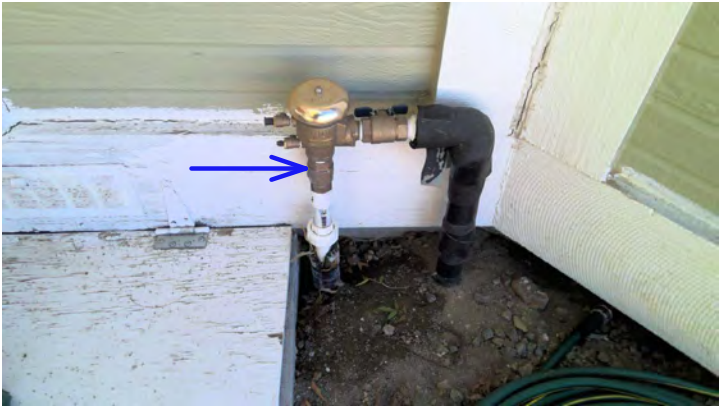
15. ☐☐☐☒ Lawn Sprinklers: Sprinkler system was not included in this inspection - Irrigation valve leaks at the pictured connection. Review and replacement or repair by a qualified landscaper is recommended.

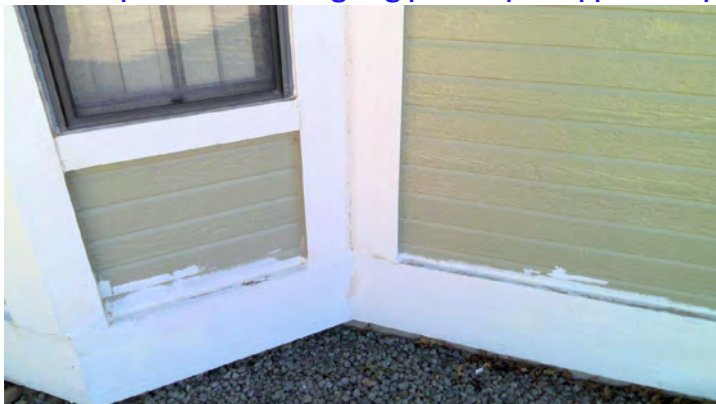
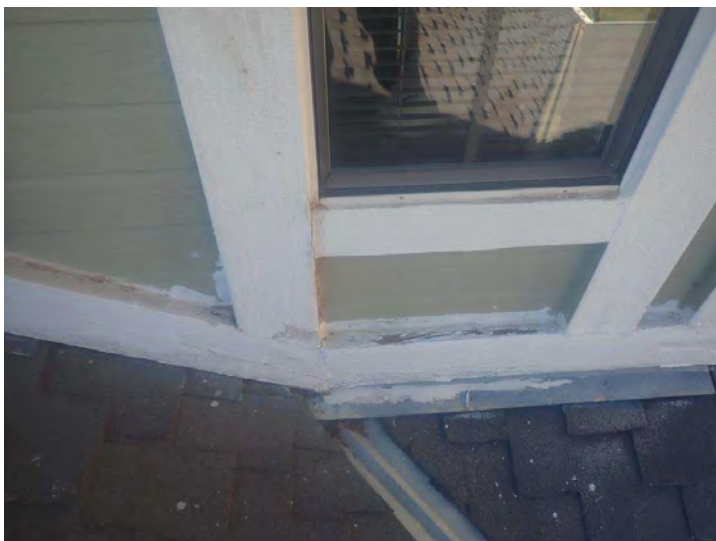
1. ☐☐☐☒☐ Type: Pressed wood/ Composite/Manufactured siding - Painting the exterior in the near future may prevent weathering of the siding. Small gaps and thin or flaking paint noted in spot locations and between panel seams. Ongoing paint repair appears in progress. Material appears otherwise intact.

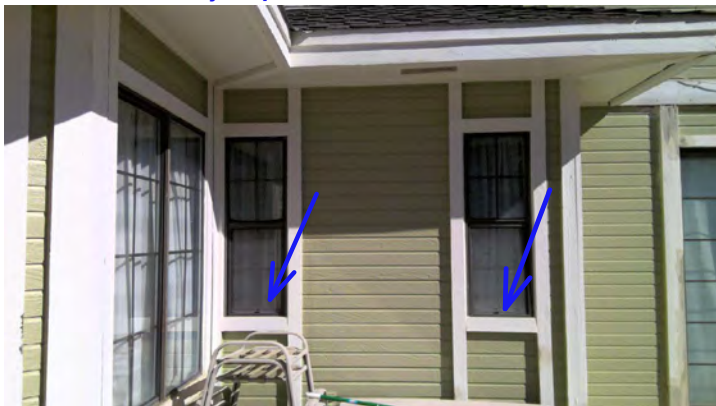
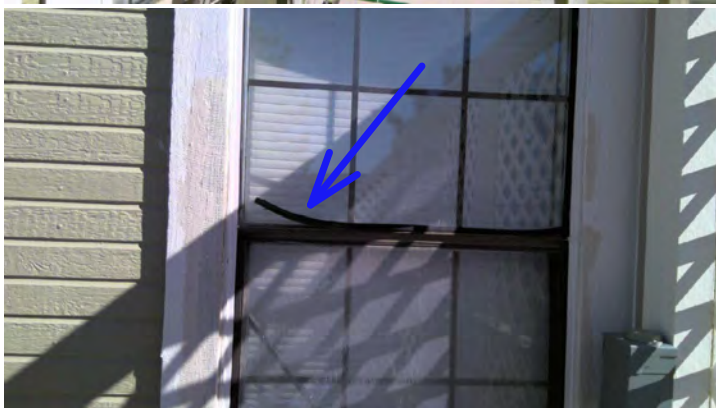
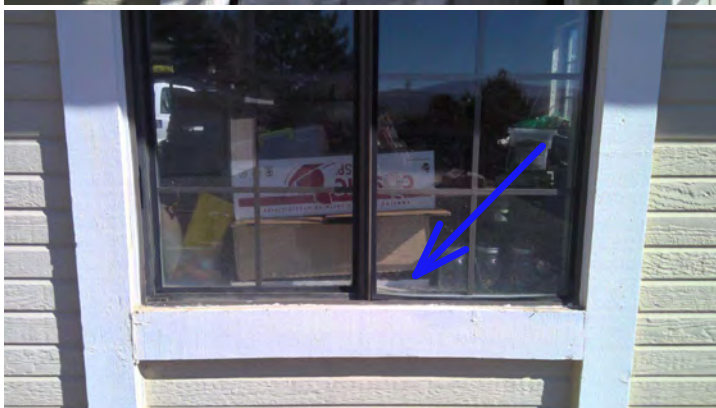
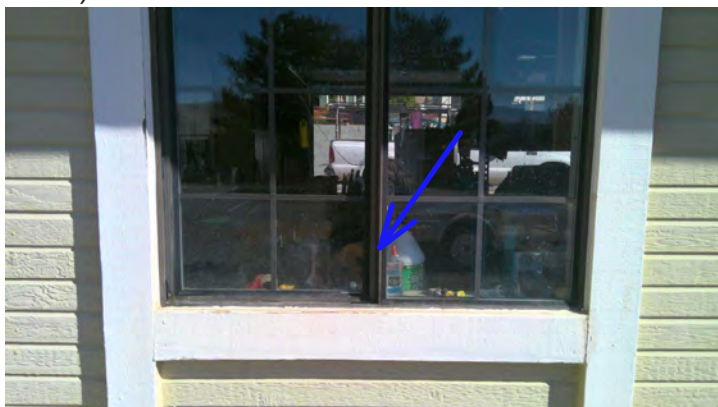
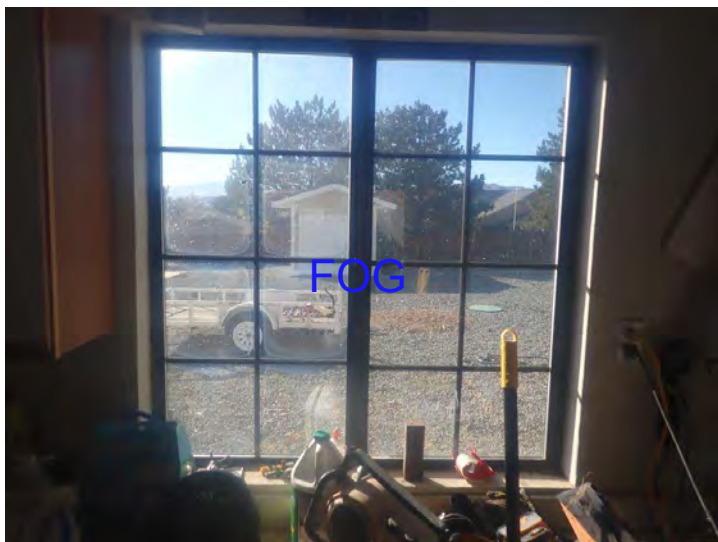
8. ☐ ☐ ☐ ☒ ☐ Windows: Vinyl Sliding Frame - Window stiles are damaged and warped at the rear facing bedroom, bathroom and garage windows.  
Rear facing garage window appears to have lost it's seal. Fog noted between panes. Depending on temperature and humidity conditions additional windows of similar age or type may show fog in the future. Review by a qualified window installer is recommended.

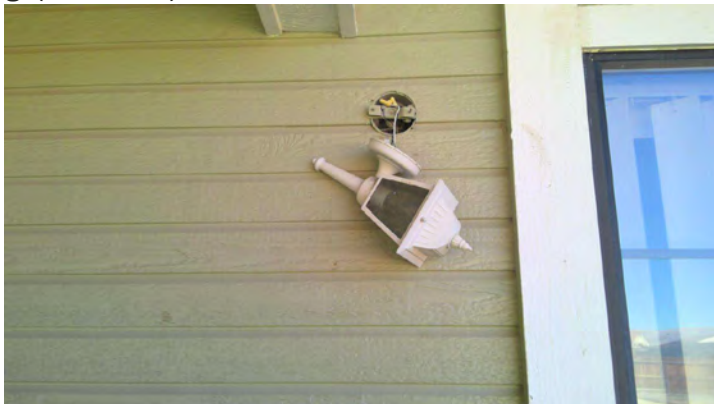
9. ☐ ☐ ☐ ☒ ☐ Window Screens: Vinyl mesh - Multiple exterior window screens are torn or weathered.
10. ☐ ☒ ☐ ☐ ☐ Basement Windows:
11. ☐ ☐ ☐ ☒ ☐ Exterior Lighting: Surface mounted lamps front and rear - Light fixture is loose at the right side of the home. Repair to secure the fixture is recommended.

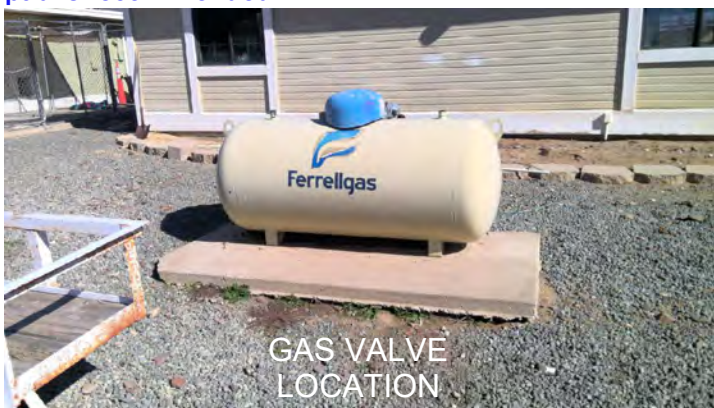
12. ☒ ☐ ☐ ☐ ☐ Exterior Electric Outlets: 110/120 VAC
13. ☒ ☐ ☐ ☐ ☐ Hose Bibs: Exterior mounted at the front and rear of the house
14. ☒ ☐ ☐ ☐ ☐ Gas Meter: At the tank - Tank pad is slightly undercut. Retaining the earth around the base of the pad is recommended.

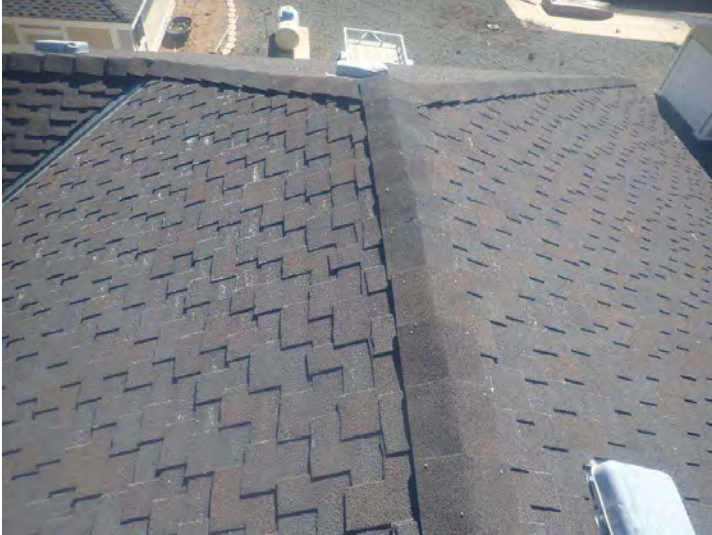
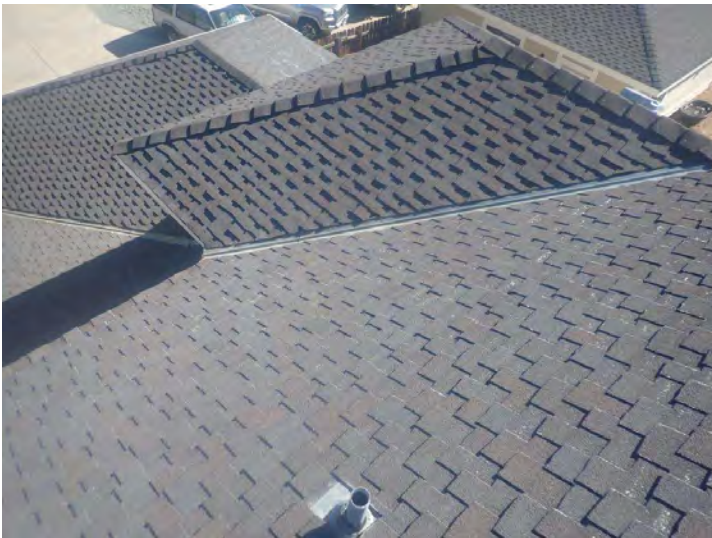
3. ☐ ☐ ☐ ☒ ☐ Material: Composite Shingle - Moderate to severe granule loss noted at the main roofing sections appears as expected for the age of the material. One shingle is missing above the 2nd garage. While the material remains intact at the time of inspection, any remaining longevity is greatly dependant on weather conditions. Evaluation of the material by a licensed roofer is recommended to determine the remaining longevity and to advise on any repairs or eventual replacement.

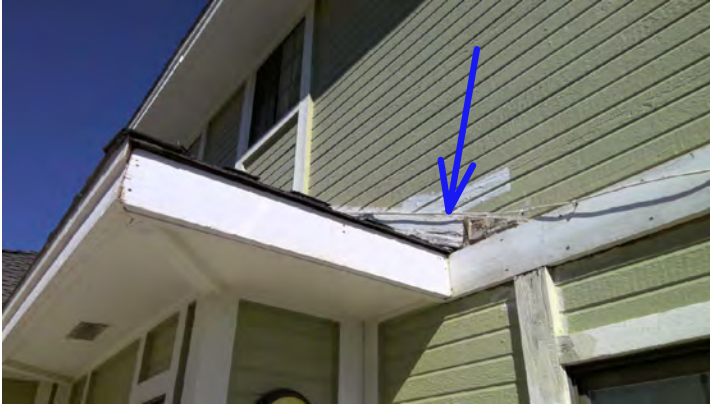
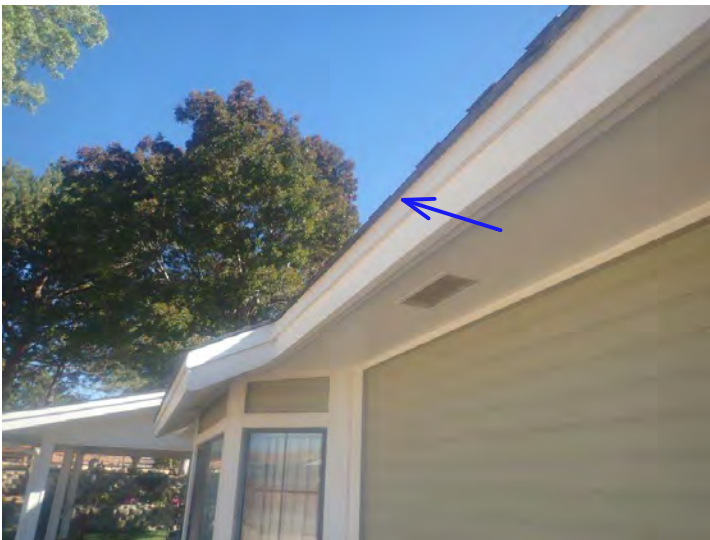
5. ☐☐☐☒☐ Flashing: Metal - Roof/fascia edge has not been equipped with kickout or drip edge flashing. Drip baton has been removed above the 2nd garage and rear patio. While likely not required at the time of original installation, revision to include kickout and drip edge flashing upon eventual installation of a new roof may improve drainage and prevent weathering of the surrounding wood components. The opinion of a licensed roofer/contractor is recommended.

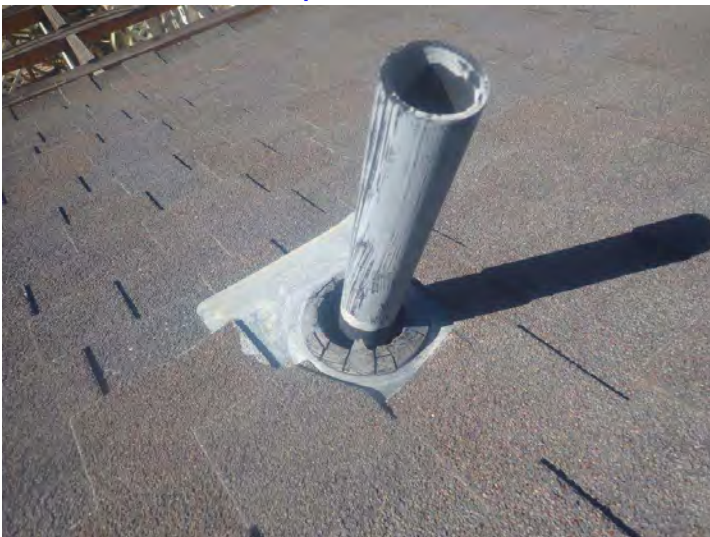
8. ☐ ☐ ☐ ☒ ☐ Plumbing Vents: ABS - Plumbing boots have cracked at the roof penetrations. Repair or replacement of the damaged boots by a licensed roofer is recommended to prevent moisture intrusion into the attic spaces.

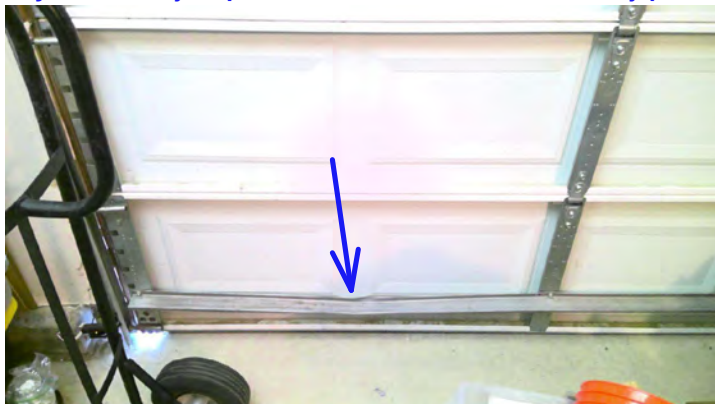
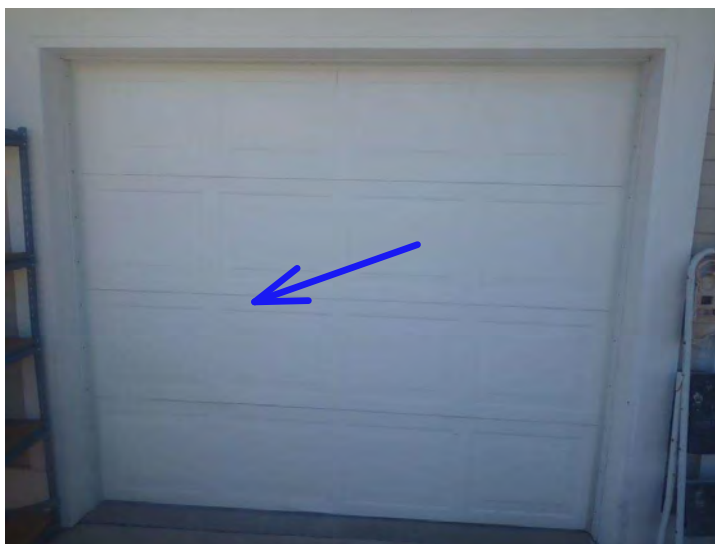
Single car vehicle door panel is split where pictured. Door remains functional. Review and repair or adjustment by a qualified overhead door tech may prevent additional damage and improve safety.

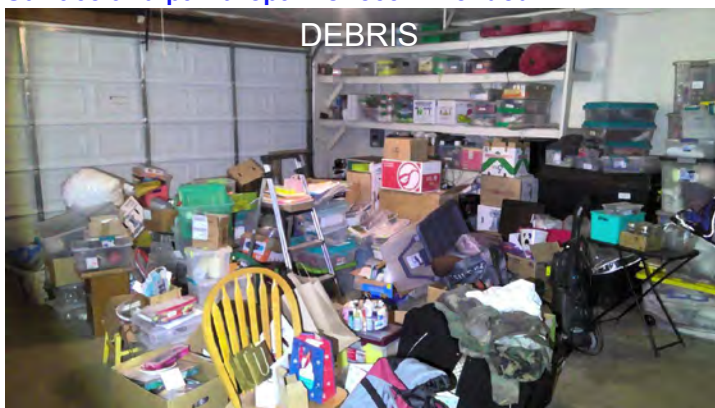
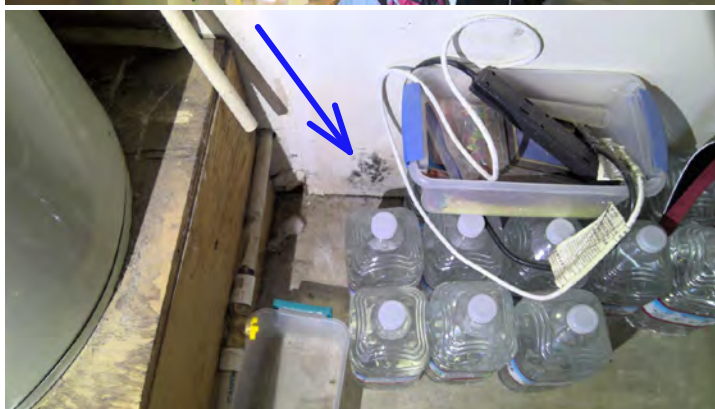
7. ☐☐☐☒☐ Walls: Painted Drywall - Wall shows stains and spotting at the garage near the person door. Surface and paint repair is recommended.

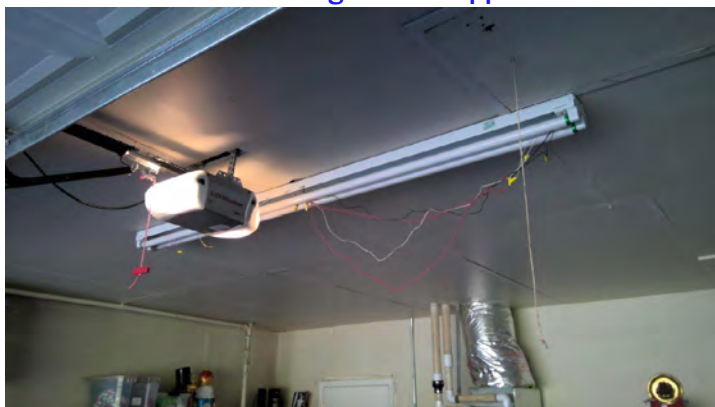
8. ☒☐☐☐☐ Floor/Foundation: Poured concrete  
9. ☐☒☐☐☐ Hose Bibs:  
10. ☐☐☐☒☐ Electrical: 110/120 VAC - Exposed wires noted at the garage light fixture. Adjustment to secure the wires is recommended. Light bulbs appear burned out. Replacement advised.

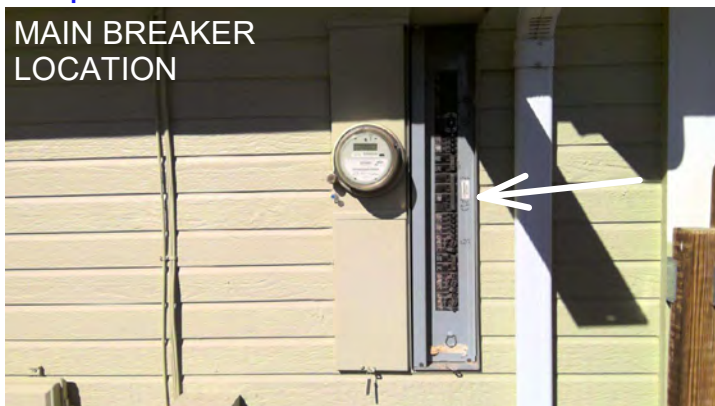
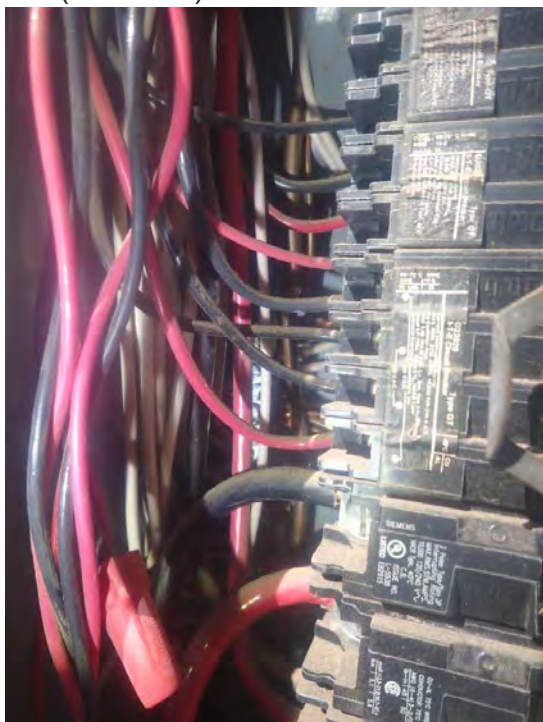
7. ☐ ☐ ☐ ☒ ☐ Main Breaker Size: 200 Amps - Main service panel is not fully labeled. Labeling of the panel by a licensed electrician is recommended to improve service access and safety. Double tap noted at the service grounds. Depending on the specific model of panel, revision to include one wire per slot may improve grounding. System remains otherwise functional. The opinion of a qualified electrician is recommended.

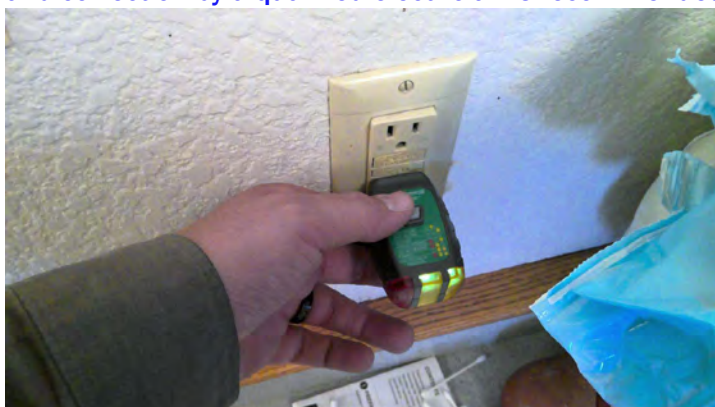
8. ☒ ☐ ☐ ☐ ☐ Breakers: Copper  
9. ☐ ☒ ☐ ☐ ☐ Fuses:  
10. ☐ ☒ ☐ ☐ ☐ AFCI:  
11. ☐ ☐ ☐ ☒ ☐ GFCI: Present at select GFCI outlets only - 2nd floor guest bathroom GFCI outlet fails to trip. Review and correction by a qualified electrician is recommended.

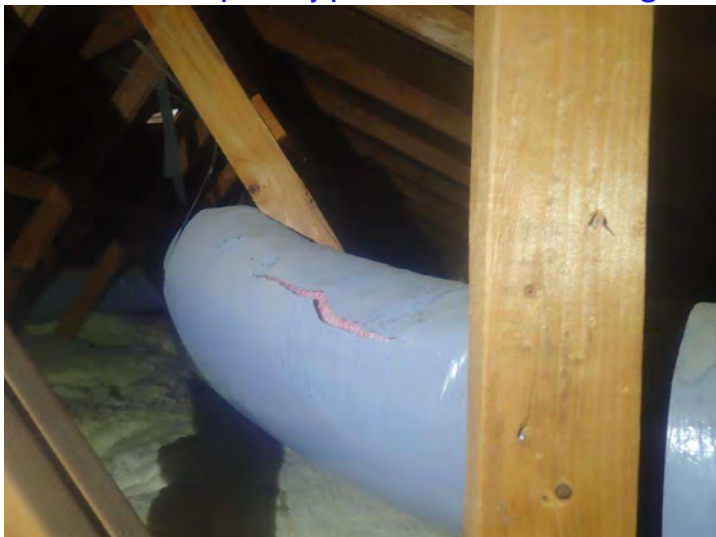
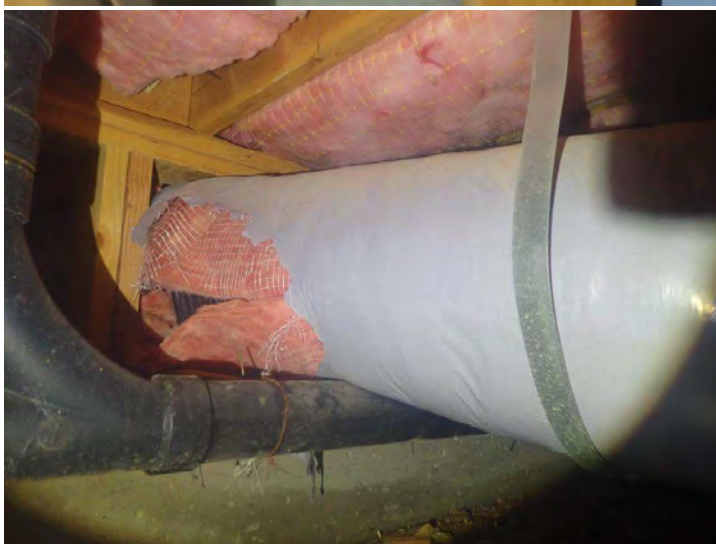
5. ☐☐☐☒☐ Distribution: Insulflex duct, Metal duct - Outer case of the HVAC duct has split in the attic above the guest bedroom and in the crawl space under the guest bathroom. Correction by a qualified HVAC tech to seal the split may prevent additional damage or improve efficiency.

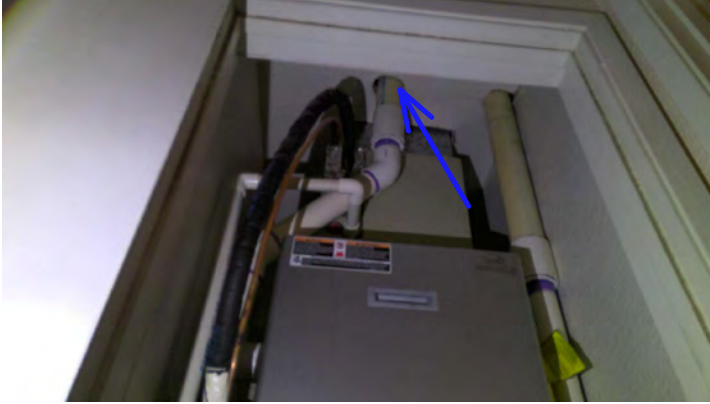
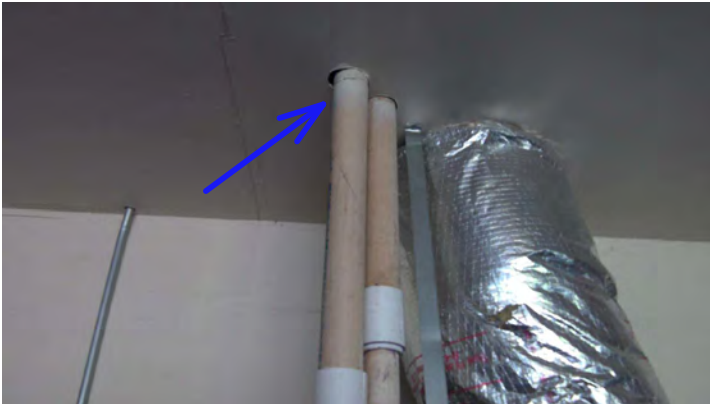
6. ☒☐☐☐☐ Draft Control: Automatic
7. ☐☐☐☒☐ Flue Pipe: PVC - Flue collar is missing around the top of the furnace flue. Adjustment/replacement is recommended to seal/sheathe the penetration.

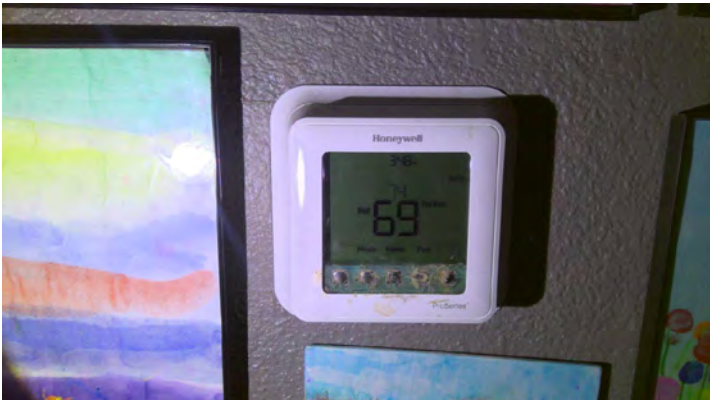
8. ☒ ☐ ☐ ☐ ☐ Controls: Automatic Safety Controls  
9. ☐ ☒ ☐ ☐ ☐ Humidifier:  
10. ☐ ☐ ☐ ☒ ☐ Thermostats: Multi Zone Multi Unit - 1st floor thermostat button is damaged. Unit remains functional. Replacement may be considered.

Master bedroom contains a terminated thermostat. Removal may be considered.

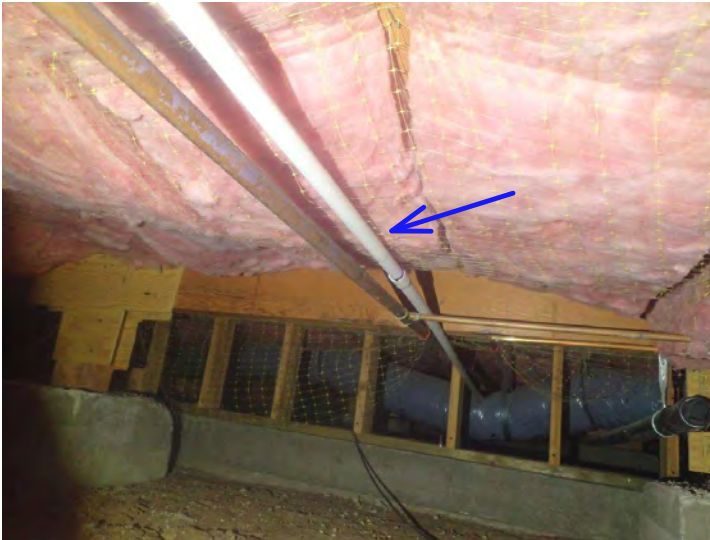
3. ☐☐☐☒☐ Water Lines: Copper, PVC - PVC line has not been supported under the right side of the home. Addition of supports may prevent damage. The opinion of a qualified plumber is recommended.

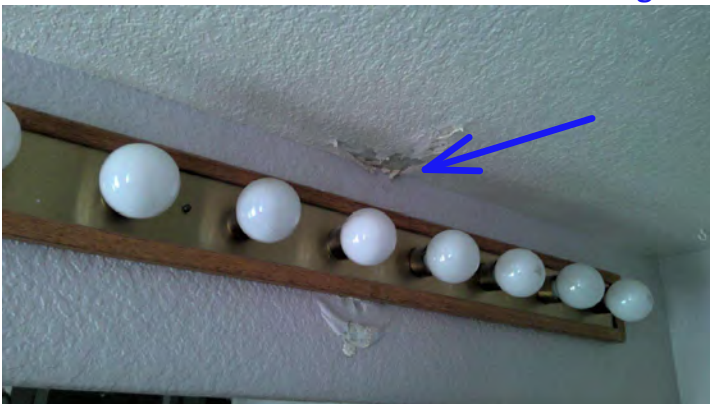
4. ☐☐☐☒☐ Drain Pipes: ABS - Active leaks are noted in the drain lines at the following locations.  
2nd floor shower leaks into 1st floor ceiling.  
Laundry room washer drain line is cracked in the crawl space.  
1st floor guest bathroom toilet drain leaks into crawl space.  
Master bathroom sink drain leaks in two locations into the crawl space.  
Evaluation and correction as needed by a licensed plumber is recommended.

One drain line has been terminated under the living room possibly indicating past remodel.

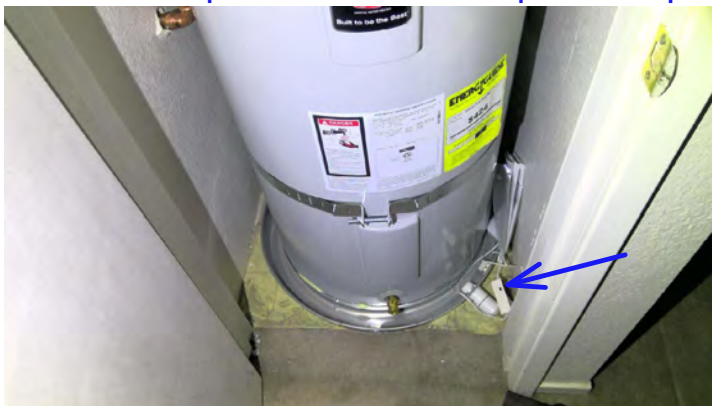
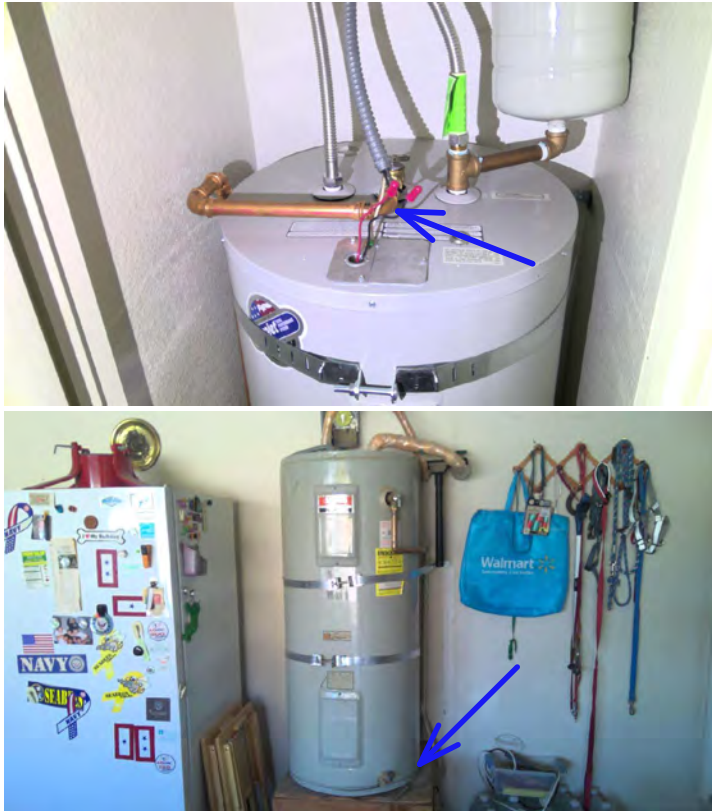
1st floor unit shows general age. Yearly flushing is recommended. Tank shows rust at the bottom of the unit possibly indicating a past leak but not leaking at the time of inspection. Unit is not equipped with a drain pan. Addition of a pan is recommended. Due to age, this unit may be near the end of its expected service life. The opinion of a qualified plumber is recommended.

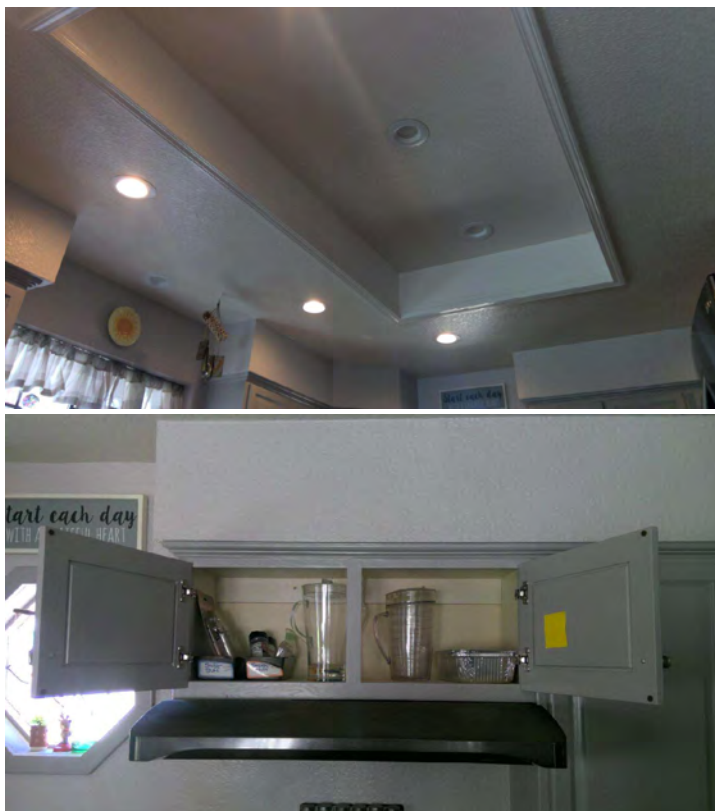
Exposed wires within 7 feet of the ground located inside the kitchen vent cabinet may be prone to damage in their current configuration. Correction to cover or sheathe the wires may improve safety. The opinion of a qualified contractor or electrician is recommended.

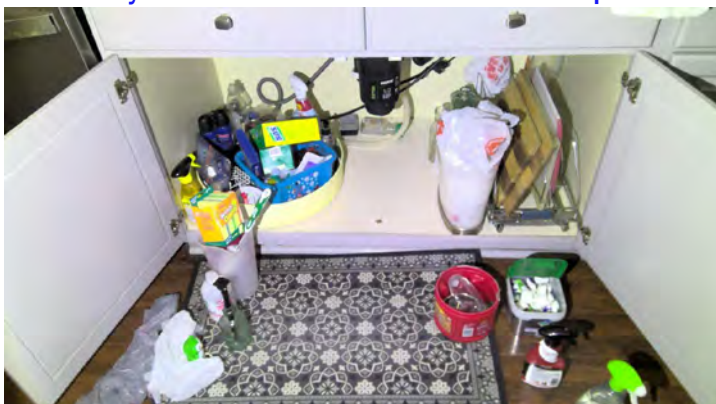
13. ☐☐☐☒☐ Cabinets: Modular Wood - Evidence of previous leaks or spills noted under the kitchen sink. Cabinet base shows stains and surface warping. Surface was probed with a moisture meter and found to remain dry and intact. Review is limited to the pictured surfaces.

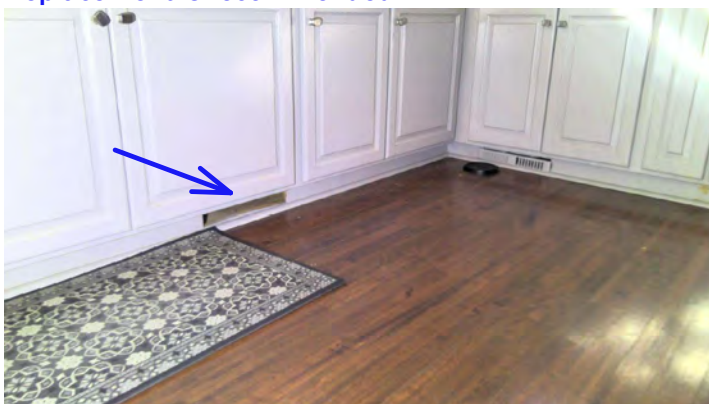
14. ☒☐☐☐☐ Pantry: Single  
 15. ☒☐☐☐☐ Ceiling: Painted Drywall  
 16. ☒☐☐☐☐ Walls: Painted Drywall  
 17. ☒☐☐☐☐ Floor: Hardwood/May be simulated/LVP  
 18. ☒☐☐☐☐ Doors: Hollow wood  
 19. ☒☐☐☐☐ Windows: Metal Sliding Frame  
 20. ☐☐☐☒☐ HVAC Source: Heating system register - HVAC register is missing from the kitchen cabinet. Replacement is recommended.

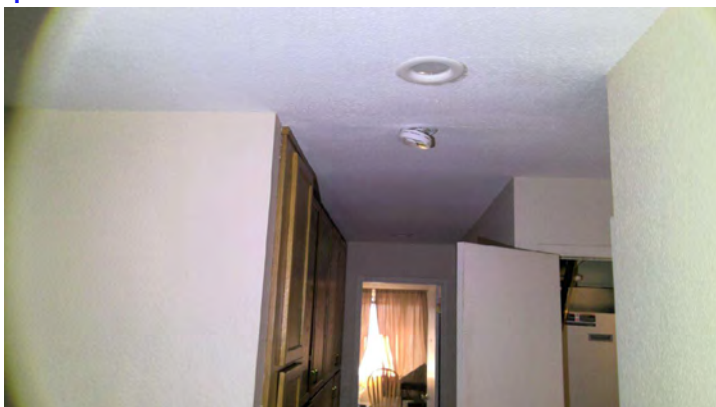
- ☒ ☐ ☐ ☐ ☐ Closet: Single
- ☐ ☐ ☐ ☒ ☐ Ceiling: Painted Drywall - Straight line cracks at the 2nd floor ceiling appear as expected for the age and location of home. Paint or surface corrections may improve appearance. The opinion of a qualified contractor is recommended.

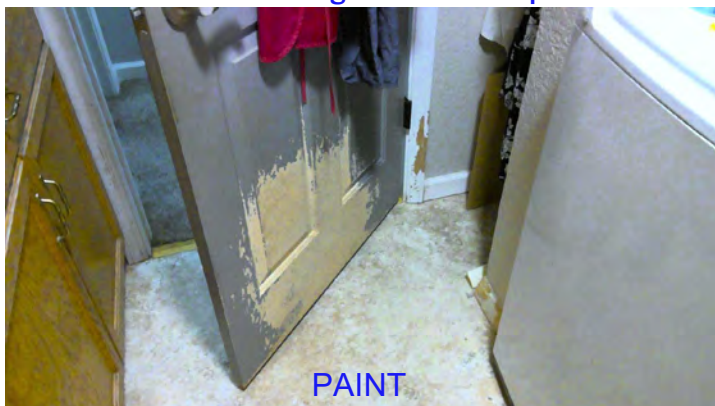
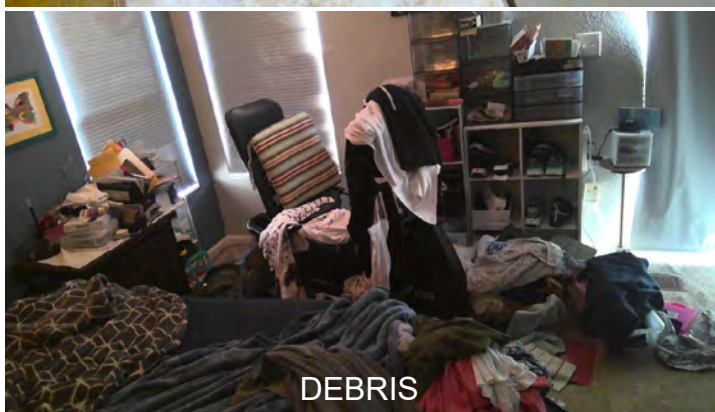
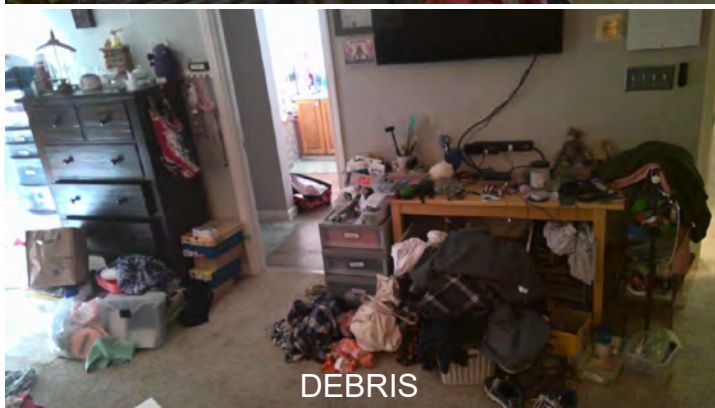
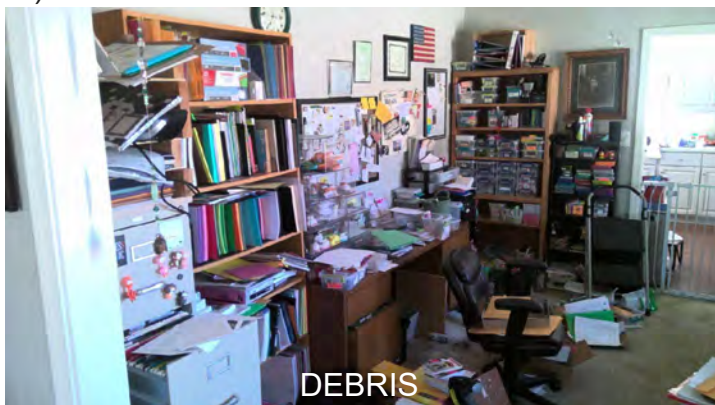
4. ☐ ☐ ☐ ☒ Walls: Painted Drywall - General paint, surface or texture flaws are noted in spot locations through the home common to a heavy, lived in condition. Repair may improve appearance. Personal items, furniture and debris through the interior spaces was not disturbed and may limit the inspection.

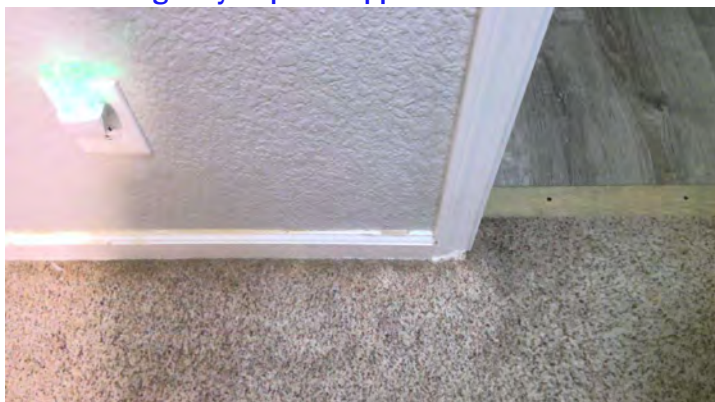
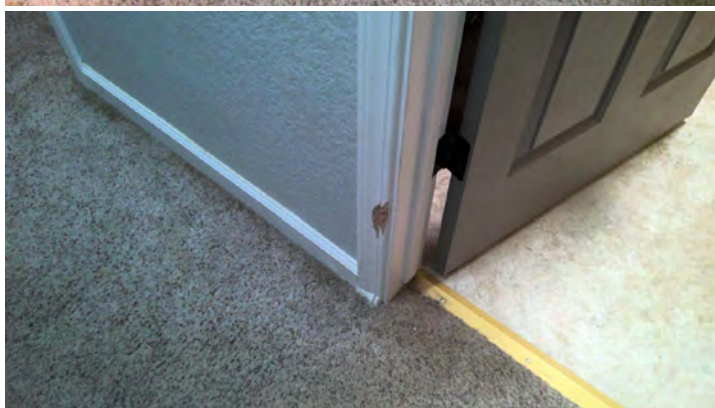
5. ☐ ☐ ☐ ☒ ☐ Floor: Hardwood/May be simulated/LVP - Hallway baseboards show stains and surface warping. Repair or replacement is recommended. Carpet is worn/wrinkled through the space. Adjustments and cleaning may improve appearance.

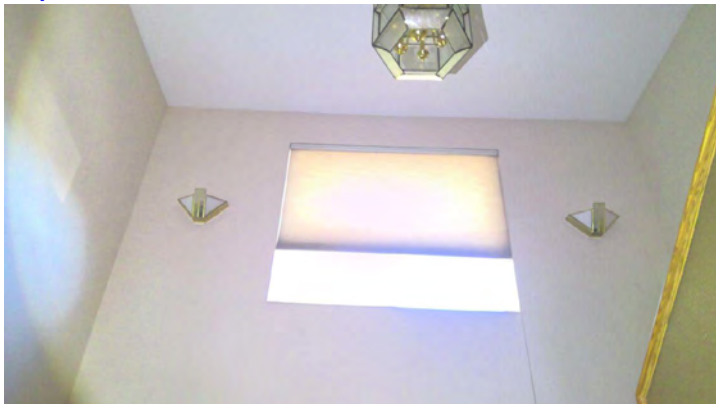
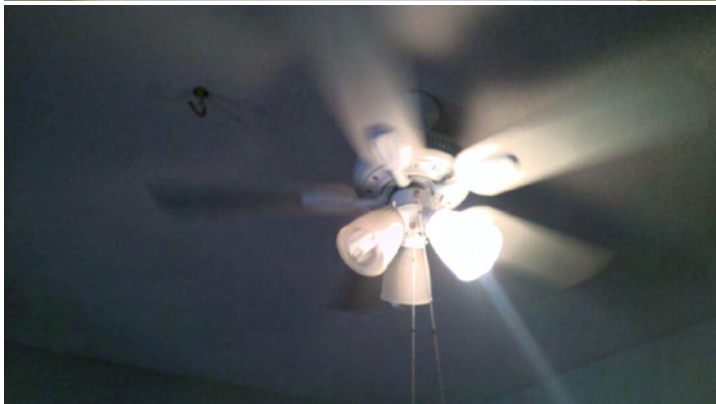
8. ☐ ☐ ☐ ☒ ☐ Electrical: 110/120 VAC outlets and lighting circuits - **Select interior light bulbs have burned out. Replacement of the bulbs is recommended.**

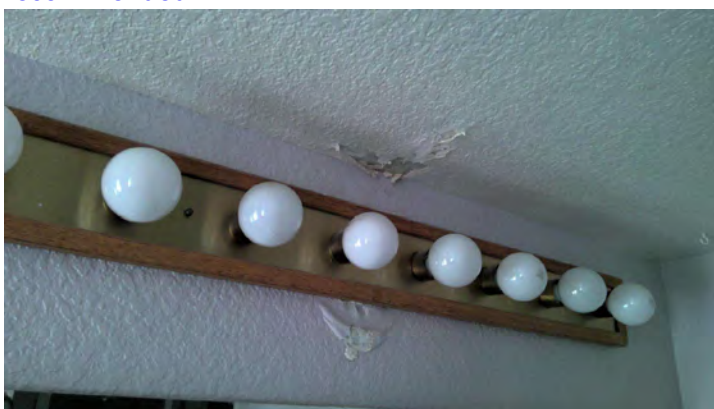
15. ☒ ☐ ☐ ☐ ☐ Closet: Single
16. ☒ ☐ ☐ ☐ ☐ Ceiling: Painted Drywall
17. ☐ ☐ ☐ ☒ ☐ Walls: Painted Drywall - Master bathroom ceiling is bubbled and is stained possibly evident of previous leaks or moisture. The inspector is equipped with thermal and moisture detection devices and observed changes in temperature and moisture after running water at the 2nd floor. Condition within the cavity cannot be viewed. Further review and repair by a qualified contractor is recommended.

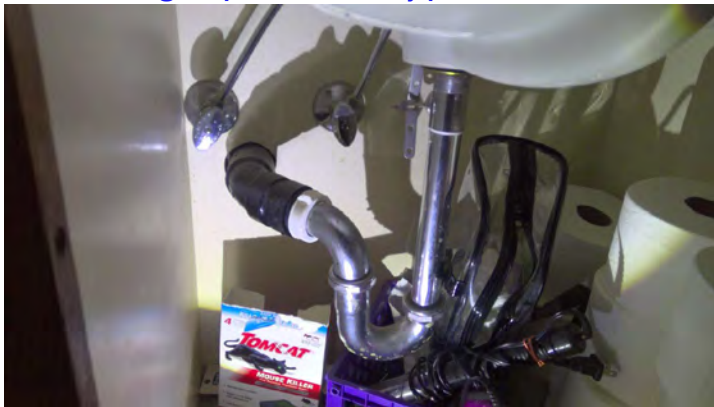
23. ☐☐☐☒☐ Sink/Basin: Porcelain/Ceramic - Galvanized drain line at the master bathroom sink has rusted but is not leaking. Replacement may prevent a leak.

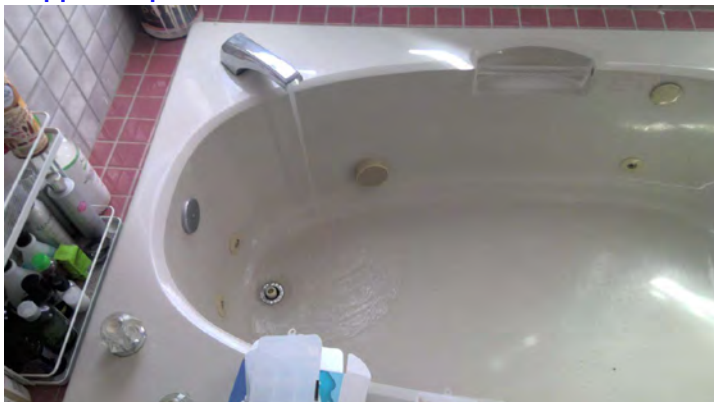
24. ☐☐☐☒☐ Tub/Surround: Fiberglass tub and ceramic tile surround - Master bathroom tub is missing the drain stopper. Replacement is needed to fill the tub.

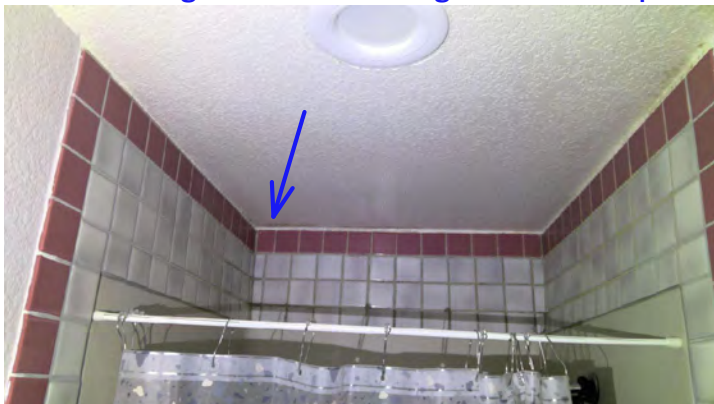
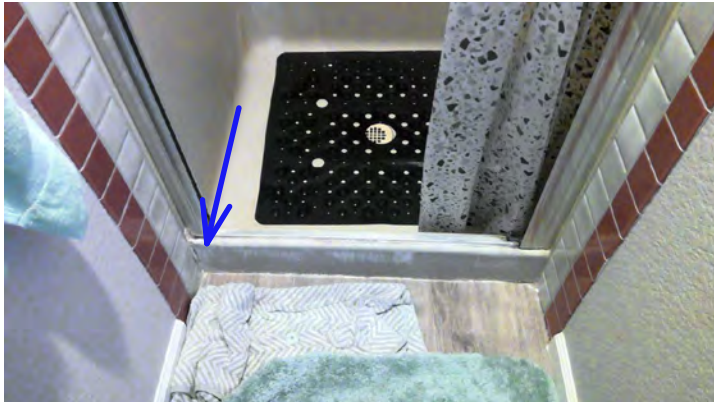
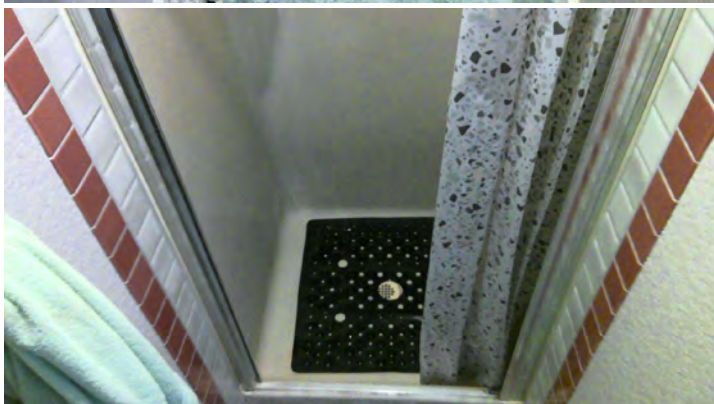
25. ☐☐☐☒☐ Shower/Surround: Curtain and Rod - Master shower door is missing. Small cracks noted in the grout. General grout repair is recommended. Shower ceiling is stained. Cleaning and surface repair is recommended.

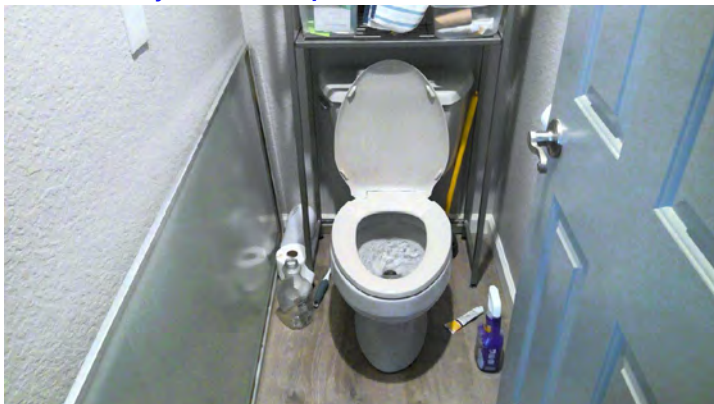
26. ☐☐☐☒☐ Toilets: Down Flush - Master bathroom toilet is loose to the floor. Review of the wax ring and correction by a licensed plumber to secure the toilet is recommended to prevent leaks.

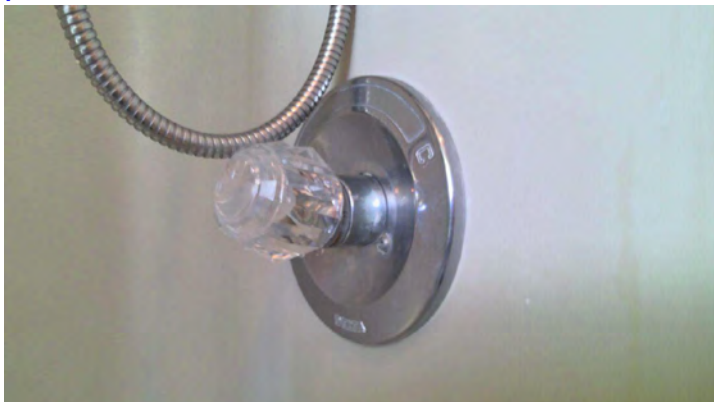
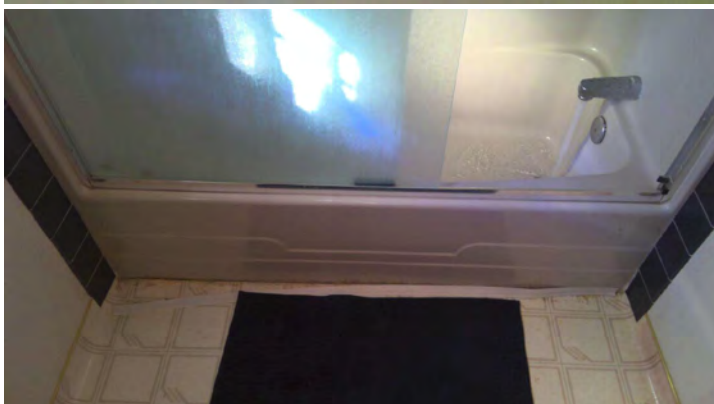
38. ☐ ☐ ☐ ☒ ☐ Tub/Surround: Fiberglass tub and fiberglass surround - 2nd floor shower faucet handle leaks. Review and repair or replacement by a qualified plumber is recommended. Correction to seal gapped areas between the tub and surrounding floor surfaces is recommended to prevent moisture intrusion to the wall or floor.
