## Home Inspection Report

PROPERTY INSPECTED:  
**2195 Canyon Point Court**  
**Sparks, NV 89436**

**Date of Inspection: 07/18/2024**

Inspection No. 401124-1-2109

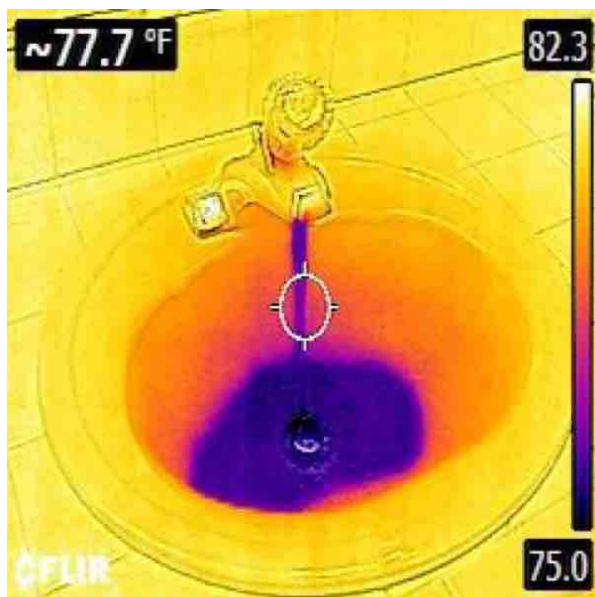
A thermal camera has been utilized to aid in the visual inspection. The Pillar To Post ® Professional Home Inspection STANDARDS OF PROFESSIONAL PRACTICE FOR THE USE OF AN INFRARED CAMERA ON A HOME INSPECTION have been used. Below is an example of a thermal image. Other thermal image(s) can be found throughout the Report. No anomalies were observed.

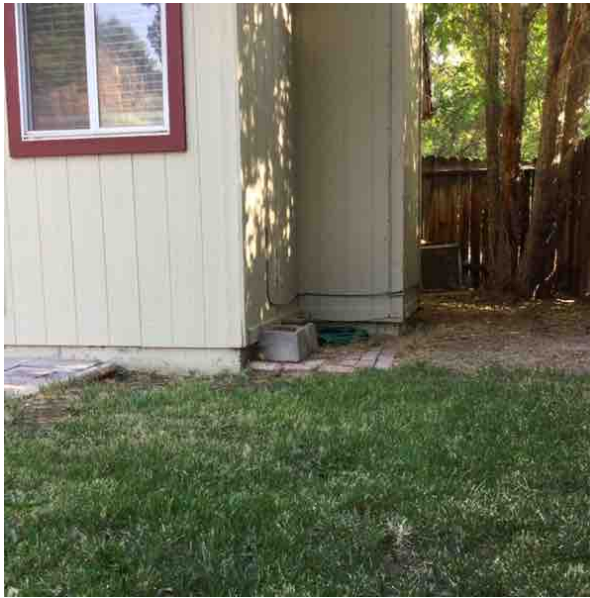
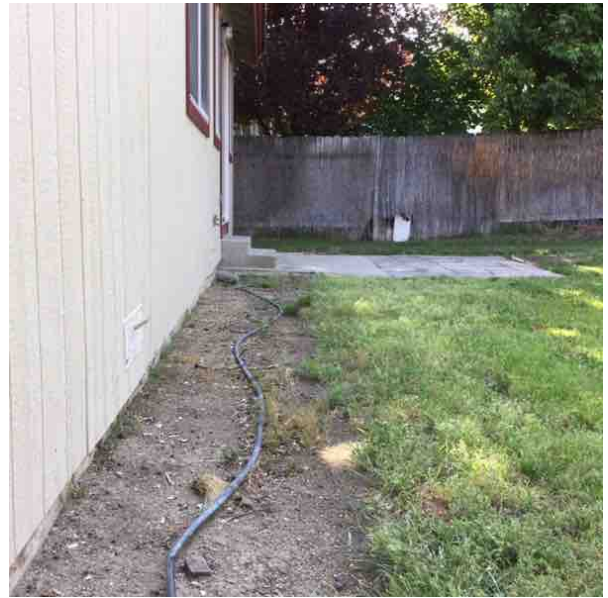
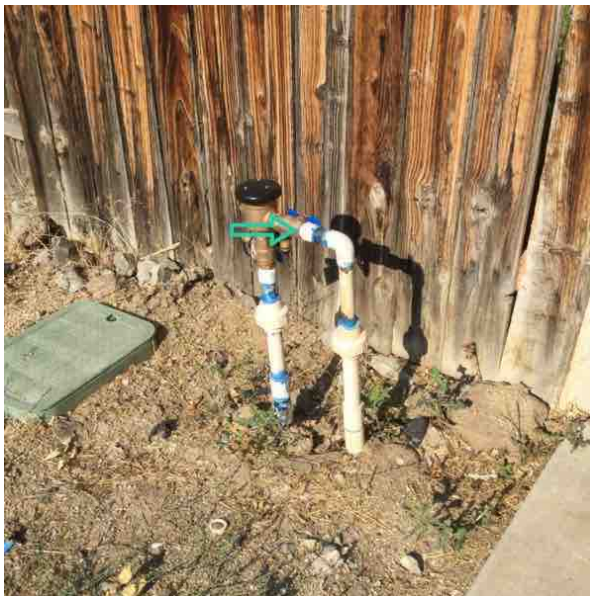
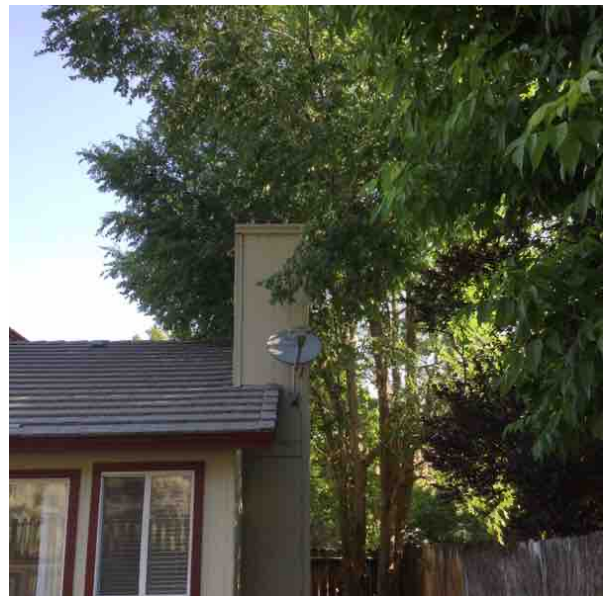
2.1.1 The ground surface is relatively flat along the left and back sides of the house. Recommend having a contractor evaluate and repair or improve site drainage as needed to help minimize potential of moisture related issues.

There is a leak or drip at the irrigation valve. Recommend having a landscaper evaluate and repair.

Recommend consulting an arborist regarding proper tree / root management on the left side of the house to help minimize further damage.

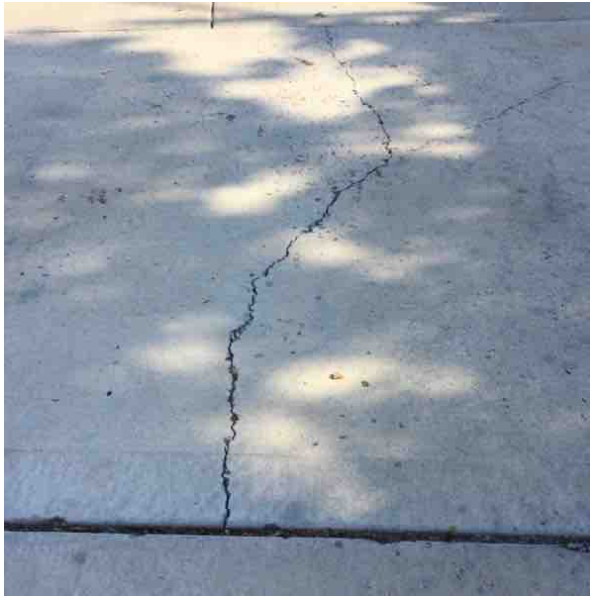
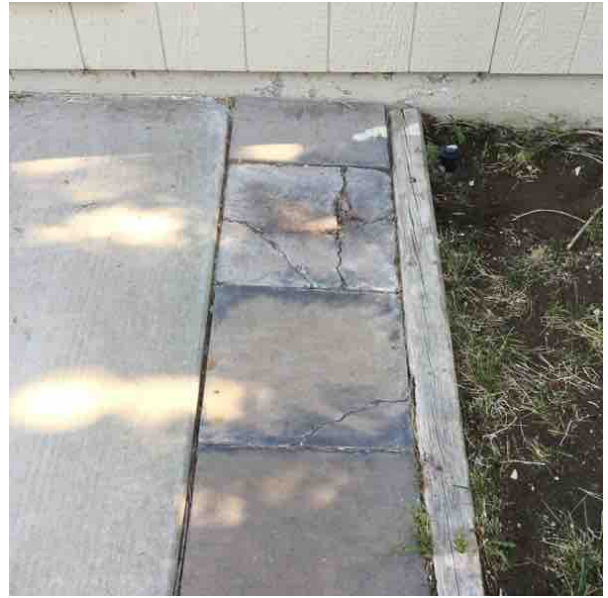
2.2.1 There are common cracks / surface deterioration in the driveway and walkways. Recommend having a contractor evaluate and repair to help minimize further damage.

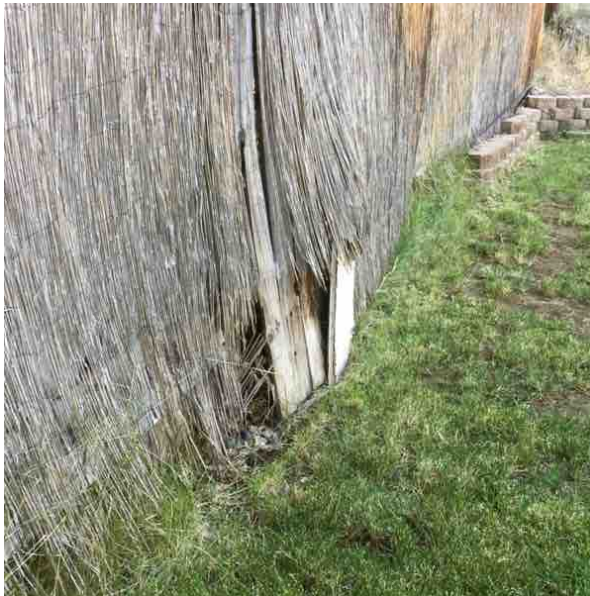
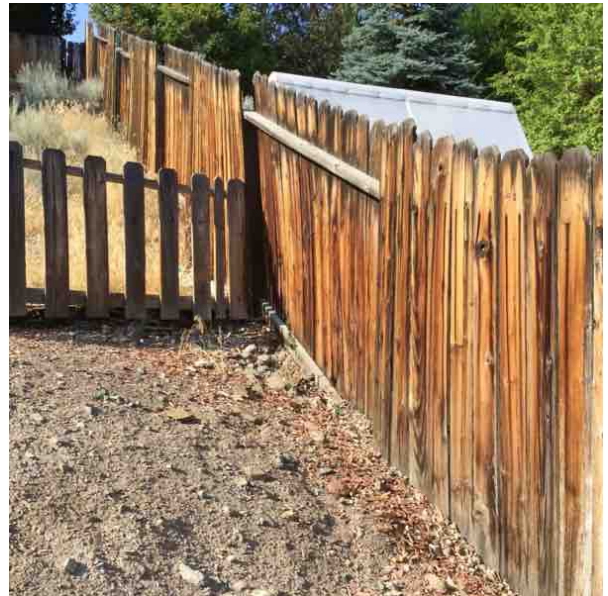
2.3.1 There are a few damaged fence boards, and the fences are loose / leaning in various areas. Recommend having a contractor evaluate and repair to help minimize further damage.

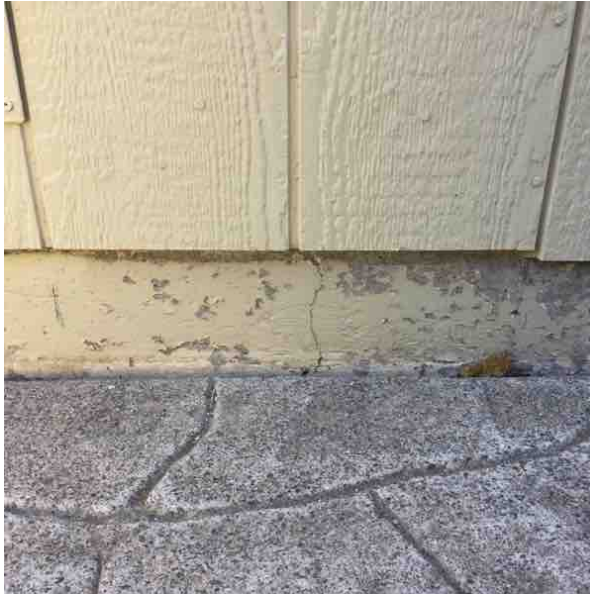
3.2.1 There are common settlement cracks and surface deterioration in the foundation wall surfaces. No indication of a significant structural defect was observed. Recommend having a contractor evaluate and repair as needed to help minimize further damage.

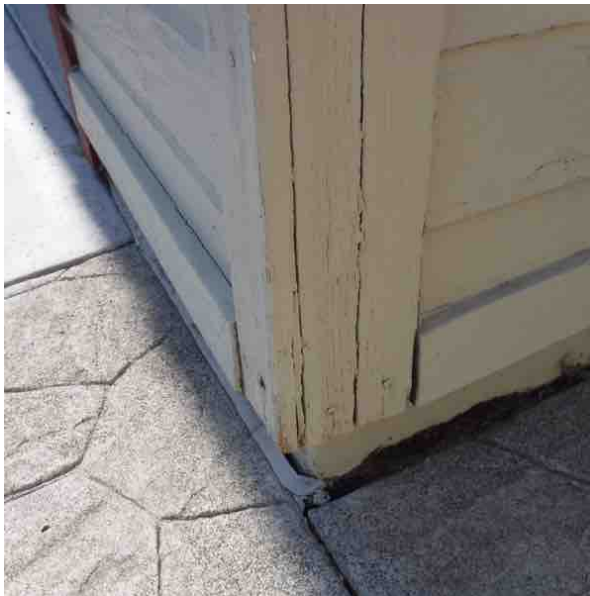
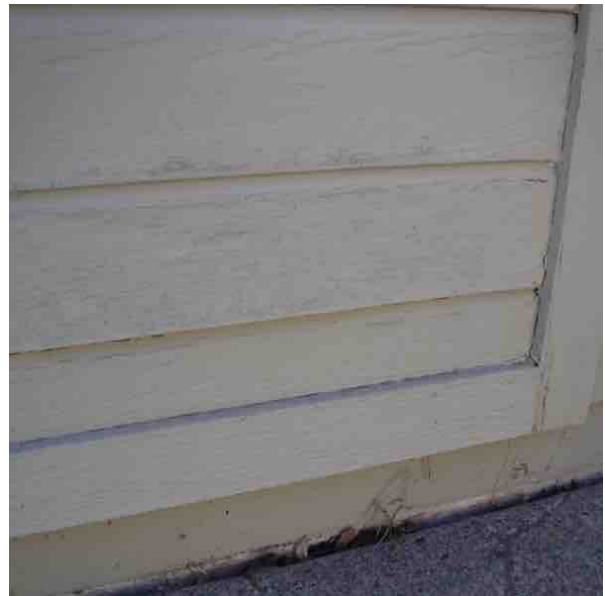
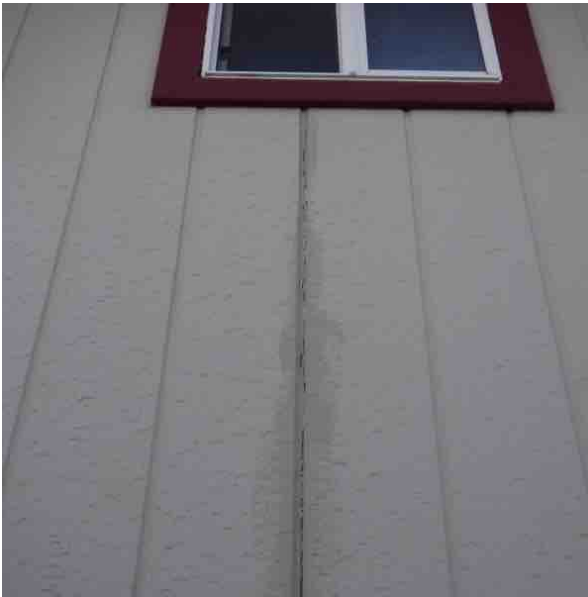
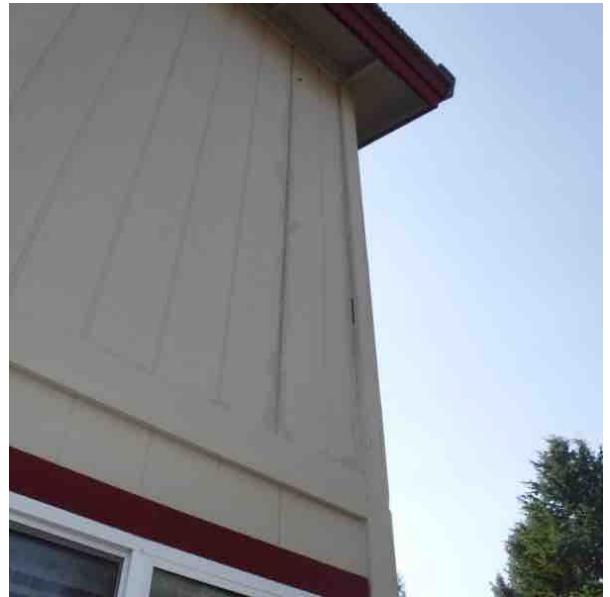
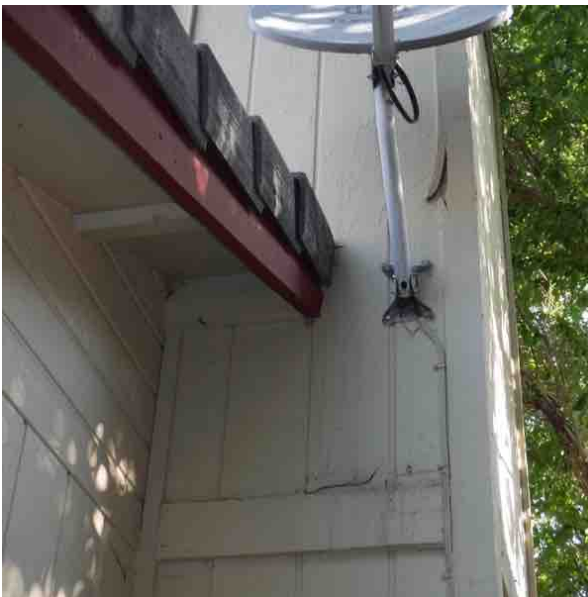
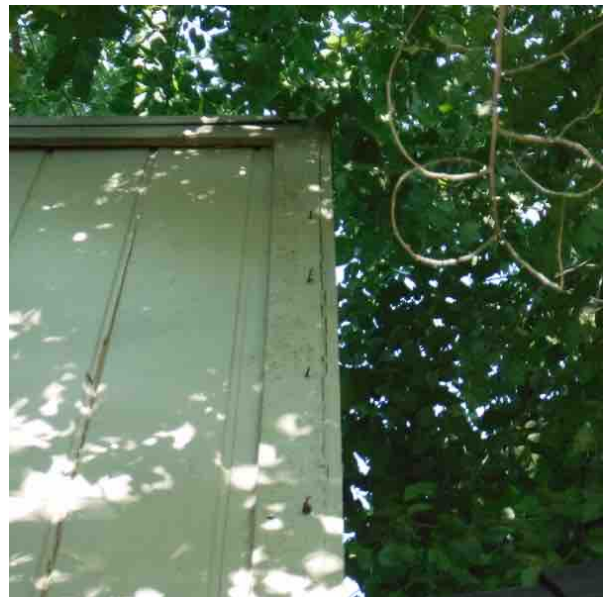
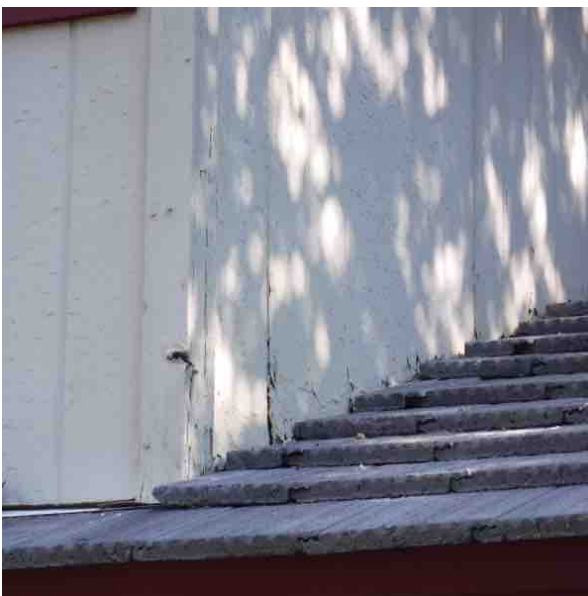
3.3.1 The exterior (siding, trims, frames, and chimney) are generally in fair to good condition with scattered areas of moisture / weather damage and a lack of deferred maintenance - note the wavy siding or slightly swollen ends, moisture damages near the ground, at mid level intersections, and trims. There are sunken or lifted nail heads, small holes, surface damages, deteriorated paint, caulking, finishes, etc. throughout the exterior. Recommend having a contractor evaluate and repair as needed to promote the exterior's lifespan and intended function.

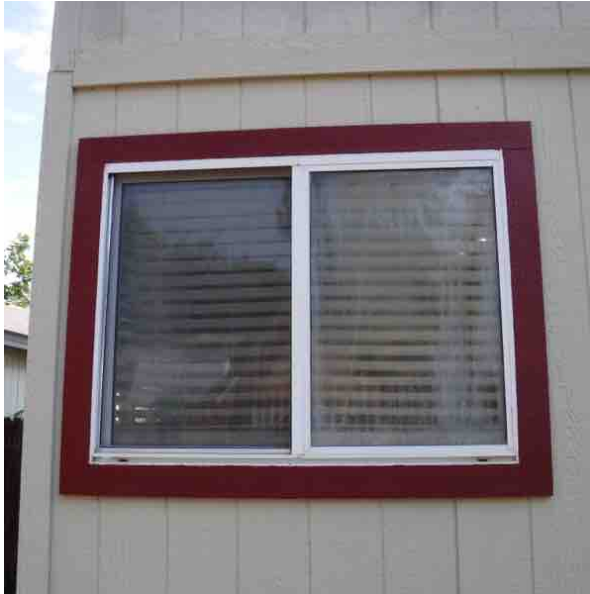
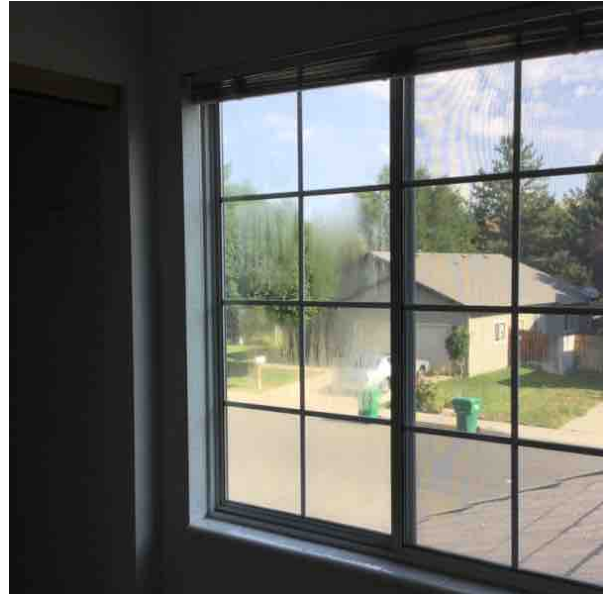
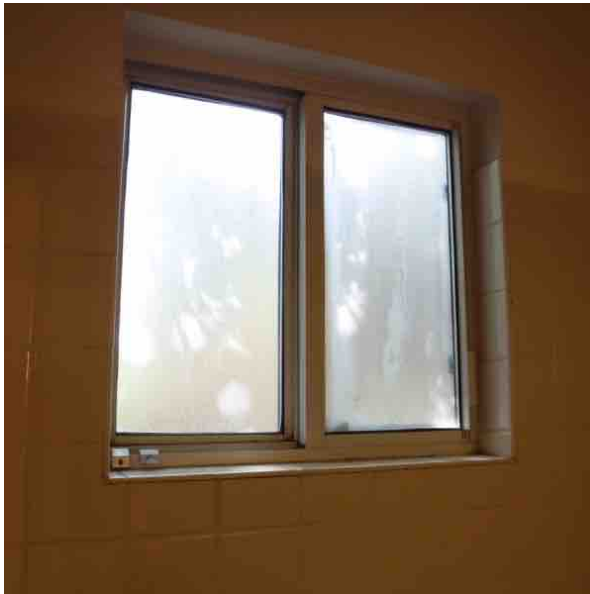
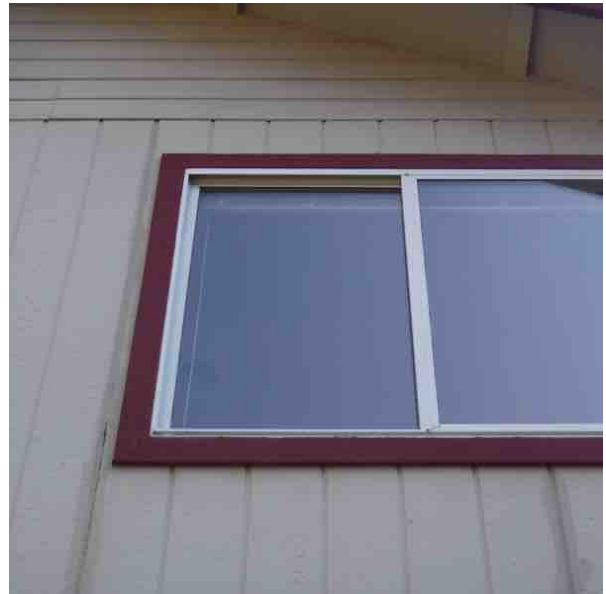
3.5.1 The kitchen, master bedroom, and downstairs guest bathroom windows appear to have failed seals as moisture stains or spotting is visible between panes. A few window screens are missing or damaged. Recommend having a contractor evaluate and repair to help promote proper or improved function.

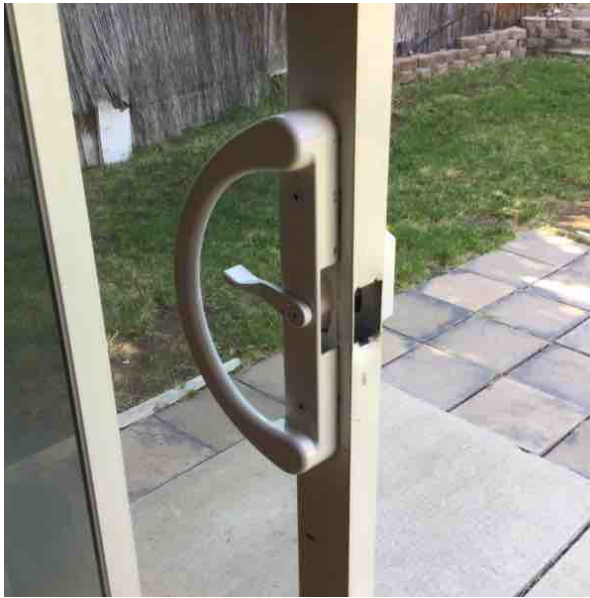
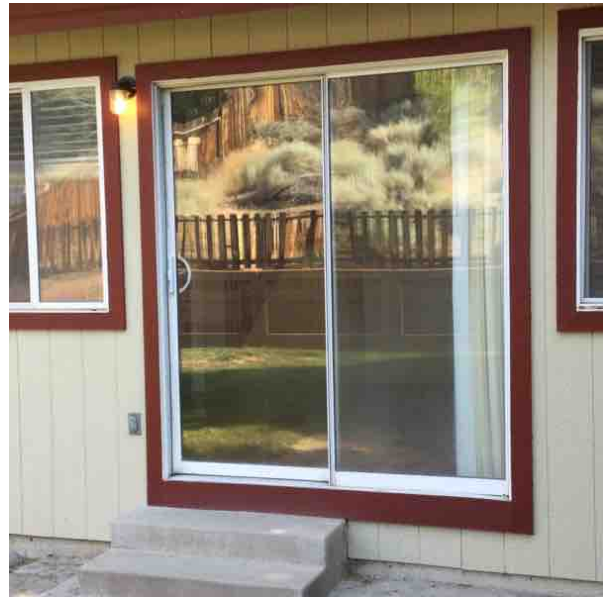
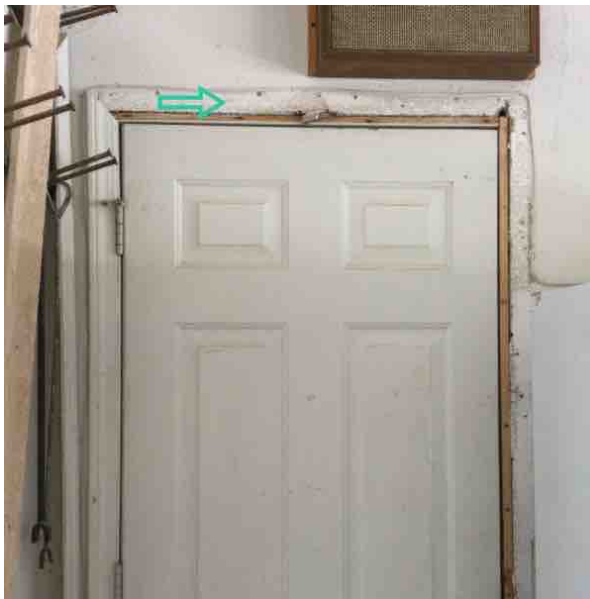
3.6.1 The back sliding door lock is damaged, and the sliding screen door is missing. The garage man door interior frame and insulation are damaged. Recommend having a contractor evaluate and repair to help promote proper or improved function.

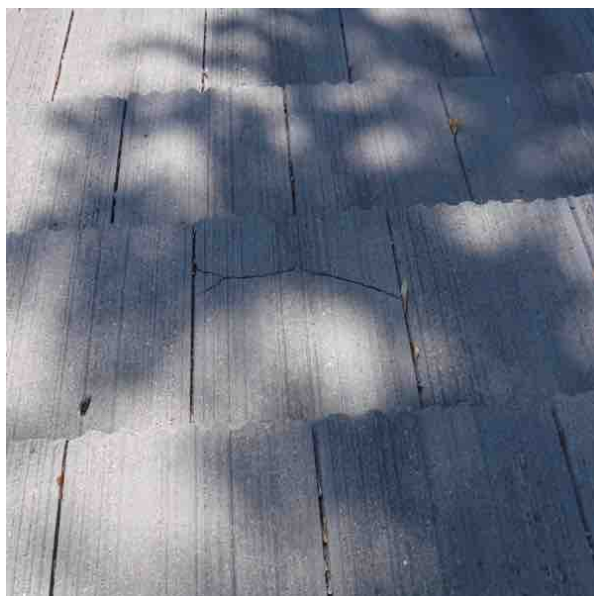
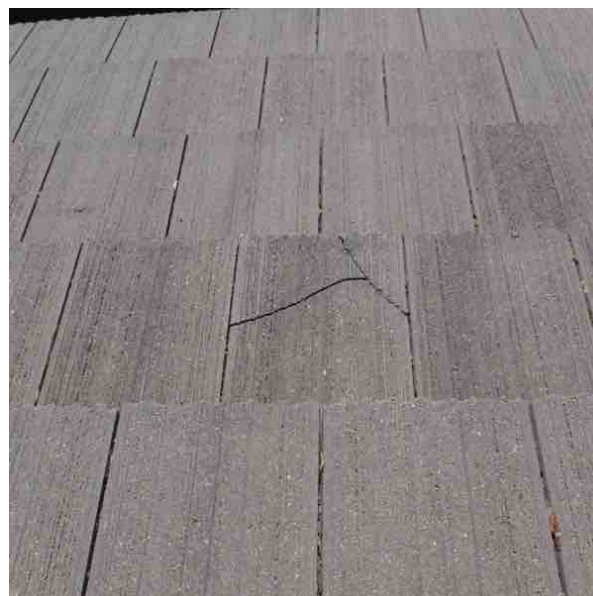
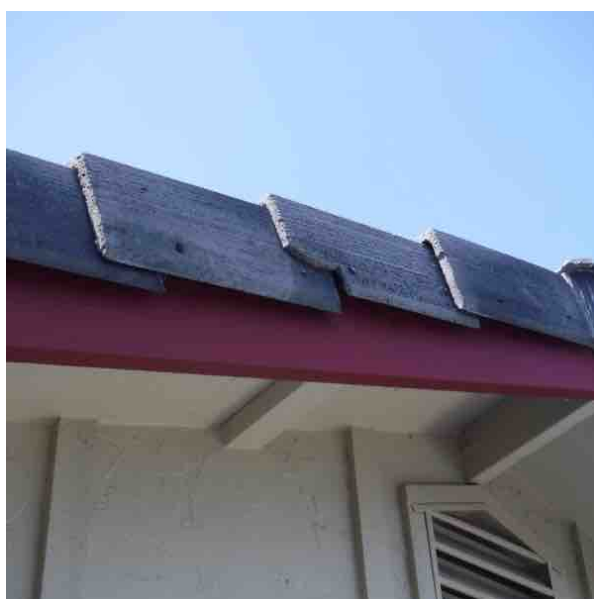
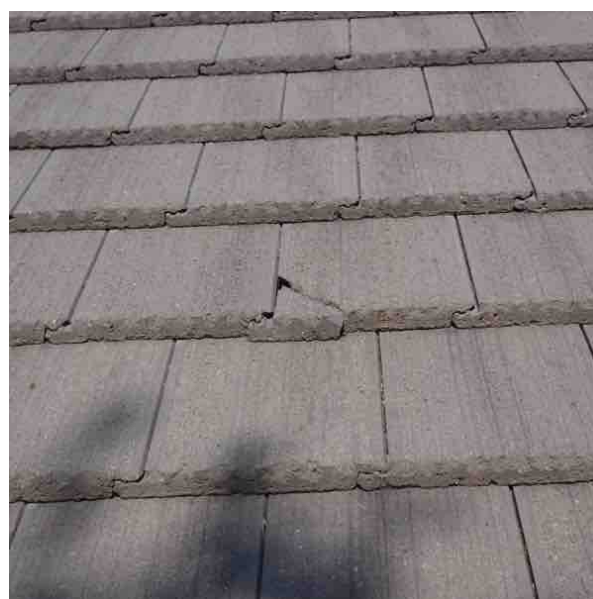
4.3.4 **There are 2 damaged roof tiles over the left side of the garage. There are 2 damaged roof tiles at the 2nd level roof edge, and in the left field. Recommend having a roofer evaluate and repair to help promote moisture protection and proper function.**

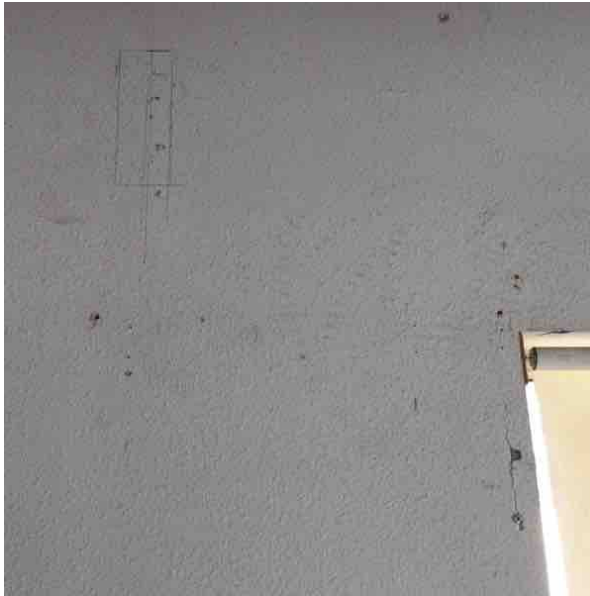
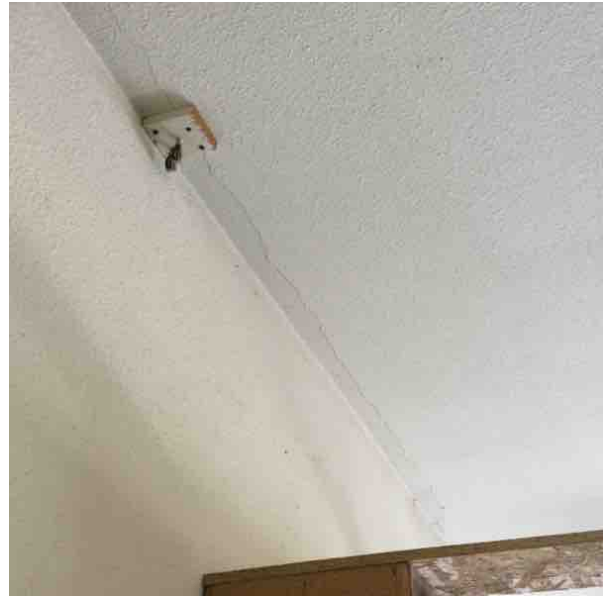
6.1.1 There are common damages to the garage walls / ceiling. Recommend having a contractor evaluate and repair as needed.

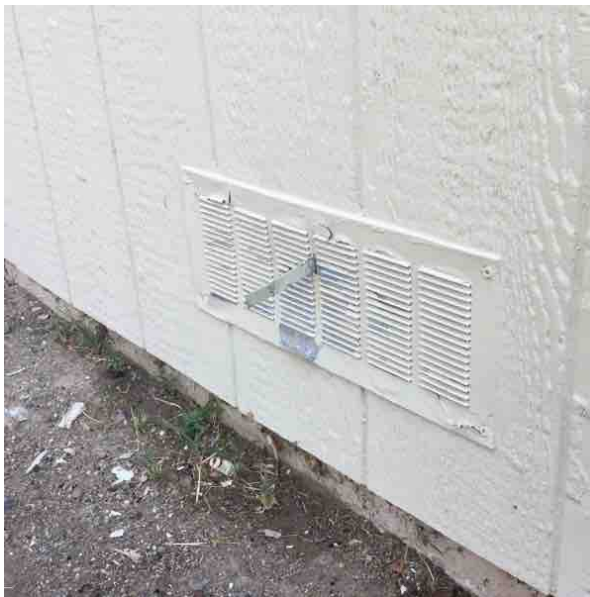
8.2.1 Recommend opening all foundation vents to promote proper crawlspace ventilation.

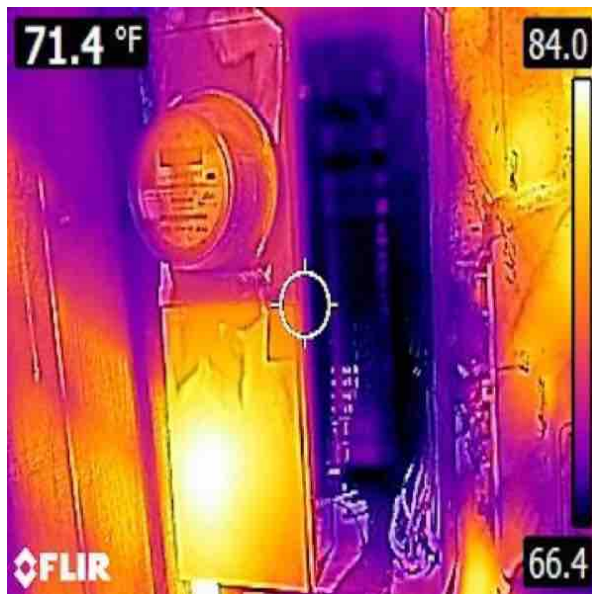
9.6.3 Note: The thermal image(s) show the electrical panel(s) operating under normal conditions. No anomalies were observed.

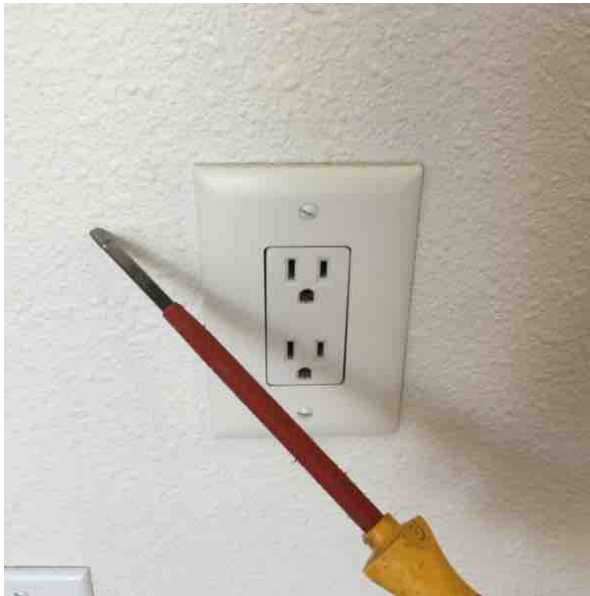
**9.9.3 One of the living room receptacles is loose in the wall. Recommend having an electrician evaluate and repair / secure to help promote or maintain proper function and safety.**

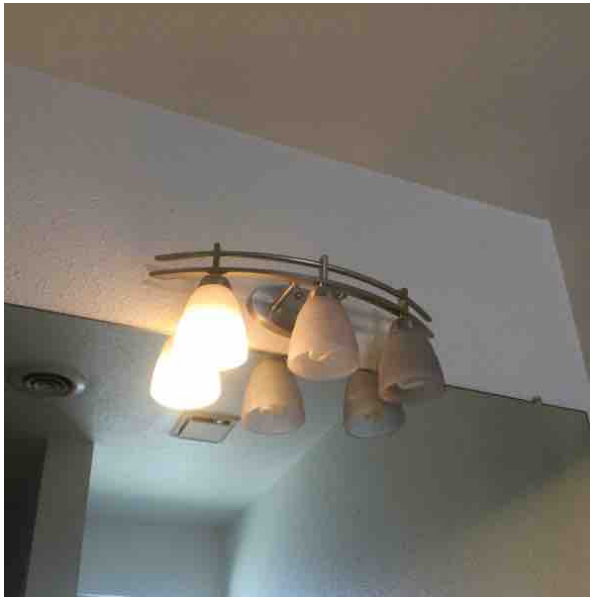
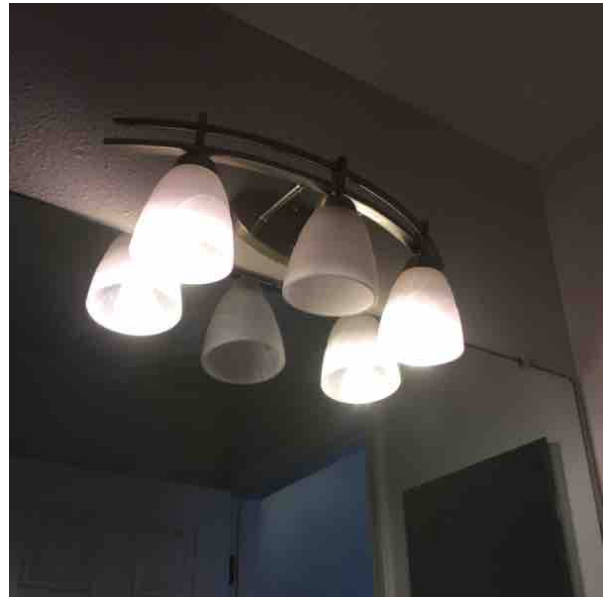
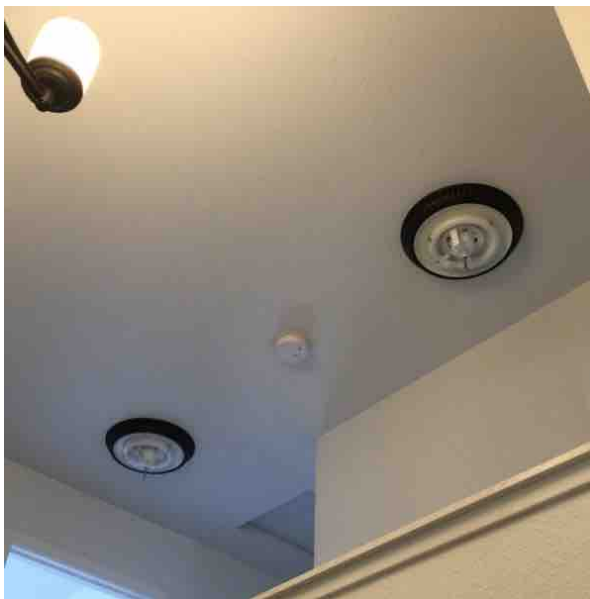
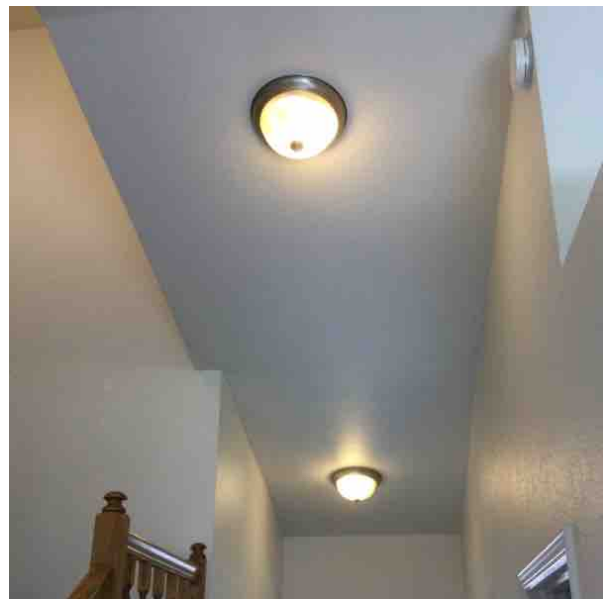
9.10.3 Some of the master and guest bathroom vanity lights do not function. A kitchen spot light does not function. The kitchen, dining area, and hallway lights / ceiling fans do not function properly, and appear to be incorrectly wired or installed. Recommend having an electrician further evaluate and repair for proper function and safety.

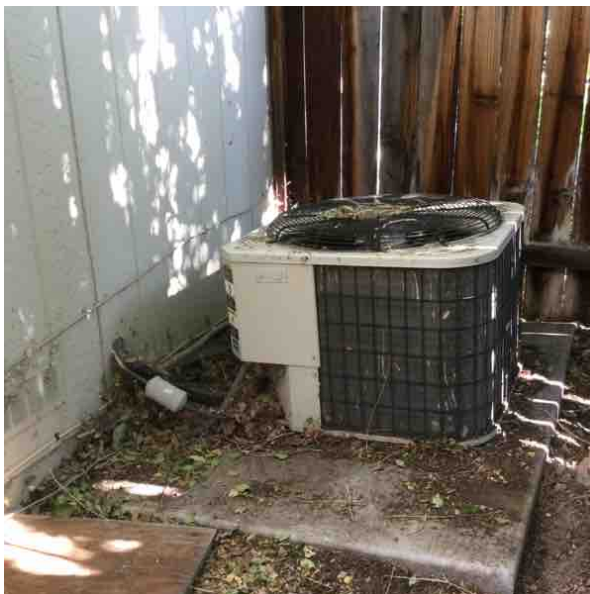
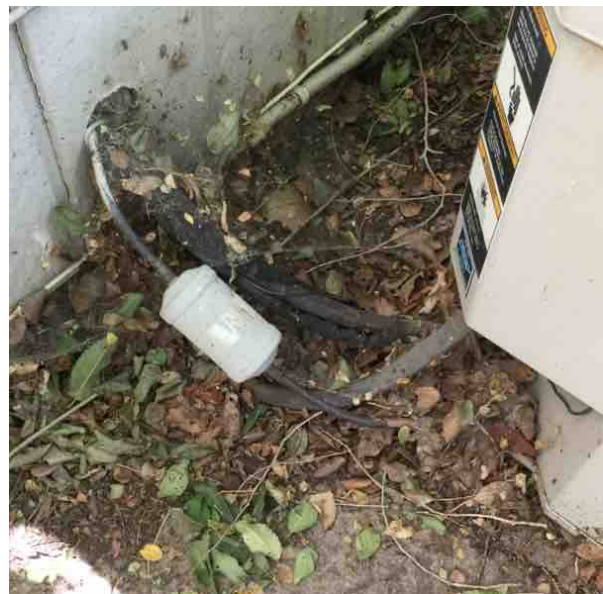
10.6.3 Although functional; due to the age, crooked / dirty condition of the unit, and damaged insulation; recommend having the unit evaluated, serviced / repaired, and cleaned by an HVAC contractor to promote moisture protection, its serviceable lifespan, and efficiency.

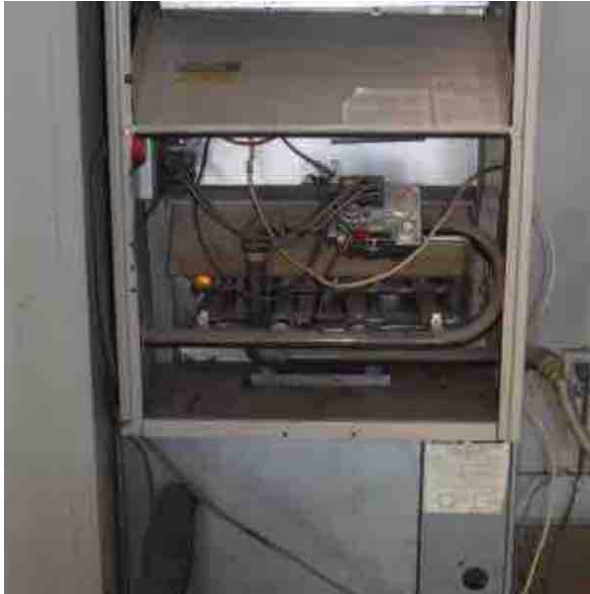
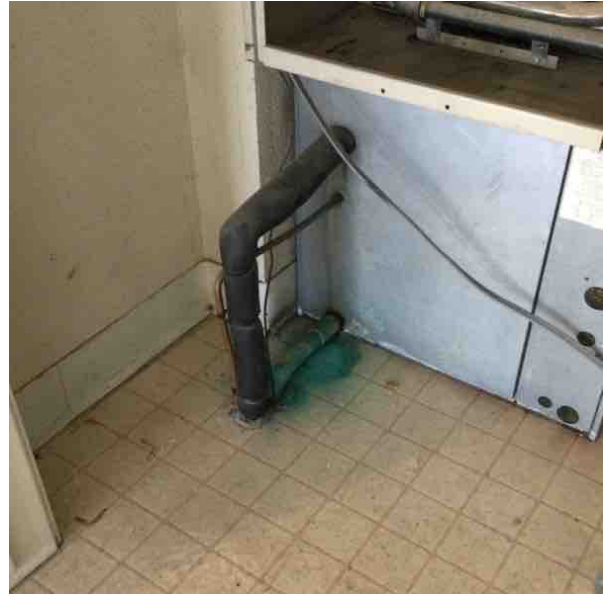
10.7.3 Although functional; Due to the age and dusty condition inside the HVAC enclosure, and the apparent leak at the condensation drain; recommend having the unit evaluated, serviced / repaired, and cleaned by an HVAC contractor to promote moisture protection, its serviceable lifespan, and efficiency.

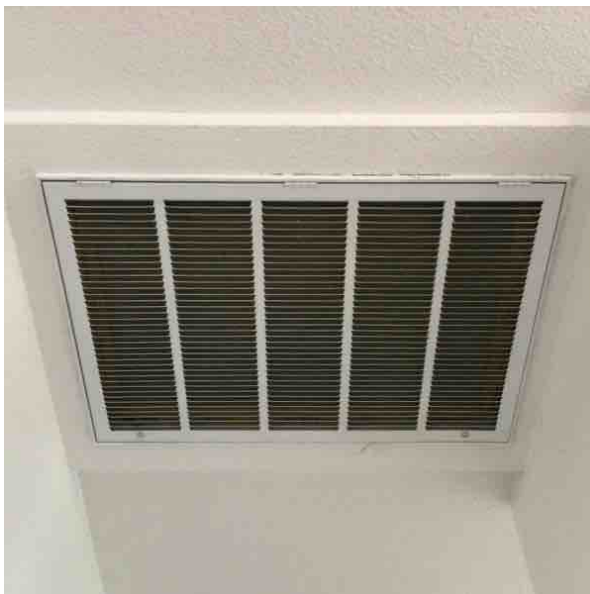
10.11.1 The air return filter is dirty. Recommend replacing.

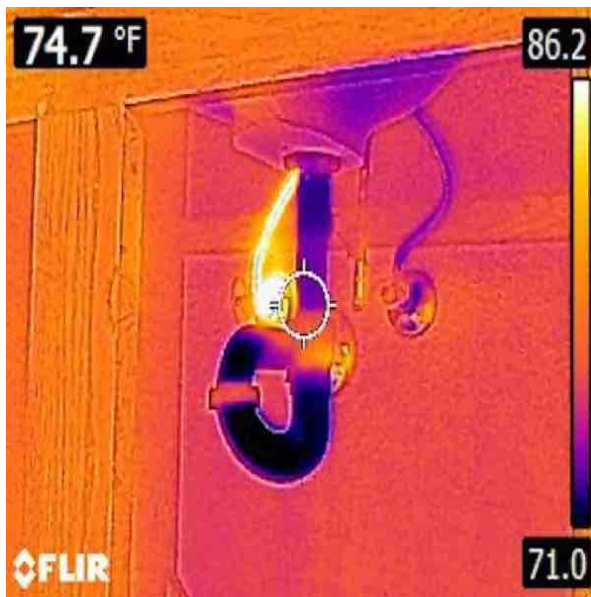
Note: The thermal image shows a plumbing trap operating under normal conditions. No anomalies were observed.

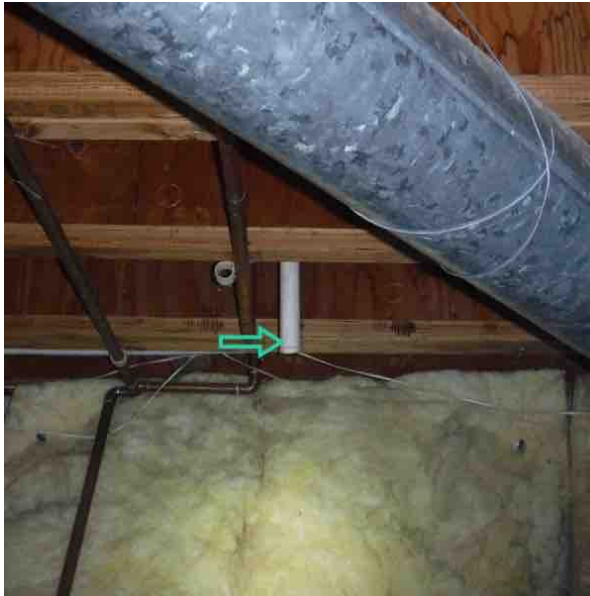
11.5.1 Upgrade: Recommend having a plumber evaluate and route the water heater drain pan pipe from the crawlspace to exterior to help promote moisture protection.

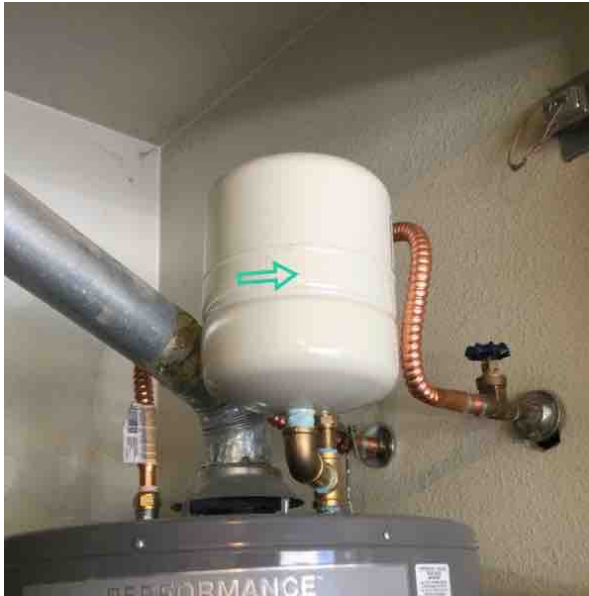
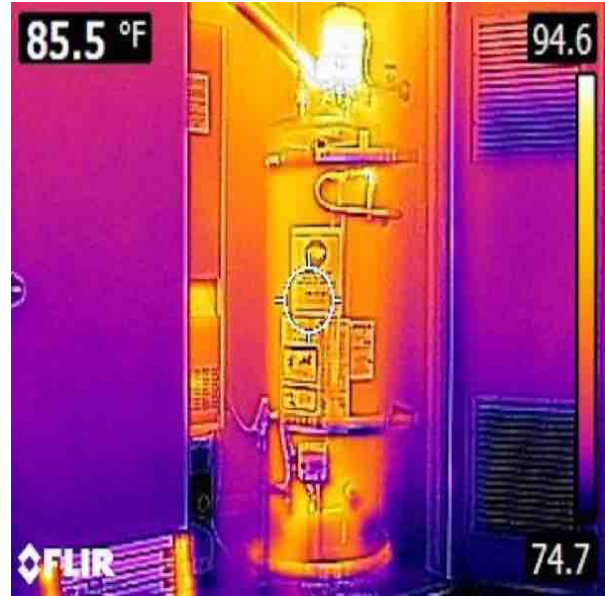
11.6.3 Upgrade: Recommend having a plumber secure the thermal expansion tank to help minimize damage / leak potential.

Note: The thermal image shows the water heater under normal conditions. No anomalies were observed.

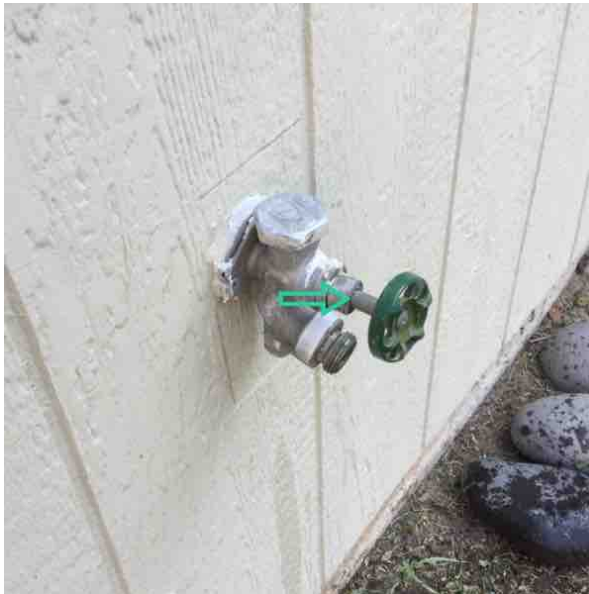
11.8.2 Both of the hose bibs leak at the handle when operated. Recommend having a plumber evaluate and repair for proper function and moisture protection.

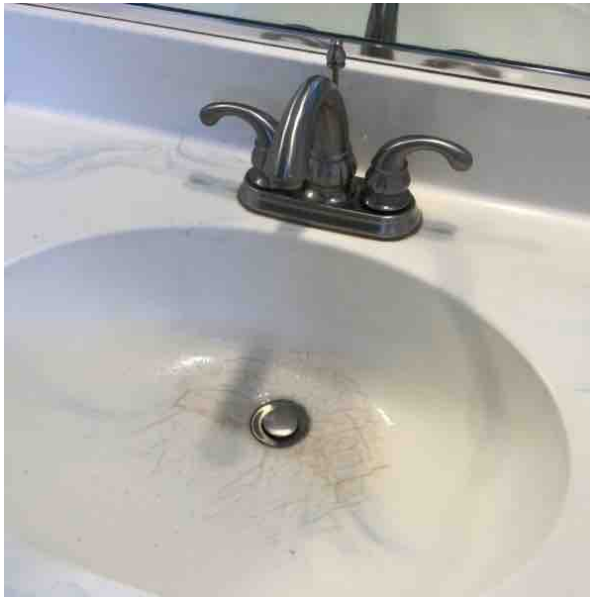
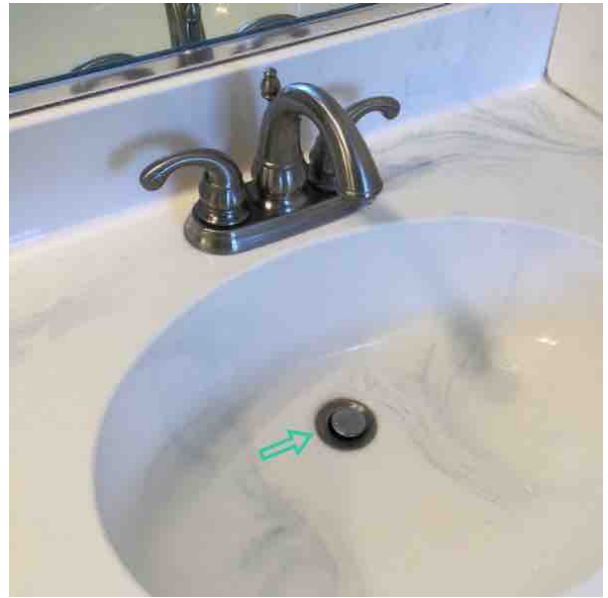
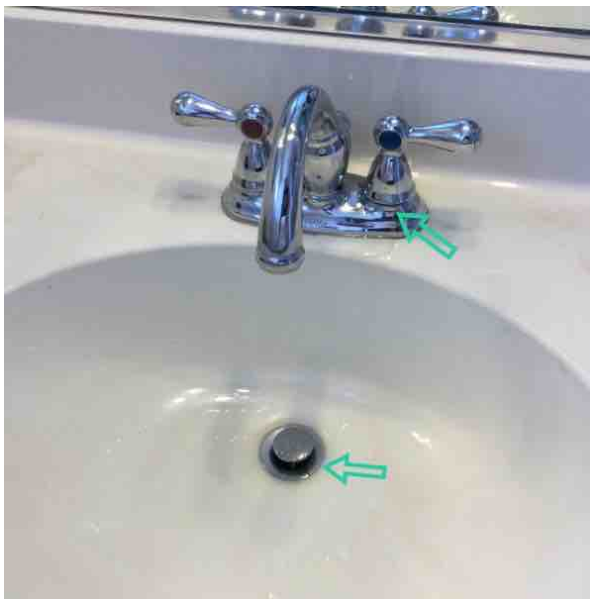
11.9.2 The left master bathroom faucet leaks in the off position, and the sink surface is damaged. The right master bathroom sink stopper does not function. The upstairs guest bathroom sink stopper does not seal properly, the drain inlet is damaged, and the cold water faucet handle leaks when operated. Recommend having a plumber evaluate and repair for proper function and moisture protection.

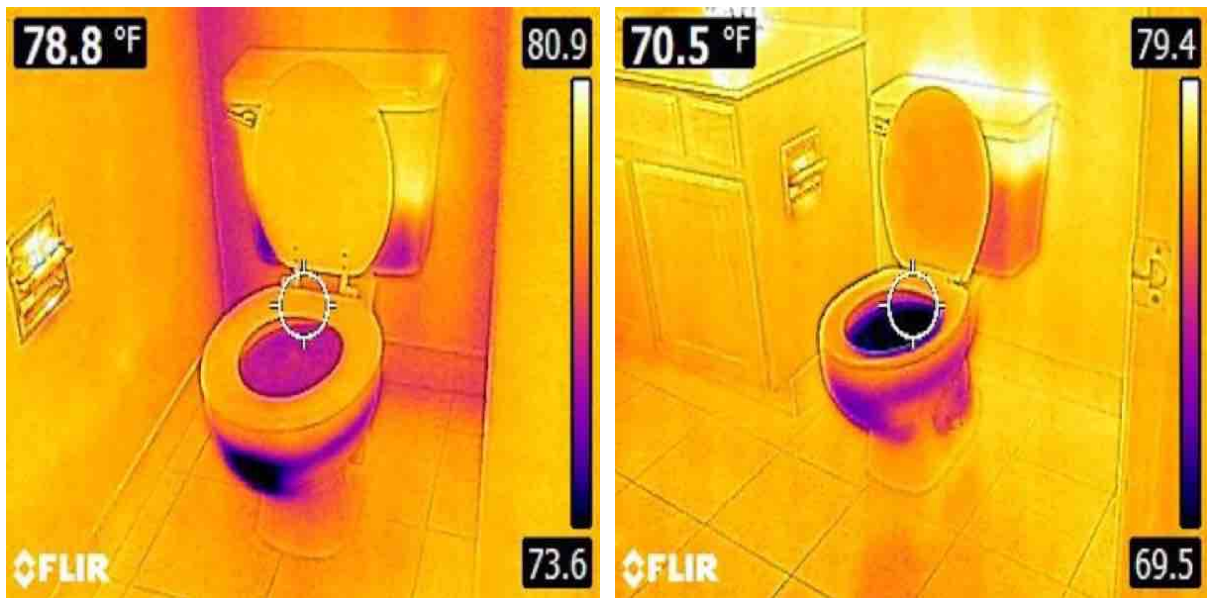
11.10.2 Note: The thermal images show the upstairs toilets under normal conditions. No anomalies were observed.

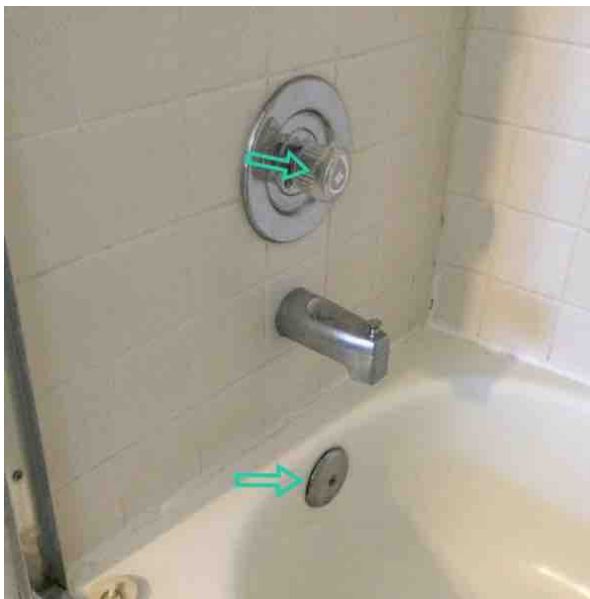
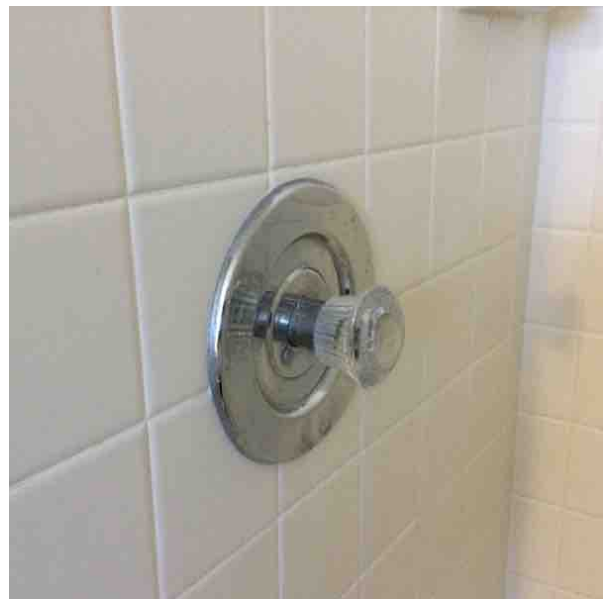
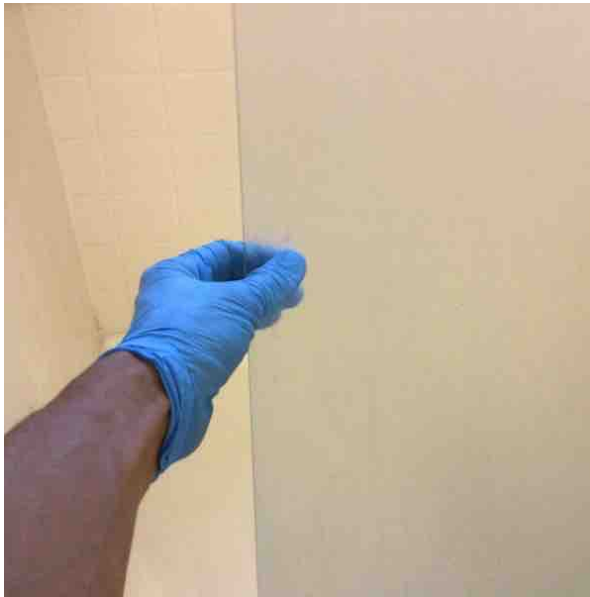
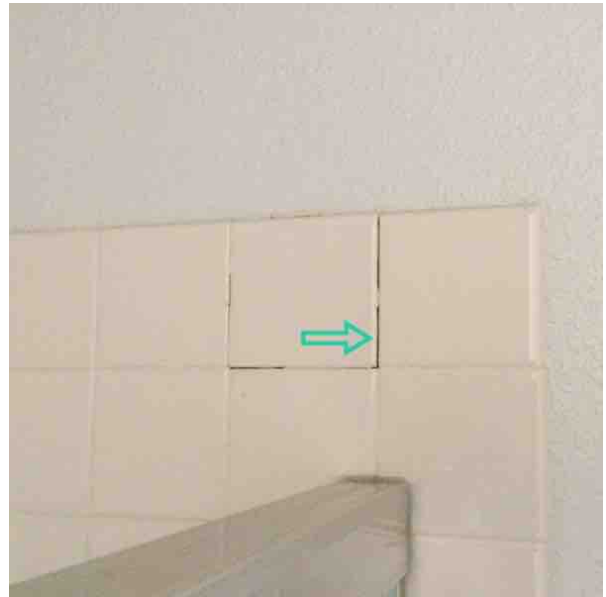
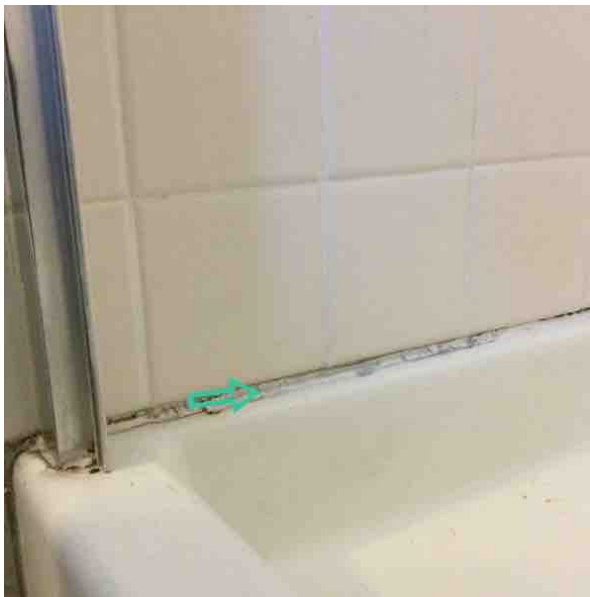
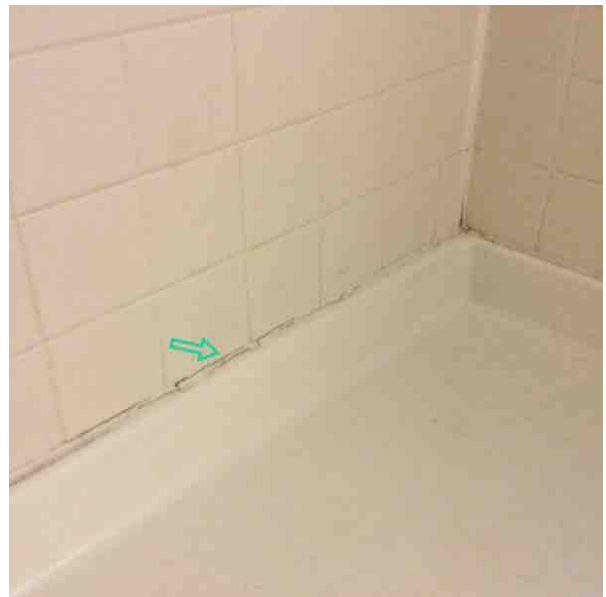
11.11.2 The master tub faucet handle lacks a positive stop, and the overflow drain is loose / upside down. The upstairs guest shower faucet assembly is loose in the wall. The downstairs guest shower door handle is missing. The grout and caulking is damaged in all 3 tub / shower surrounds. Recommend having a plumber evaluate and repair for proper function and moisture protection.

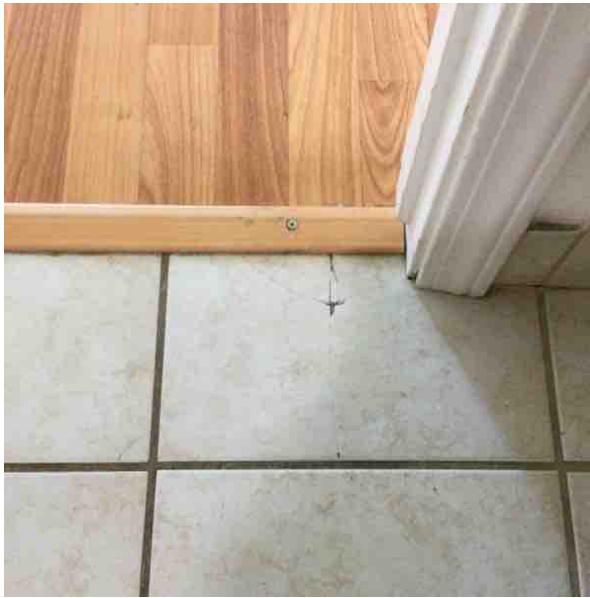
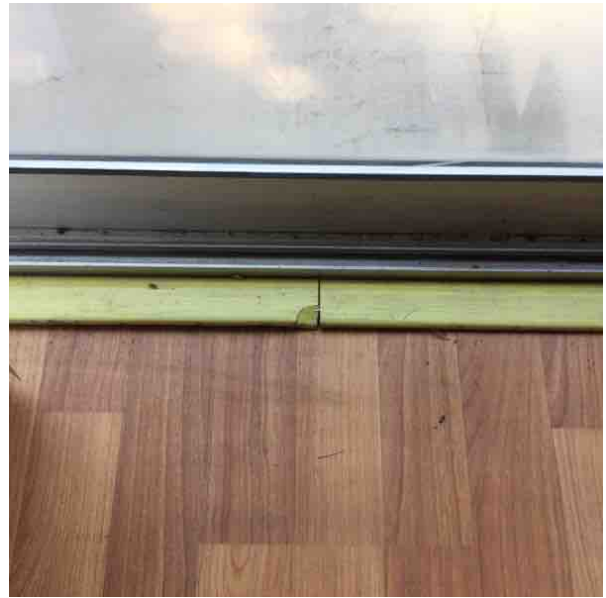
12.2.1 There is a damaged floor tile in the laundry room. The trim is damaged near the back sliding door. There are a few gaps in the laminate flooring intersections. Recommend having a contractor evaluate and repair.
