## Home Inspection Report

PROPERTY INSPECTED:  
**2195 Canyon Point Court**  
**Sparks, NV 89436**

**Date of Inspection: 07/18/2024**

Inspection No. 401124-1-2109

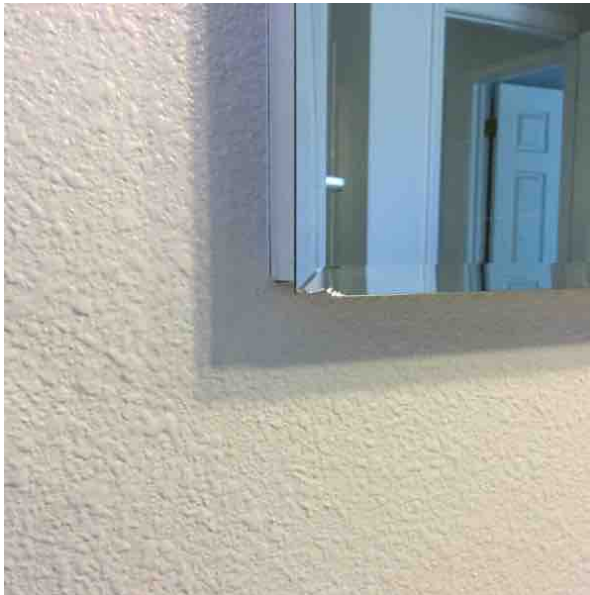
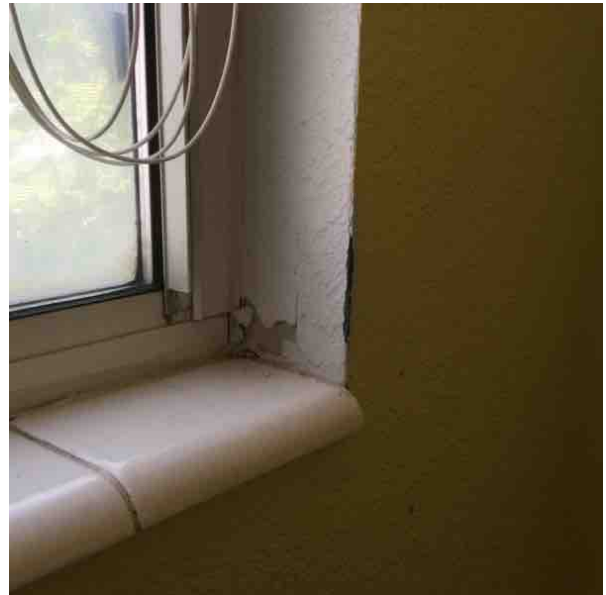
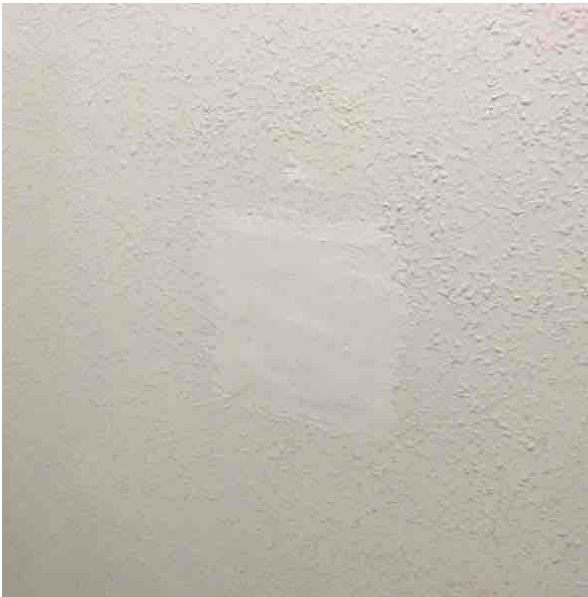
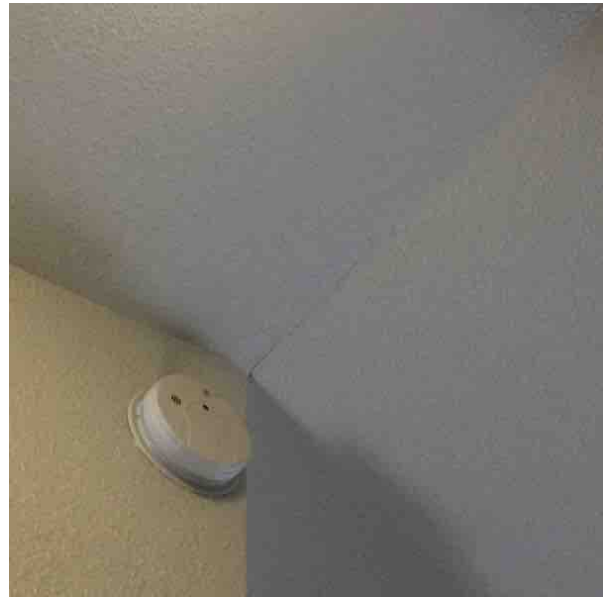
12.3.1 The upstairs guest bathroom mirror is damaged. There are a few common wear and tear damages, blemishes, patches, settlement cracks, nail pops, and small holes in the walls, ceilings, and surfaces throughout the house. Recommend having a contractor evaluate and repair.

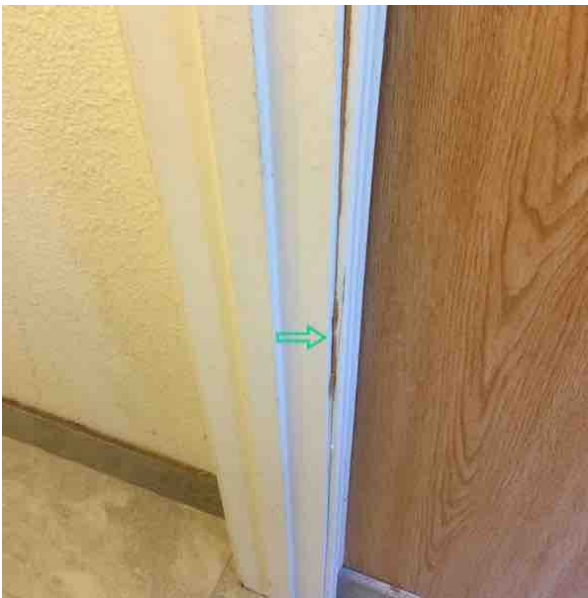
12.5.1 The pantry door frame or casing is damaged. Recommend having a contractor evaluate and repair.

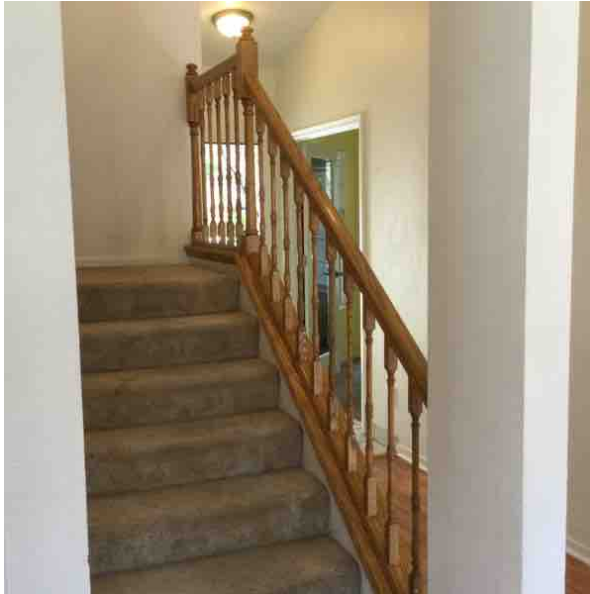
12.6.1 The lower hand / guard rail is loose. Recommend having a contractor evaluate and repair / secure to promote safety.

Upgrade: Recommend having a contractor evaluate and upgrade the hand / guard rails to modern safety standards to help promote safety from falls.

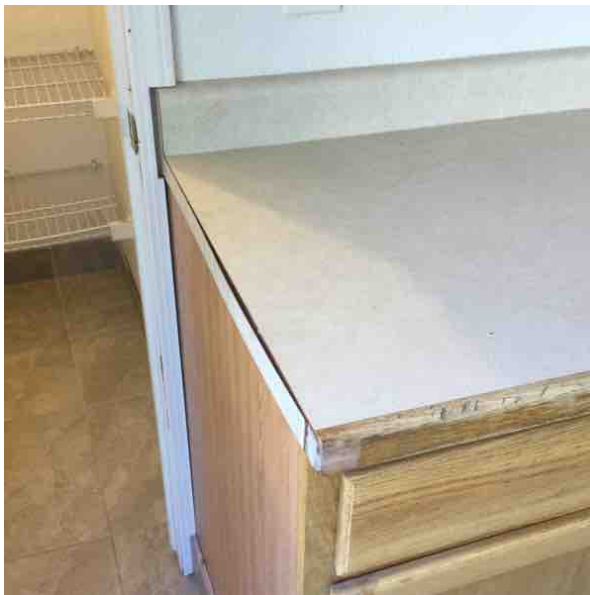
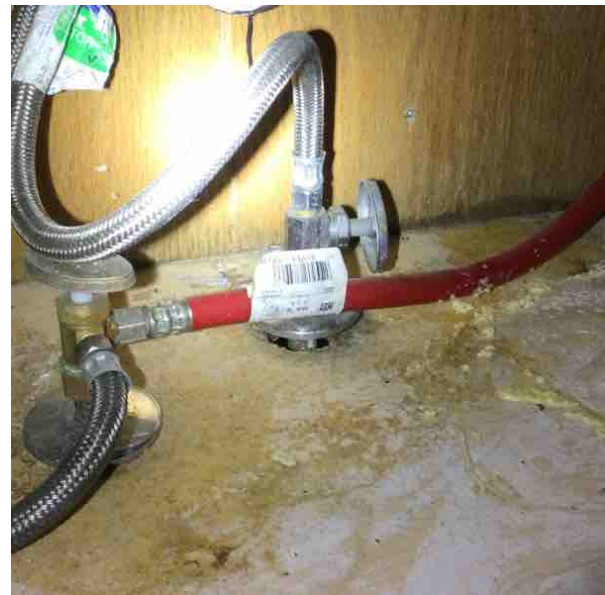
12.7.1 There are common wear and tear damages at the cabinets and countertops. There are gaps in the cabinet below the kitchen sink that may allow for rodent intrusion. Recommend having a contractor evaluate and repair.

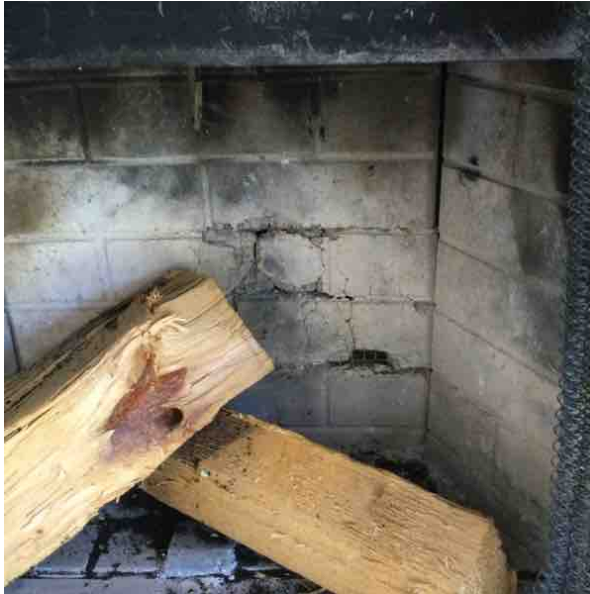
13.1.1 The back refractive panel is damaged in the fireplace enclosure. Recommend having a chimney sweep evaluate and repair prior to use.

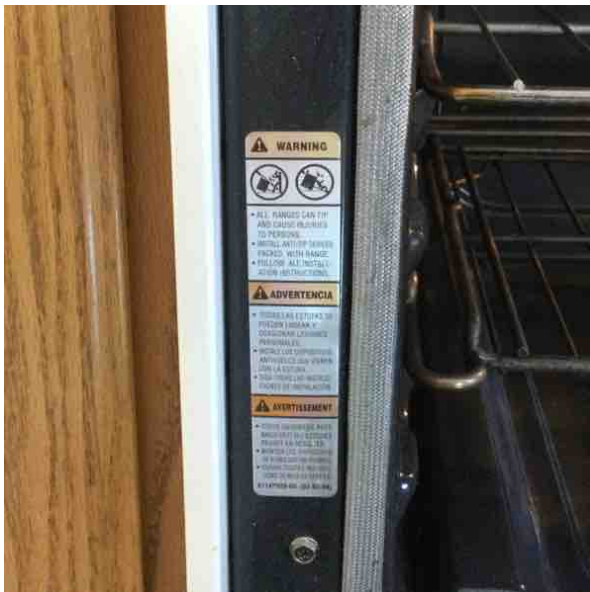
14.3.2 The range is missing its anti - tip bracket. Recommend having a contractor install the appropriate bracket to promote safety.

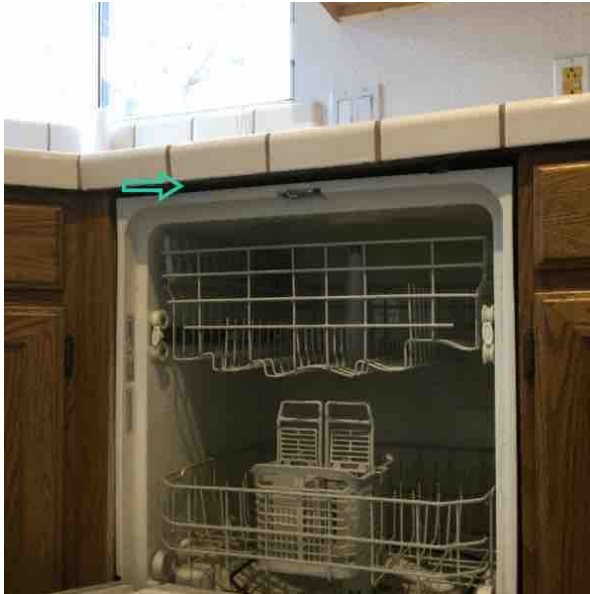
14.5.2 The dishwasher is loosely secured in the cabinets. Recommend having a contractor evaluate and repair / secure.
