EAGLE ROCK INSPECTIONS

## RESIDENTIAL PROPERTY INSPECTION

3293 Belford Rd  
Reno, NV 89509

Dawn Koerner  
07/28/2026

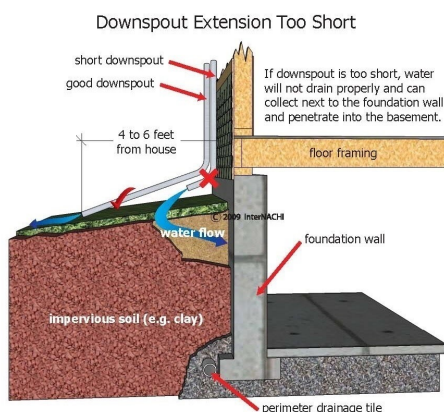
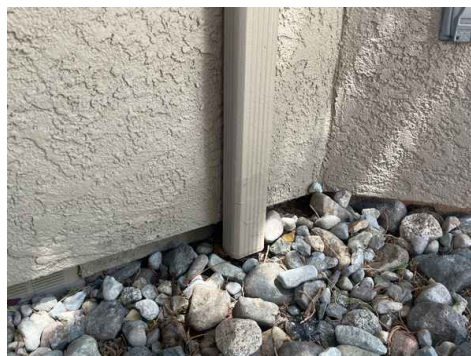
#### 4.9.1 Gutters/Downspouts

### DOWNSPOUT - MISSING ELBOW AT BASE

The downspout at the northeast corner of the house was missing the bottom elbow. This piece directs the rainwater away from your home's foundation to prevent water damage and erosion. Repairs should be made by a qualified person.

Marginal Defect

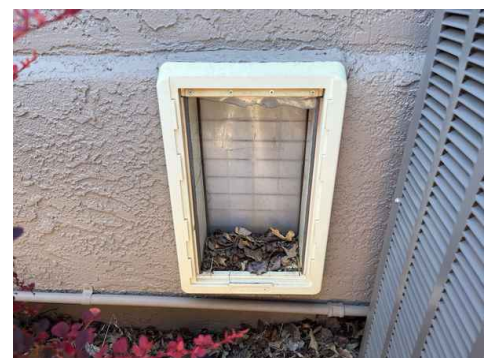
There was a pet door cut into the back wall. This opening may allow air and dust/debris into the house and is an avenue for moisture to enter the wall cavity. If this opening is not closed up, recommend the wall seal around it be maintained.

Minor Defect, Maintenance Item, or FYI Item

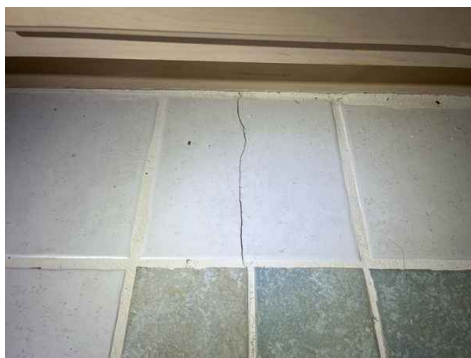
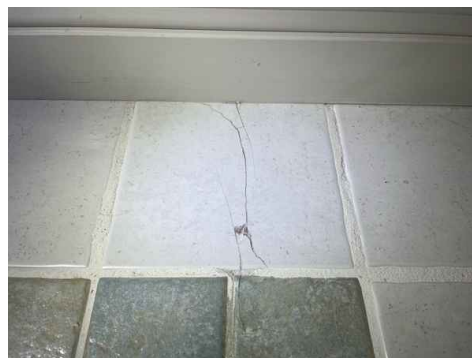
##### DOWNSTAIRS HALLWAY BATHROOM

There were cracked and/or damaged tile(s) present at the referenced area(s). An evaluation of the tile floors in the home is recommended to be performed by a qualified professional with replacement of any damaged or cracked tile(s) made as needed.

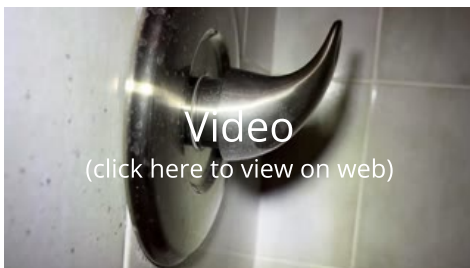
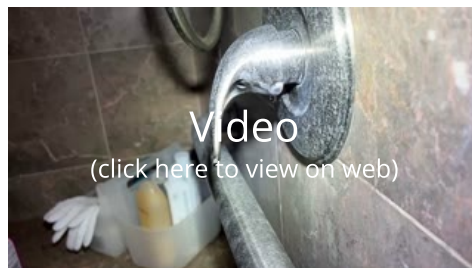
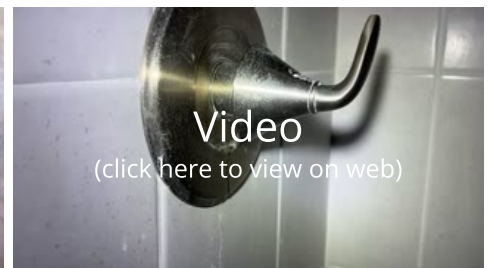
UPSTAIRS HALLWAY BATHROOM, MASTER BATHROOM, DOWNSTAIRS HALLWAY BATHROOM

A water leak was present from the faucet mixing valve. Repairs are recommended to be performed as needed by a licensed plumber to rectify the leak.

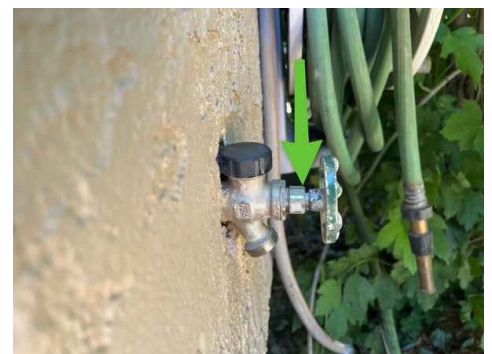
EAST SIDE YARD

#### VALVE STEM - LEAKING

The referenced hose bibb(s) leaked from the valve stem area while under pressure. Repairs are recommended to be performed as needed by a licensed plumber or other qualified person for proper operation.

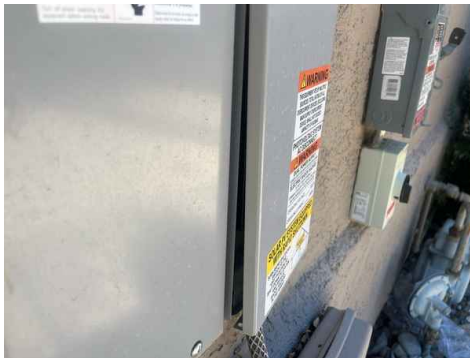
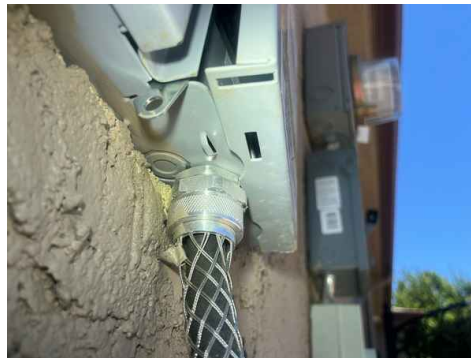
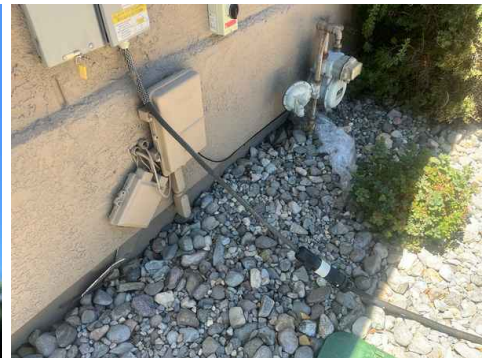
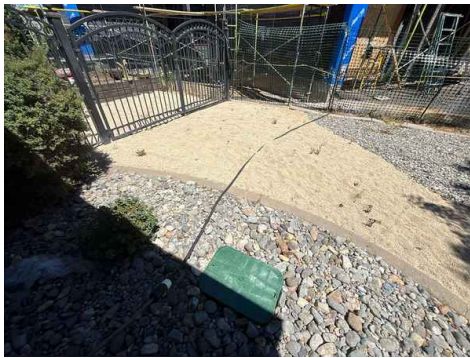
#### COVER - OBSTRUCTION

The main electrical panel exterior cover cannot fully close due to obstruction. A 240-volt cable has been added to the panel, creating the obstruction, to power a neighboring property for construction purposes. This cable creates a safety hazard and should be removed, and the exposed knockout hole should be properly sealed to prevent electrical hazards and pest entry. Recommend further evaluation with repairs made by a qualified electrician.

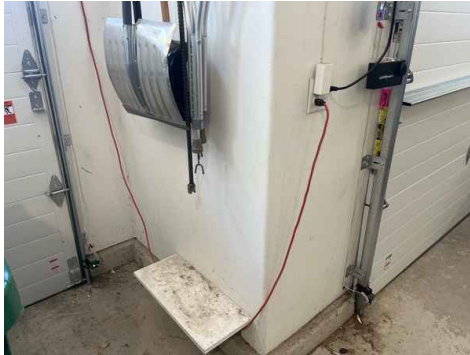
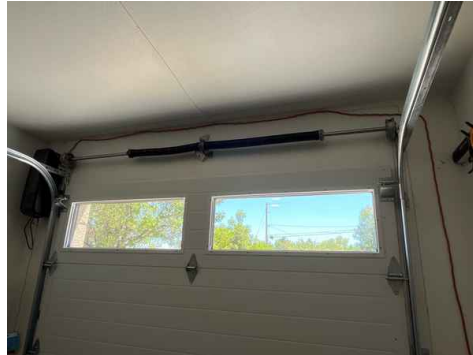
### GARAGE - SMALL GARAGE DOOR OPENER

## WIRING - EXTENSION CORD USED

An extension cord was used as a permanent source of wiring. Extension cords should not be used as a substitute for permanent wiring and are for temporary use only. The installation of a permanent wiring solution is recommended to be performed here by a licensed electrician.

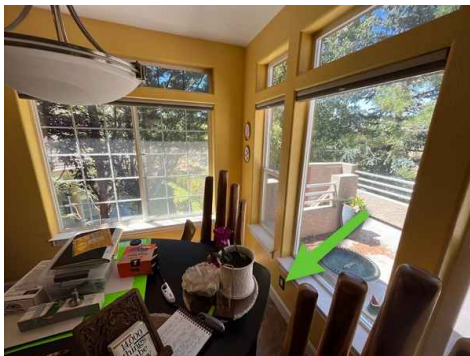
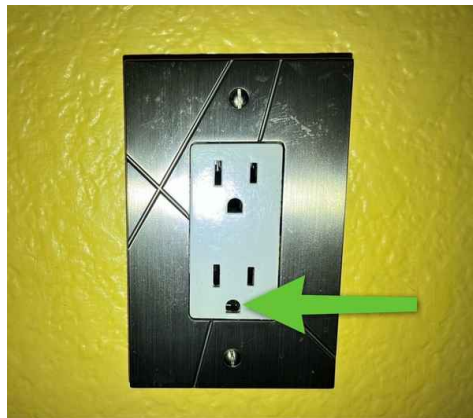
### KITCHEN NORTH WALL

## GROUND SLOT - OBSTRUCTED

There is an object obstructing the ground slot in the referenced outlet that should be removed or repaired.

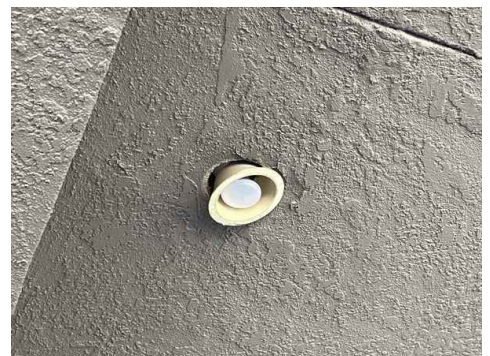
### REAR PATIO

## EXTERIOR LIGHT(S) - LOOSE

Referenced light fixtures were loose at the referenced area(s). Recommend repairs by a qualified person.

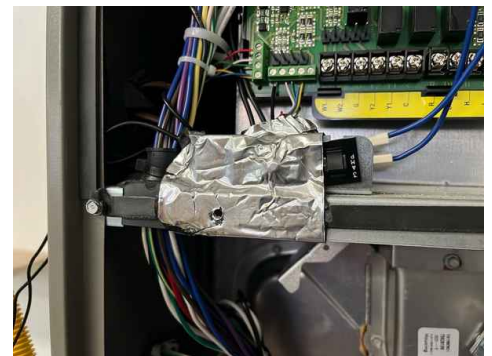
### BLOWER CABINET - TAPED INTERLOCK SWITCH

The blower cabinet door interlock switch did not shut the blower when the panel was opened due to being taped. The tape should be removed and any repairs as necessary by a licensed HVAC contractor.

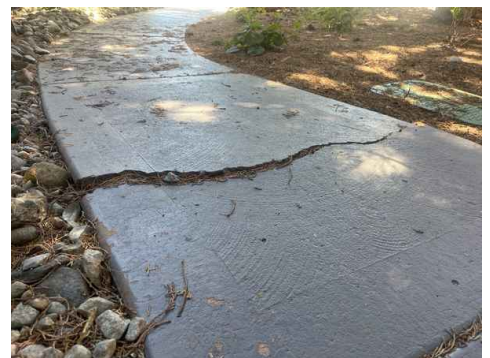
##### ENTRY WALKWAY

There are predictable chips and cracks in the flatwork that would not necessarily need to be serviced. Some areas have settling, deterioration, offsets or cracks that may be trip hazards that you may wish to evaluate for repair. Offsets and surface deterioration were observed mostly in the front driveway areas.
