# Inspection Report

2987 Del Rio Ln  
Minden NV 89423

## Clear Choice Home Inspection Services

| <b>Date:</b> 9/7/2026 | <b>Time:</b> 09:00 AM | <b>Report ID:</b> SPA298 |

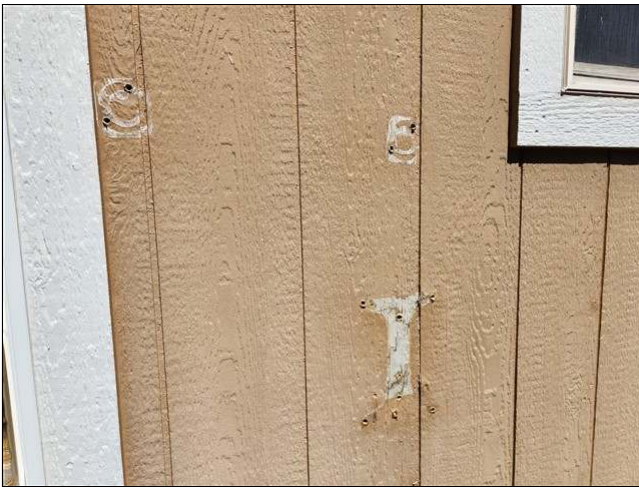
(2) Maintenance item... Recommend caulking maintenance at the South wall cladding, where holes have been made through the siding for mounting brackets. Recommend seal holes with approved exterior Sealant to prevent moisture intrusion behind wall cladding materials.

1.1 Item 1(Picture) caulking maintenance at the South wall cladding

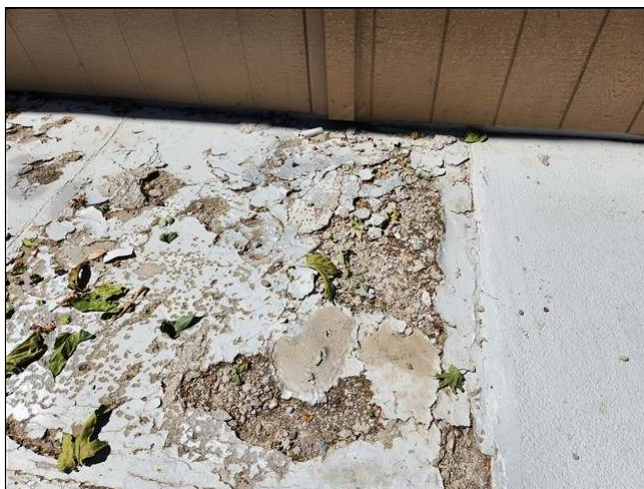
(2) Some Spalling damage of the concrete surfaces was noted at the driveway behind the main house garage. Spalling is the result of moisture freezing within the cracks of concrete surfaces that causes pieces of the concrete to break loose when freezing water expands as it turns into ice. NOTE: This condition does not appear structural, but rather cosmetic.

1.7 Item 1(Picture) Spalling damage of the concrete surfaces

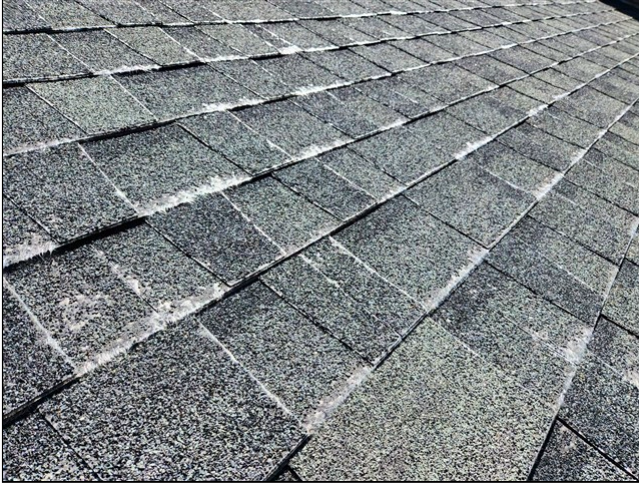
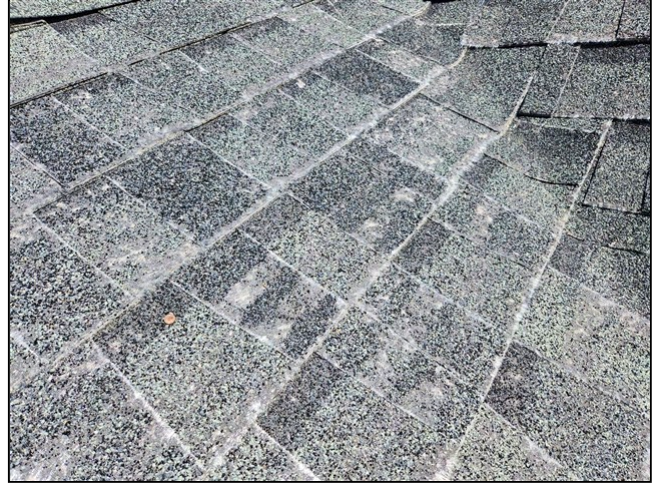
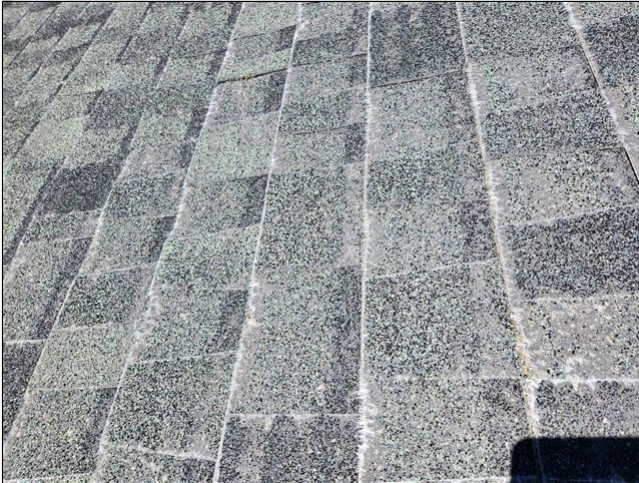
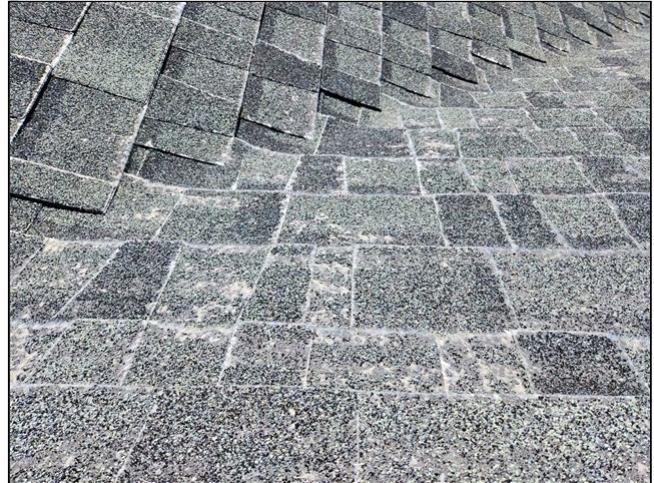
The roof covering appears to be original (36 years) and is a 40 year architectural, asphalt/fiberglass Composition shingle with a few years of it's life remaining (with proper maintenance and repairs). Typical loss of granules noted from shingles, however is more advanced at the South slope of roof. Recommend further evaluation of roof covering materials by a licensed Roofing Contractor for estimated remaining life of roof, due to amount of bare fiberglass shingle edges noted.

2.1 Item 1(Picture) condition of south shingles

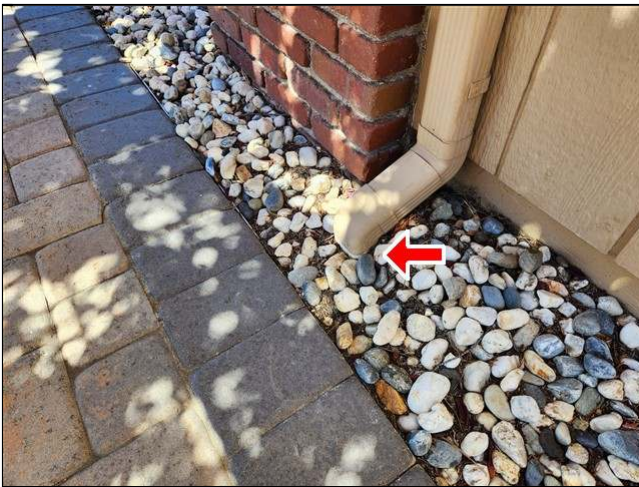
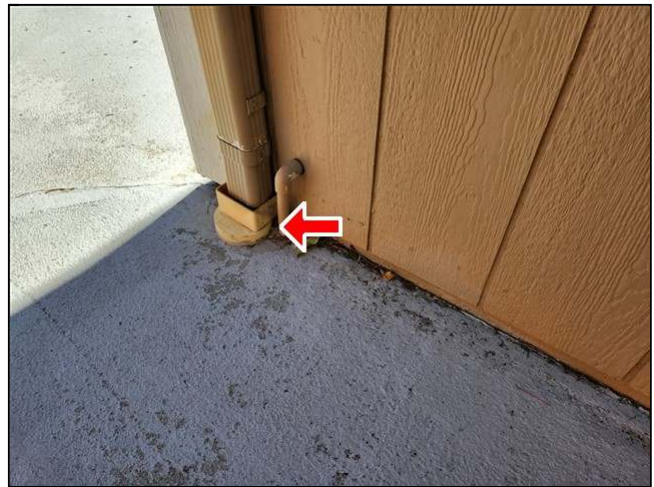
(2) NOTE: I am unable to determine if in-ground drains for gutter downspouts operate as intended.

2.4 Item 1(Picture) in-ground drains for gutter downspouts

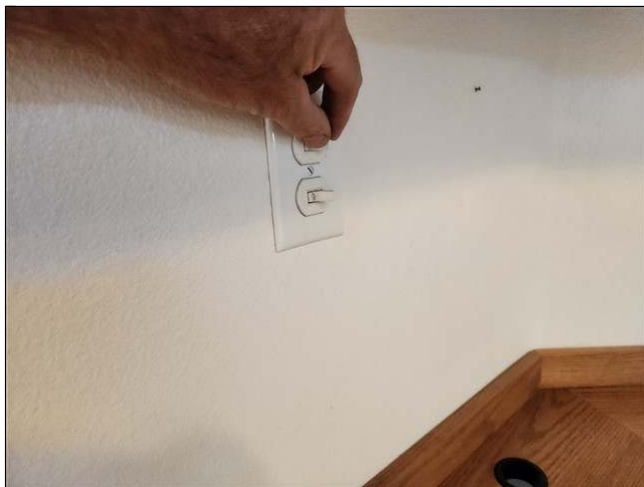
(1) Faulty light switch noted at the Office, with arcing heard inside the switch when operating. Recommend further evaluation/repair by a licensed Electrician.

4.5 Item 1(Picture) Faulty light switch noted at the Office

**RE: ITEM 4.5(1)—\*\*SCHEDULED\*\*** Please see *Exhibit: Seller Repair Itemization* for Updates

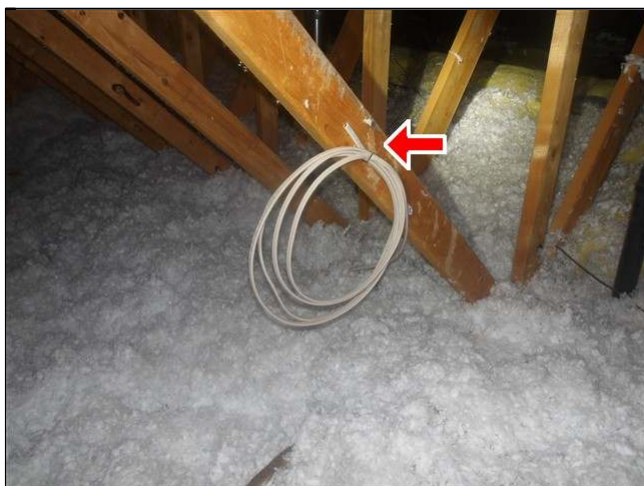
(2) Loose wire end needs placing inside a box with a cover-plate in the attic area over the kitchen. A qualified licensed electrician should perform repairs that involve wiring.

4.5 Item 2(Picture) loose wire end in attic area

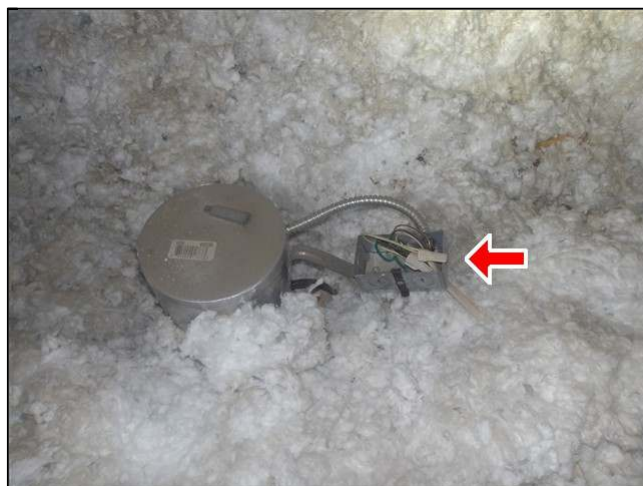
4.5 Item 3(Picture) Open wire connection

(3) Open wire connection noted in the attic area over the master bathroom (missing cover plate).

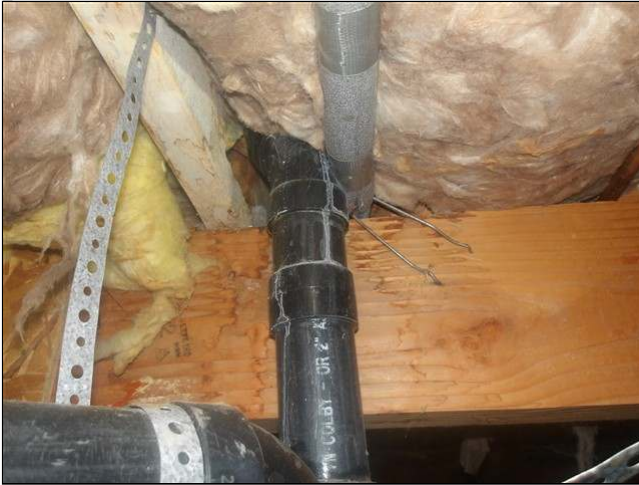
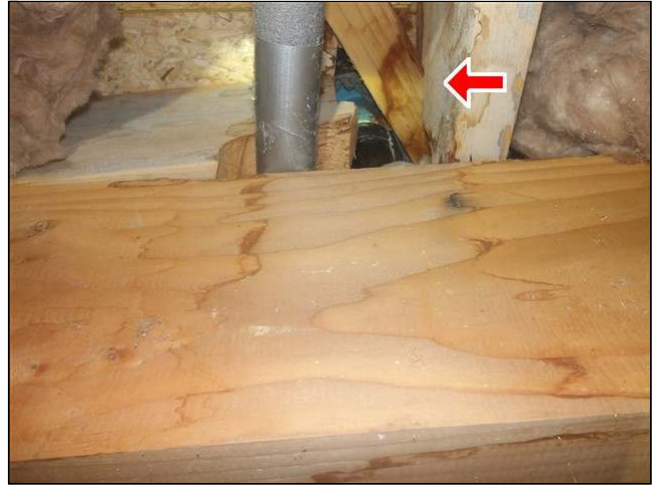
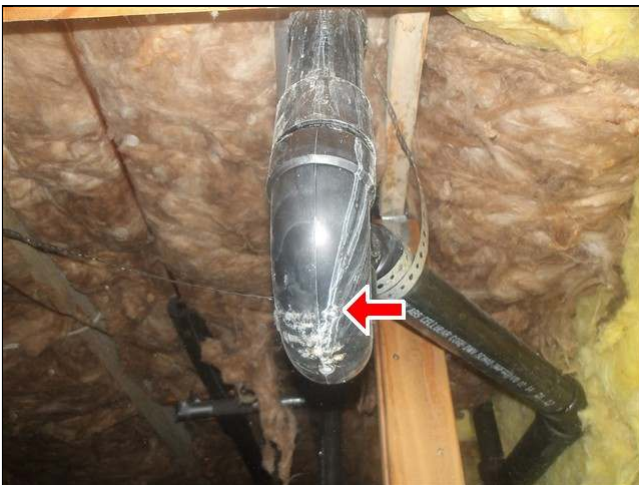
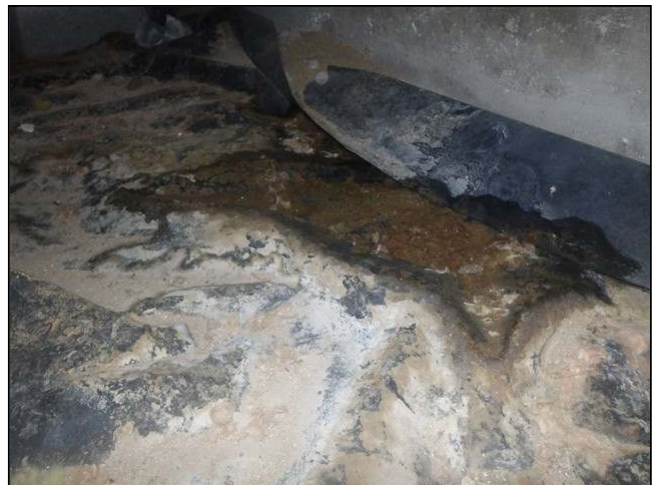
(1) Shower drain is leaking in the crawlspace area under the master bathroom. Recommend repair by a licensed plumbing contractor to prevent excessive moisture, which can lead to mold/fungus, in the crawlspace.

5.3 Item 1(Picture) master bath shower drain leaking

**Comments:** Inspected **RE: ITEM 5.3(1)—\*\*SCHEDULED\*\*** Please see *Exhibit: Seller Repair Itemization* for Updates

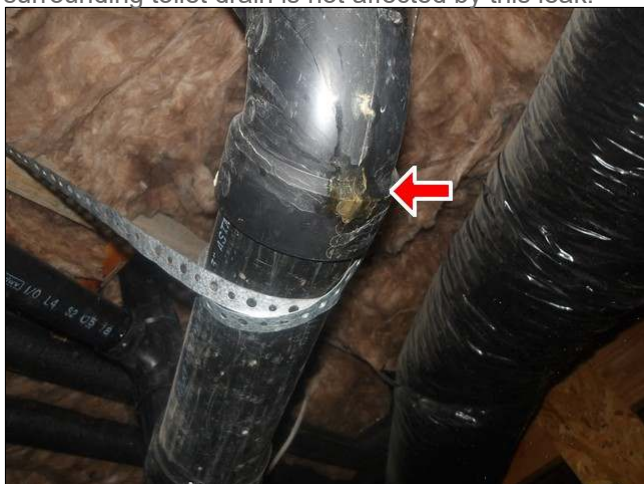
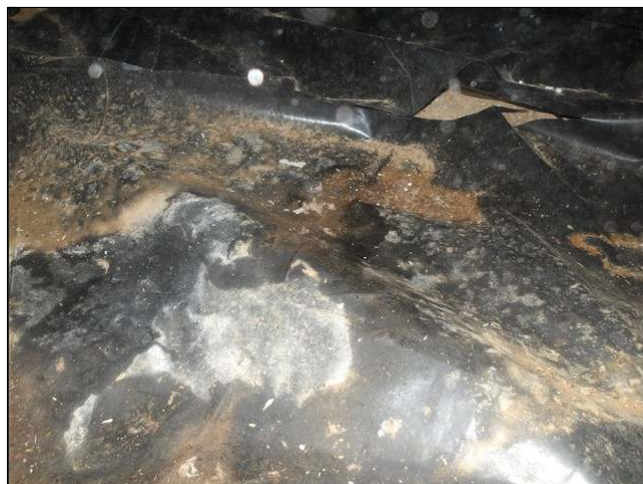
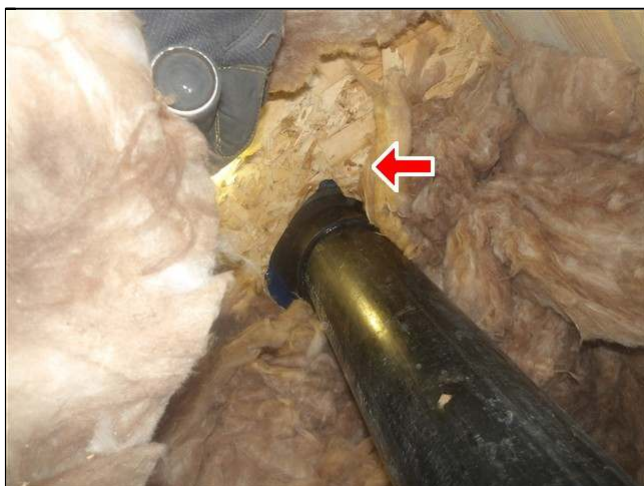
(2) Toilet drain is leaking in the crawlspace area under the Guest Bathroom. Recommend repair by a licensed plumbing contractor to prevent excessive moisture, which can lead to mold/fungus, in the crawlspace. Subfloor surrounding toilet drain is not affected by this leak.

5.3 Item 5(Picture) guest bath toilet drain leak

**RE: ITEM 5.3(2)—\*\*SCHEDULED\*\*** Please see *Exhibit: Seller Repair Itemization* for Updates

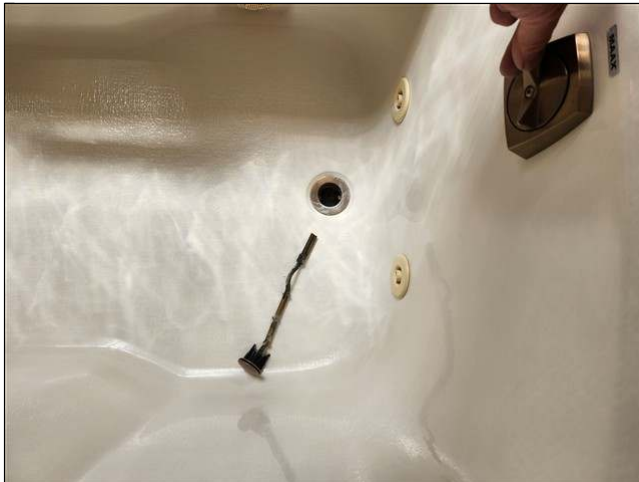
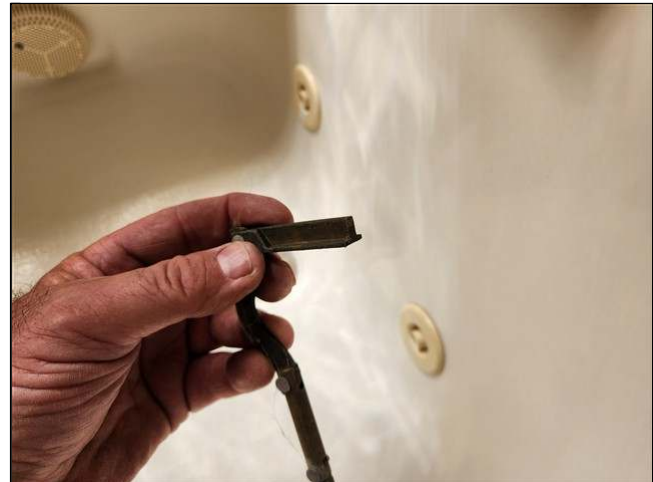
NOTE: Jetted tub at master bathroom was only checked at the supply faucet and drain systems, due to drain plug not able to operate properly (broken linkage). Recommend repair as needed by a qualified person, and check for proper operation of the the jet and pump systems.

5.5 Item 1(Picture) drain plug broken

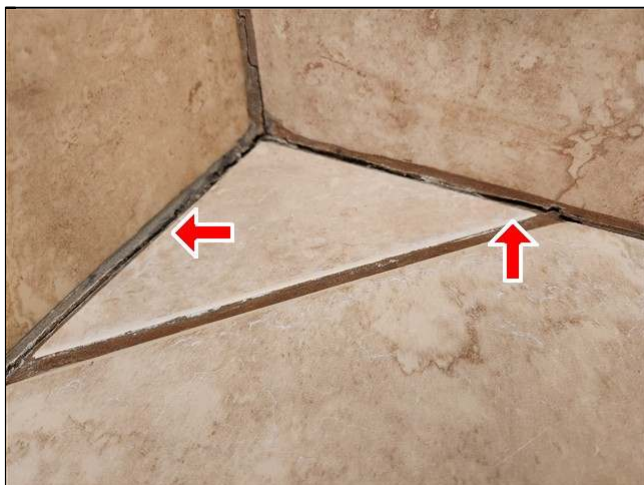
Recommend seal corners of tub/shower surrounds to prevent moisture intrusion into wall framing areas. Note: This is part of maintenance, and should be done as needed.

5.7 Item 1(Picture) seal as part of home maintenance

**RE: ITEM 5.7—\*\*SCHEDULED\*\*** Please see *Exhibit: Seller Repair Itemization for Updates*

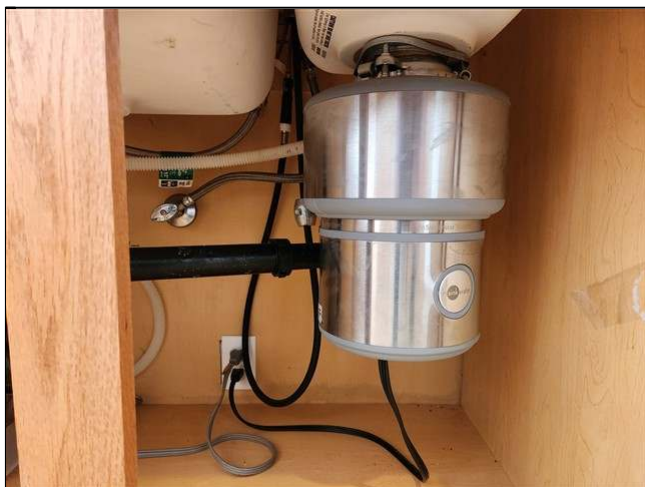
Disposer operated smoothly and quietly, appears clean and without cracks or signs of leaks... NOTE: disposer has a "delayed" start, indicating a possible electrical issue with the start capacitor. Recommend further evaluation by a qualified person as needed.

6.4 Item 1(Picture) disposer has a "delayed" start

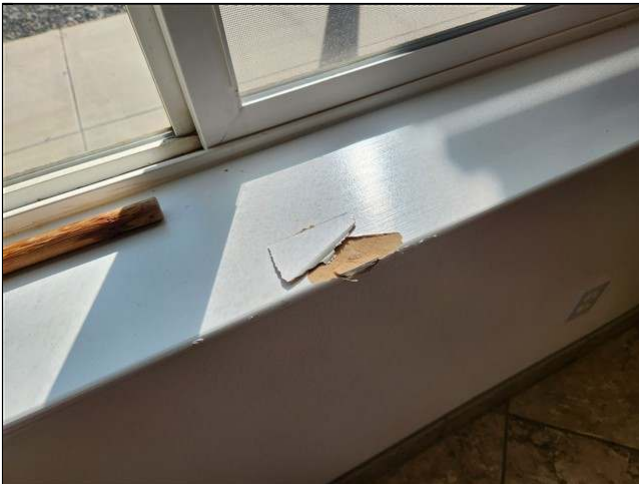
NOTE: Small damage noted at the living room East wall window sill board.

7.5 Item 1(Picture) East wall window sill board

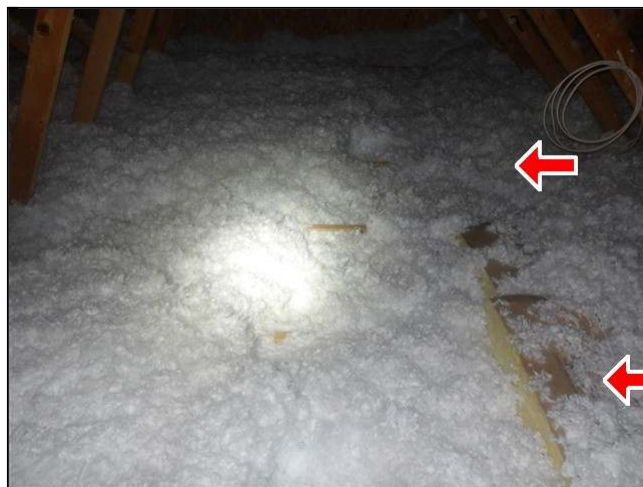
(1) The flat ceiling attic insulation is blown-in loose-fill fiberglass, and is approximately 10 to 12 inches deep (R-30), in most areas, with insulation tapering down to about R19 in a few locations. No major problems noted.

9.0 Item 2(Picture) tapering down to about R19 in a few locations

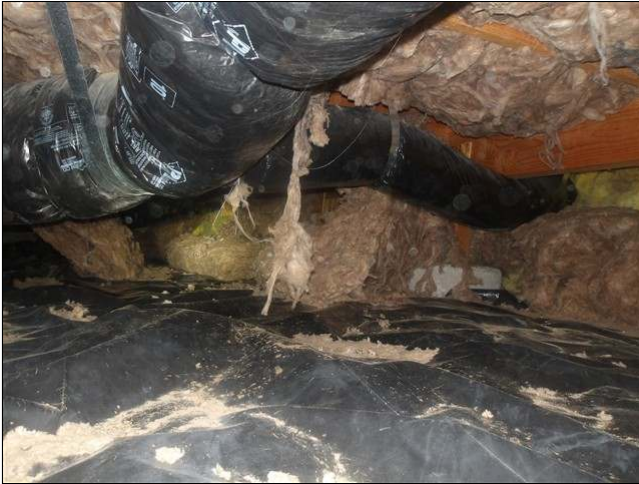
9.1 Item 2(Picture) fallen subfloor insulation

**RE: ITEM 9.1(2)—\*\*SCHEDULED\*\*** Please see *Exhibit: Seller Repair Itemization* for Updates

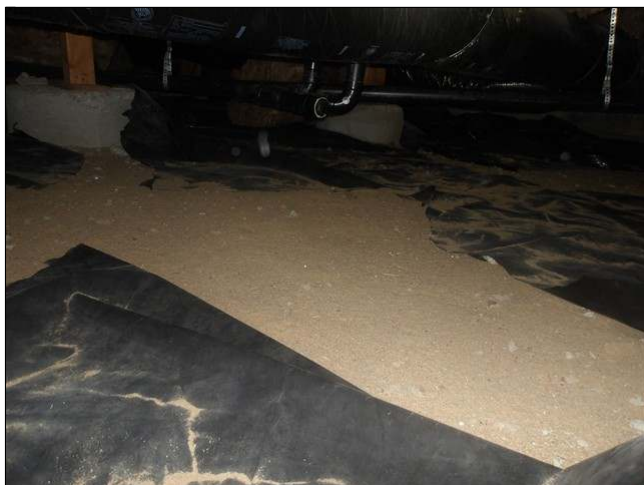
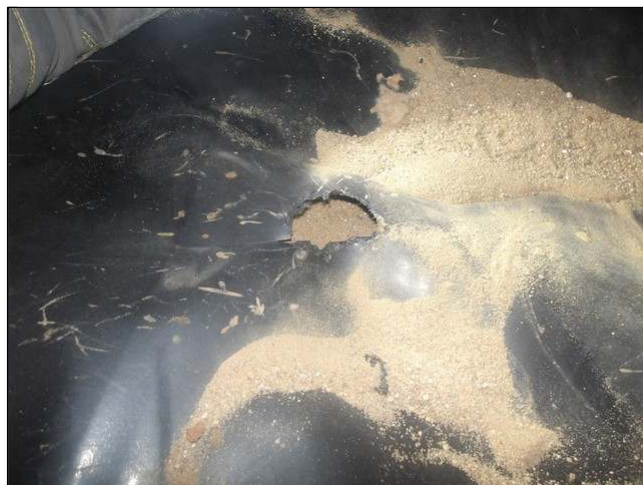
Vapor Barrier is 6 mil black plastic that appears in fair-good overall condition, with better than 95% of crawlspace ground covered. Recommend stretching out plastic to fully cover the ground. There are a few small holes chewed through the plastic, appears from pest/rodent.

9.2 Item 1(Picture) Recommend stretching out plastic

9.2 Item 2(Picture) rodent hole through vapor barrier

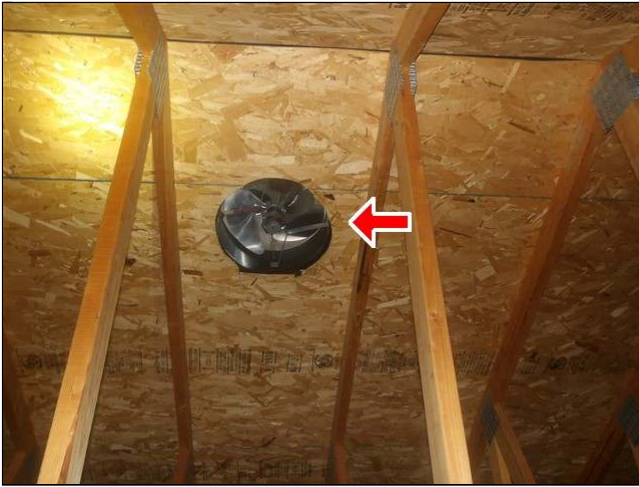
Solar powered ventilation fan noted installed at the East slope of roof, however was non-operational at time of inspection.

9.5 Item 1(Picture) Solar powered ventilation fan

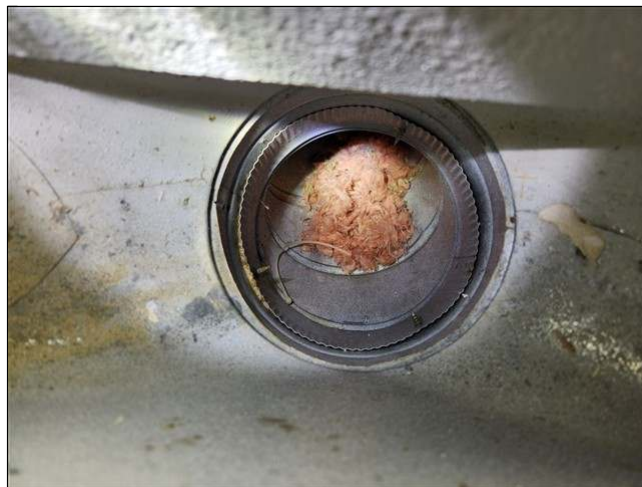
10.3 Item 2(Picture) debris (and mice nest/urine odor) seen in the vents

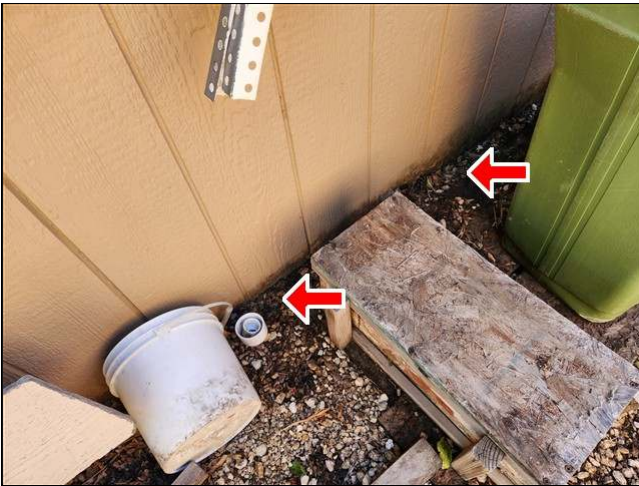
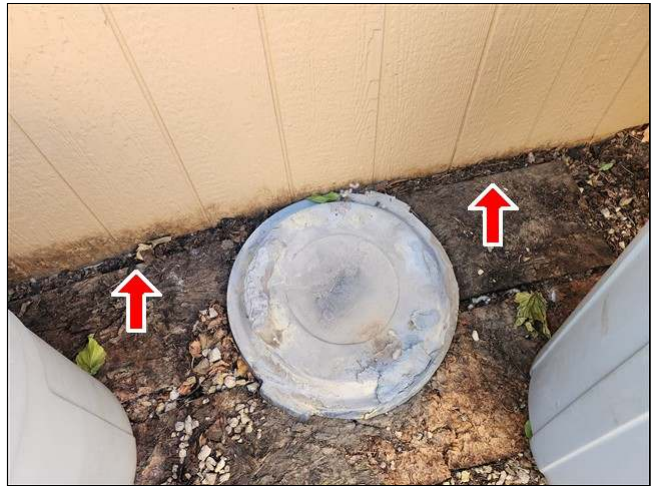
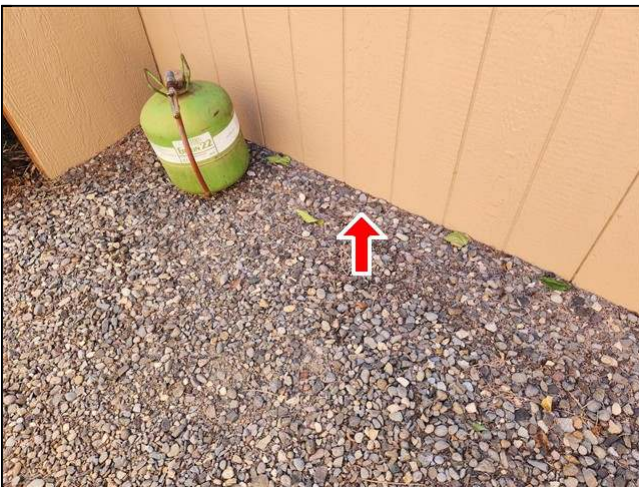
(2) NOTE: Improper clearance under the lower edge of wall siding was noted along the North side of building in a few locations, contacting the ground. This condition can cause advanced deterioration of the siding if not corrected.

11.1 Item 3(Picture) Improper clearance under the lower edge of wall siding

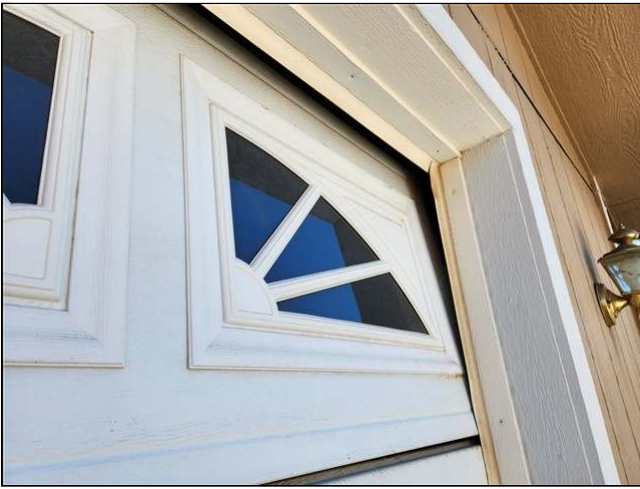
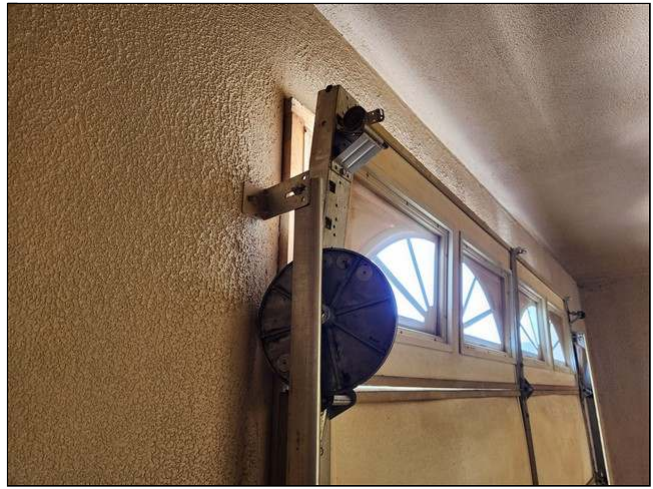
NOTE: Garage door is NOT fully installed, missing the upper radius and upper horizontal door track sections for the door rollers.

11.2 Item 1(Picture) Garage door is NOT fully installed

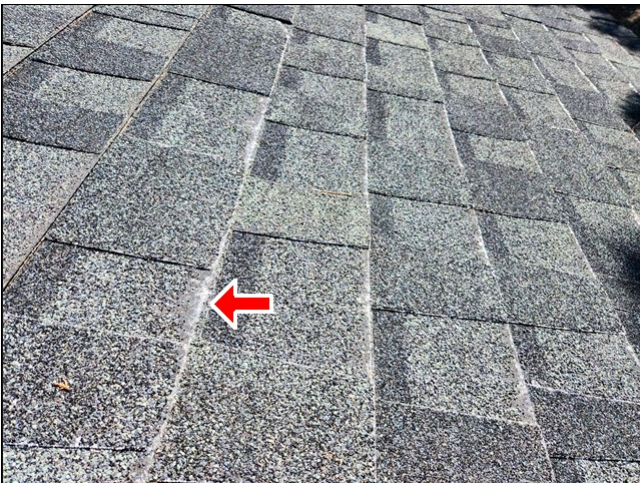
11.3 Item 3(Picture) Typical loss of granules noted

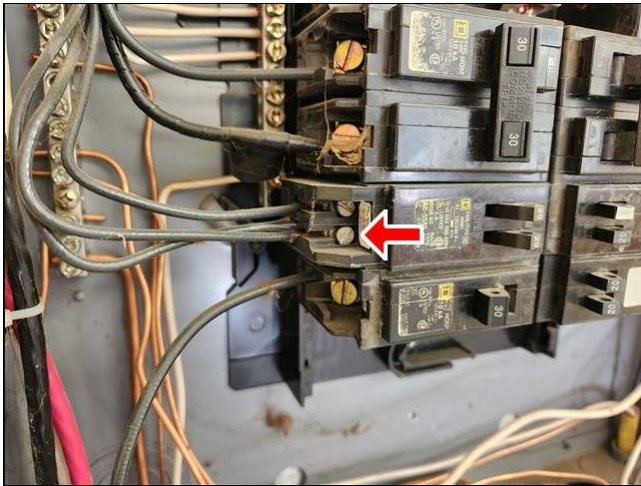
(2) Note: There is a "double tap" circuit breaker noted inside the Distribution Panel. Each conductor should be wired and connected to separate circuit breakers. Recommend repair by a licensed electrician.

11.6 Item 5(Picture) "double tap" circuit breaker

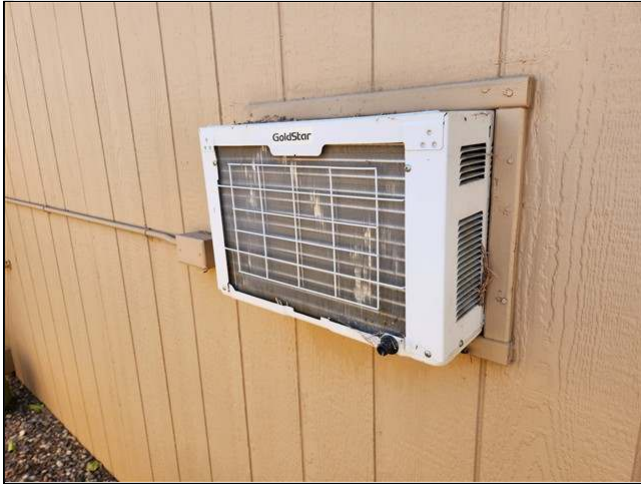
No heating source was noted. Cooling unit mounted at the North wall did not cool, and only recirculated the room air and appears needs service to function as intended.

11.9 Item 1(Picture) cooling unit at north wall
