EAGLE ROCK INSPECTIONS

## RESIDENTIAL PROPERTY INSPECTION

6040 Cielo Cir  
Sparks, NV 89436

04/08/2026

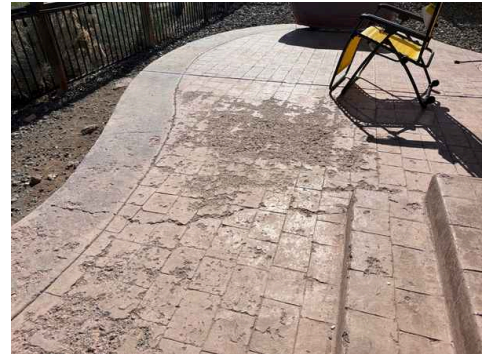
##### PATIO

Spalling damage to the concrete surface was present. This is typically related to the use of "Ice Melt" like products but can also be associated with the composition of the concrete when poured or even the weather when poured. Repairs are recommended to be performed as desired by a concrete contractor.

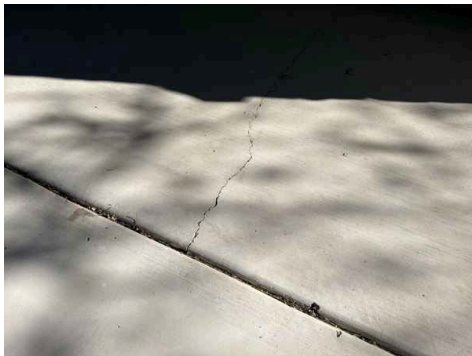
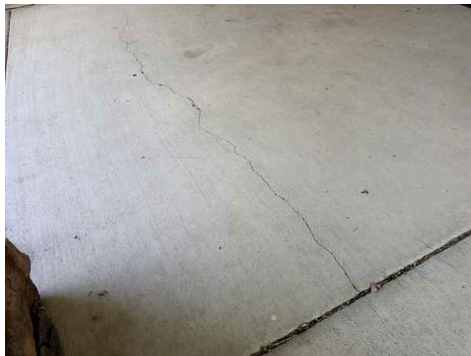
#### FLATWORK - CRACKS

There were cracks in the concrete flatwork which would not necessarily need to be serviced.

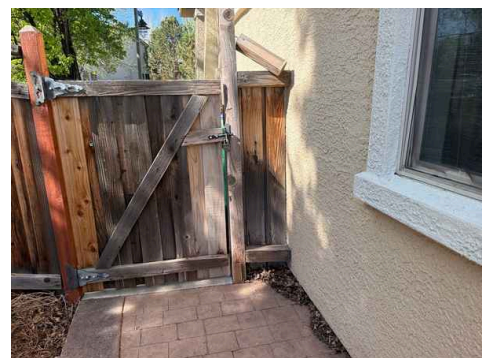
##### EASTSIDE OF STRUCTURE

There was damage to the fence and/or gates that should be repaired by a qualified person.

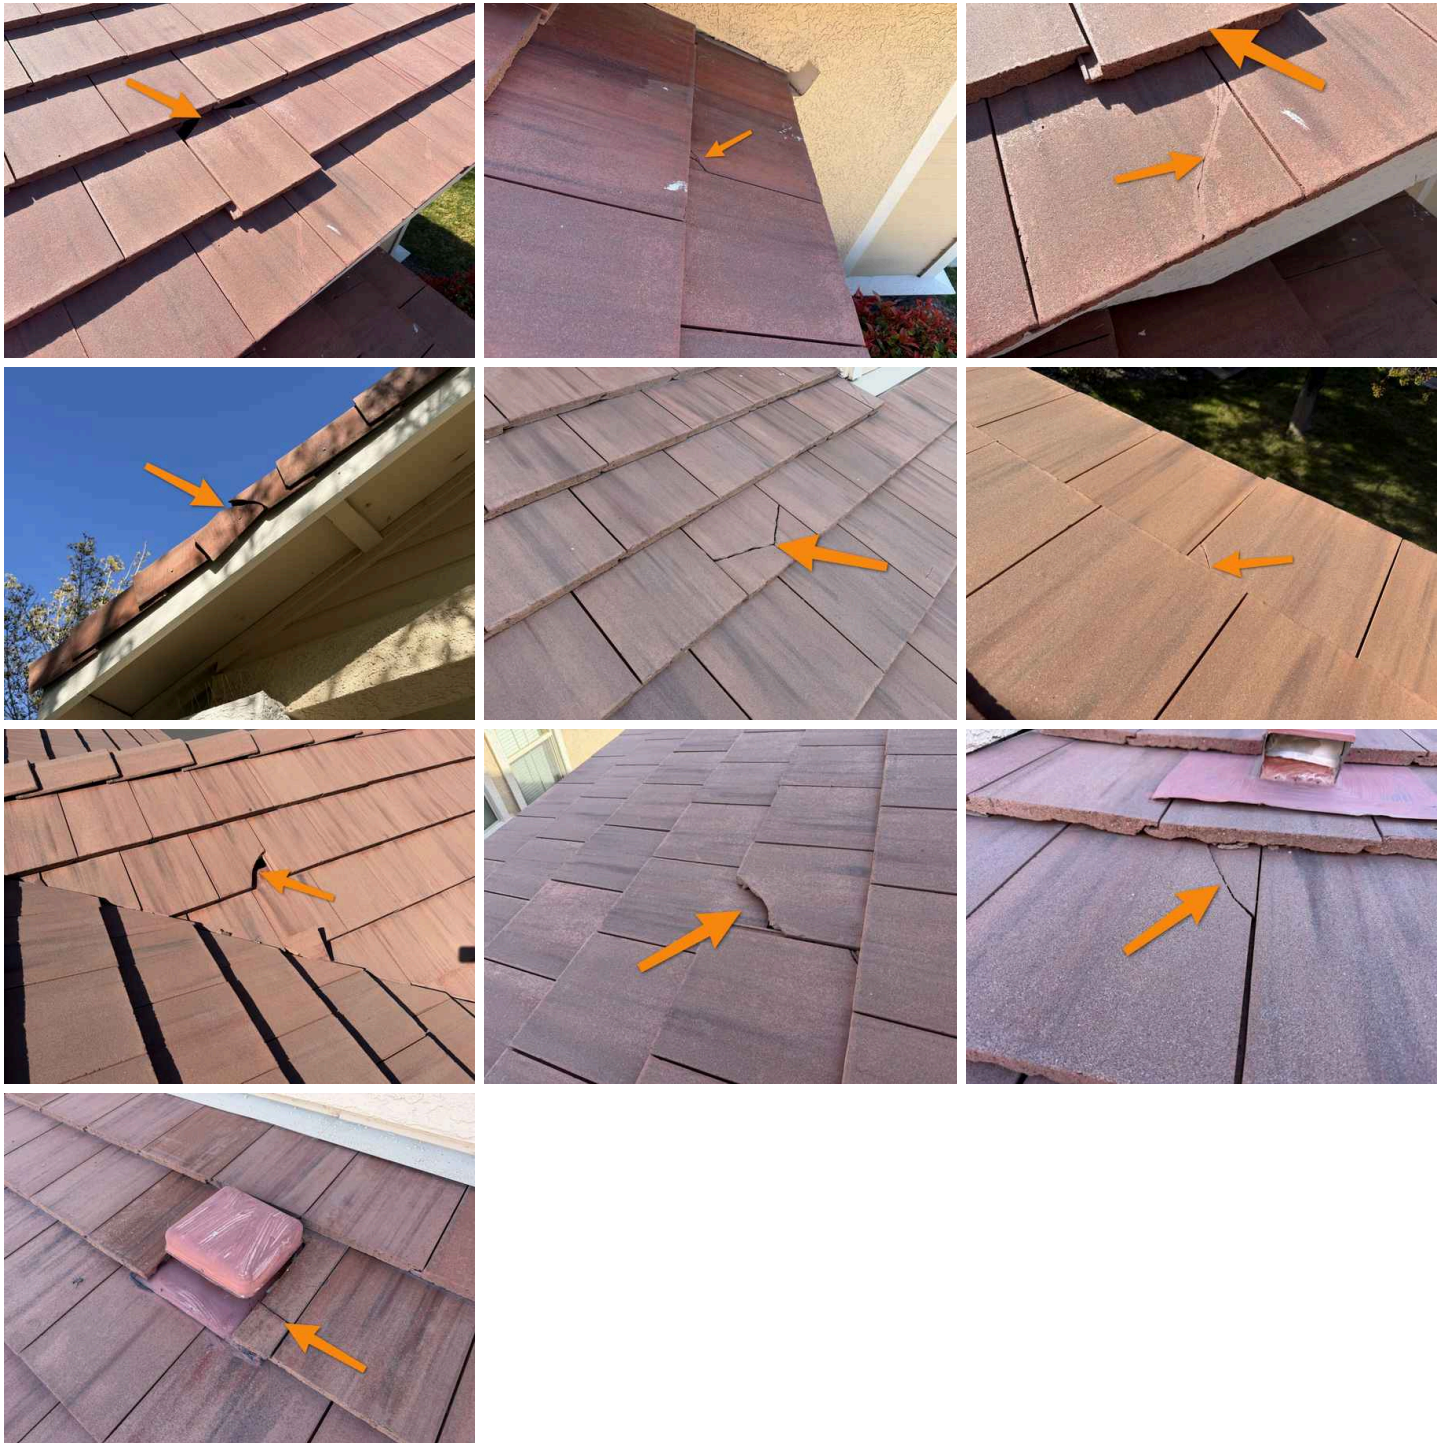
**CRACKED AND SEPARATED**

There were multiple broken/separated/slipped tiles exposing the underlayment. Recommend these known faults be repaired by a licensed roofing contractor and, at that time, that the roof cover be evaluated for any additional needed repairs.

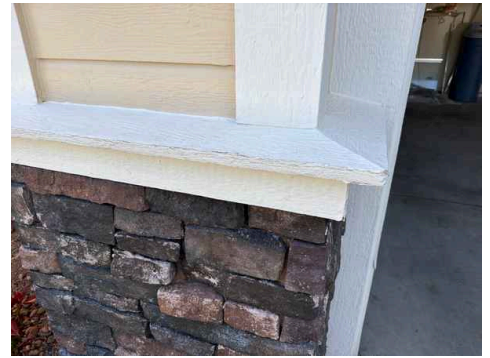
**TRIM - WEATHER DAMAGED**

Sections of trim around the house were weather damaged. Repairs or replacement of any damaged wood is recommended to be conducted by a qualified person.

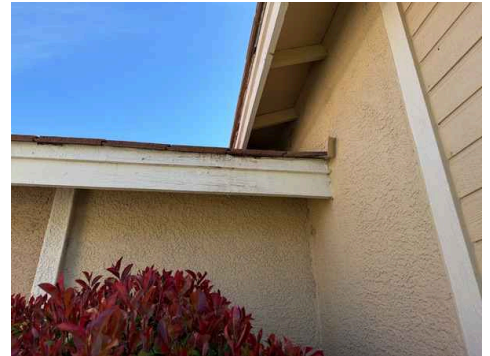
**FASCIA - WEATHER DAMAGED**

Sections of fascia around the house were weather damaged. Repairs or replacement of any damaged wood is recommended to be conducted by a qualified person.

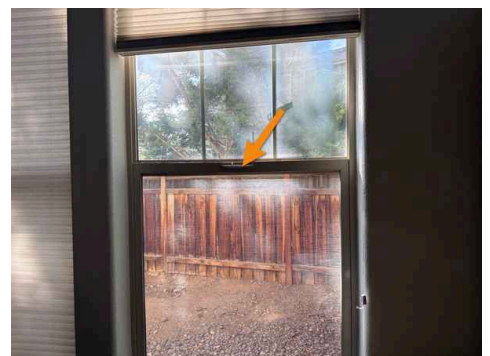
## FRONT FAMILY ROOM

The window(s) in the referenced area(s) were difficult to lock/latch. Repairs are recommended to be performed as needed for proper operation of the latches by a window contractor or other qualified person.

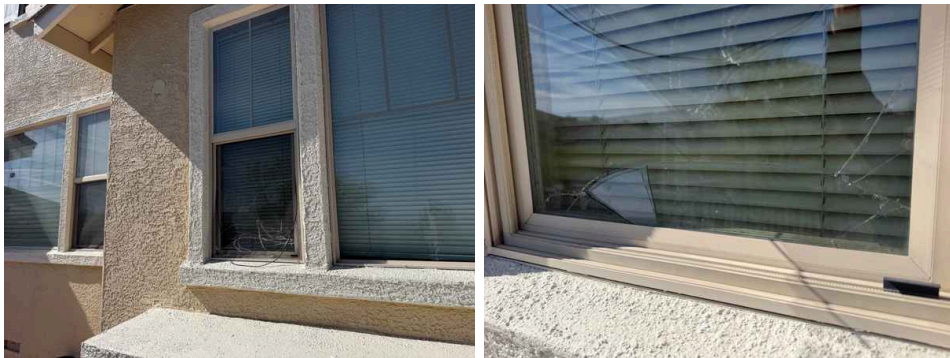
**GLASS - BROKEN GLASS PRESENT**

**Significant Defect**

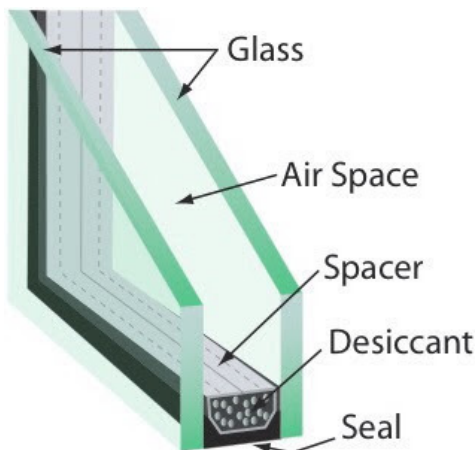
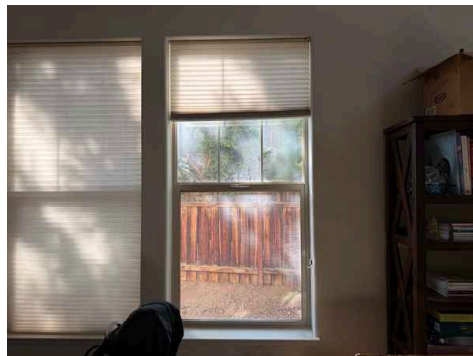
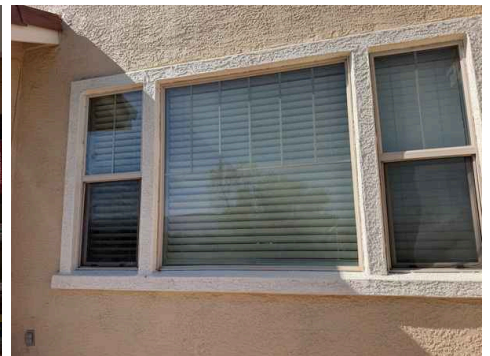
**GLASS - SEAL FAILURE**

**Marginal Defect**

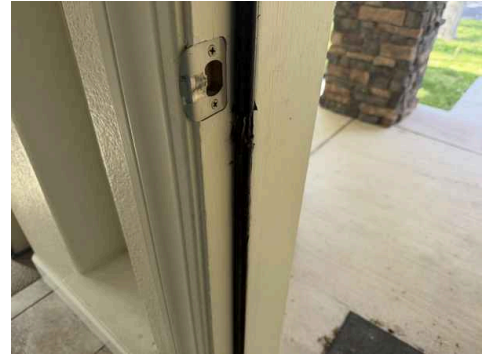
## MAIN ENTRY

The referenced door(s) had damaged weatherstripping. Replacement of the weatherstripping is recommended to be conducted as needed by a qualified person.

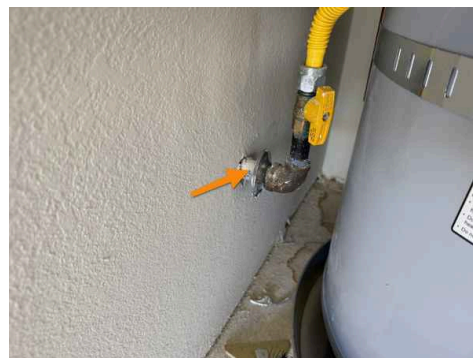
BY WATER HEATER

There were holes and/or protrusions through the separation wall(s) that were not properly sealed. This compromises garage to dwelling space fire separation. Proper sealing of these area(s) is recommended to be conducted by a qualified person.

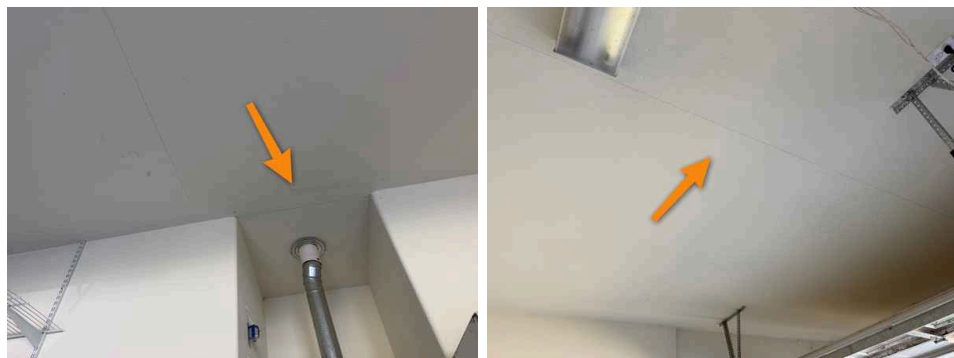
GARAGE CEILING

There were indications of what appeared to be typical settlement and/or expansion and contraction present in areas. This may include minor cracking, separation between mouldings and surfaces, drywall tape visible at wall to ceiling transitions, nail pops, etc. Recommend re-sealing or repairs to these areas as needed by qualified trades people and to monitor the areas for further cracking and separation, with the understanding that if continual movement is observed. Further evaluation and/or repairs may be needed.

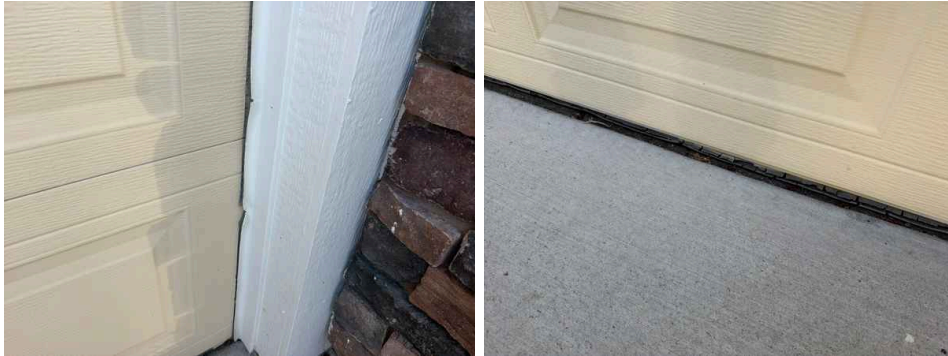
#### WEATHERSTRIPPING - DAMAGED

The garage door weatherstripping was damaged at the bottom and/or sides of the door. Repairs or replacement of the weatherstripping is recommended by a qualified person as needed.

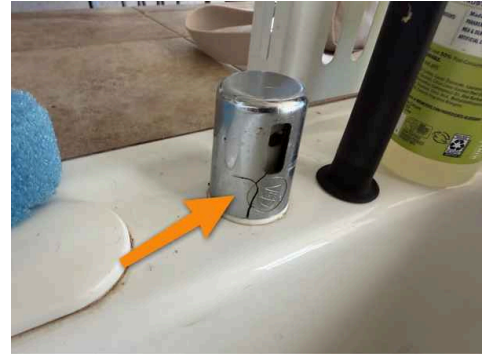
**AIR GAP CAP - DAMAGED**

The air gap cap on the counter top was damaged and should be replaced.

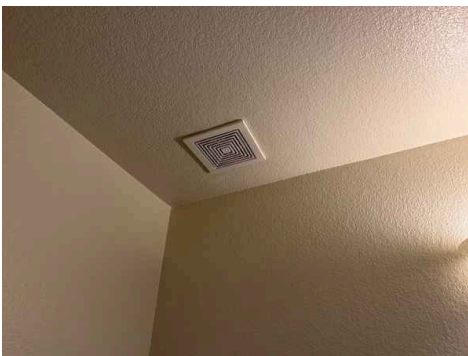
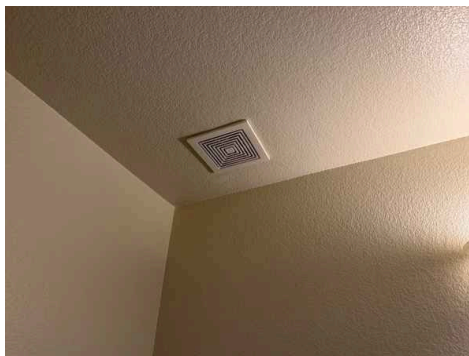
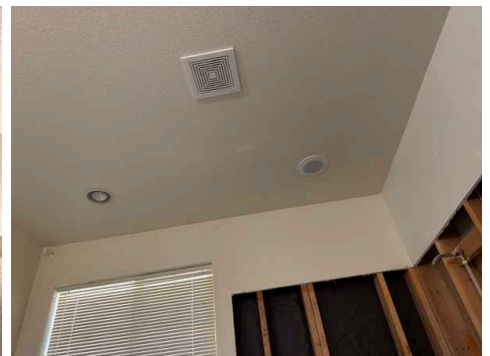
##### BATHROOMS

The exhaust fans in the bathrooms had excessive lint on them, which can be a fire hazard and needs to be cleaned by a qualified person.

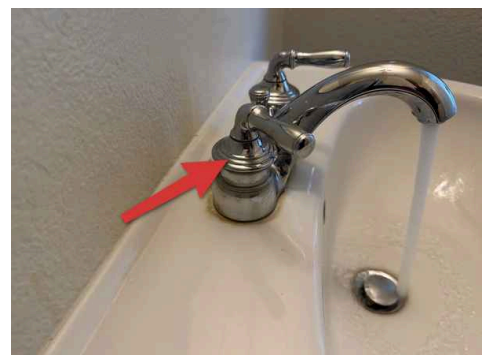
##### DOWNSTAIRS HALF BATHROOM (HOT HANDLE)

The hot water handle at the sink faucet in the downstairs half bathroom leaked during operation. Recommend repairs by a licensed plumber.

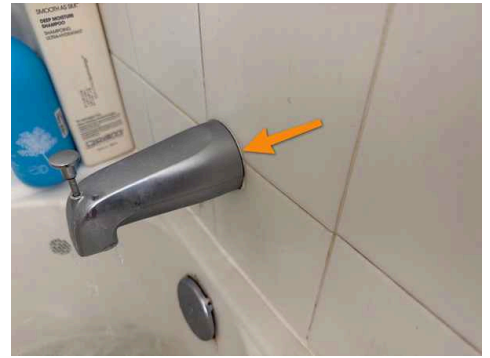
UPSTAIRS HALL BATHROOM

At the referenced bathtub, there was a gap between the spout and the wall which could allow water to penetrate behind the spout into the wall. Recommend this gap be closed and sealed by a qualified person.

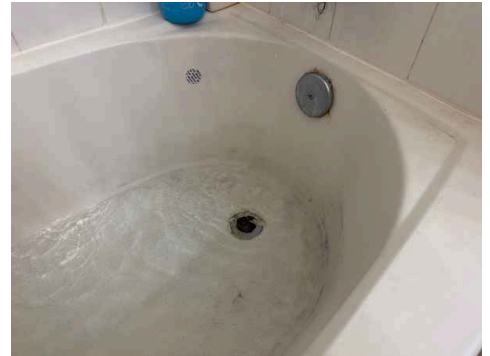
UPSTAIRS HALL BATHROOM

Slow or hindered drainage was present in the referenced bathtub(s). Repairs are recommended to be conducted as needed by a licensed plumber.

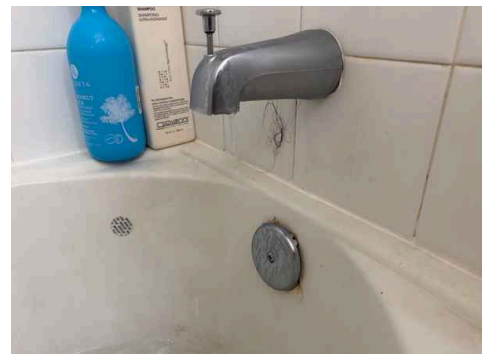
UPSTAIRS HALL BATHROOM

The shower diverter was not engaging fully, preventing full water flow from the showerhead. Repairs are recommended to be performed by a licensed plumber as needed for proper operation.

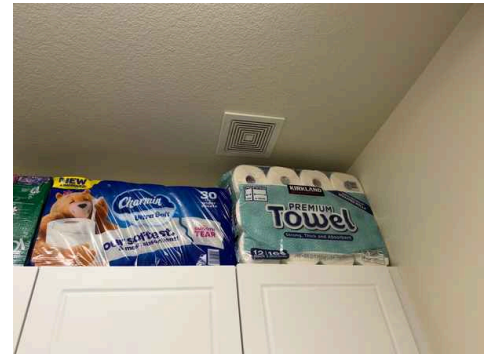
The exhaust fan in the laundry room had excessive lint on it, which can be a fire hazard and needs to be cleaned by a qualified person.

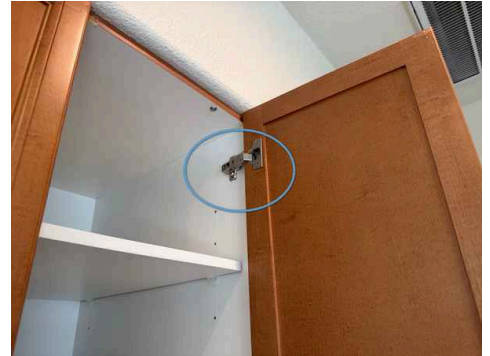
##### UPSTAIRS LOFT

There were loose hinge(s) present on cabinet door(s) preventing the doors from operating as intended. Repairs to secure all hinges is recommended to be conducted by a qualified person.

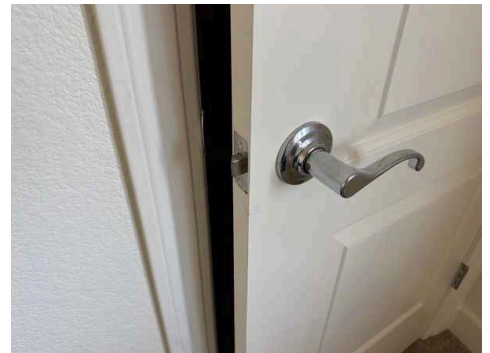
##### UPSTAIRS NORTHEAST BEDROOM CLOSET

The referenced door(s) were not latching properly. Adjustments or modifications made as needed for proper operation is recommended to be conducted by a qualified person.

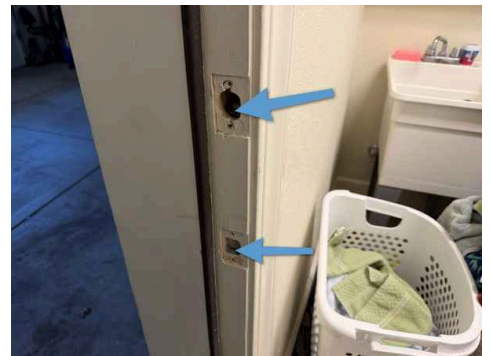
##### GARAGE DOOR TO THE INTERIOR

Strike plates were missing for the referenced interior door(s). Strike plates act as a receiver for the handle's latch, allowing the door to latch smoothly and securely. Repairs to install a proper strike plate at any areas in need is recommended to be performed by a qualified person.

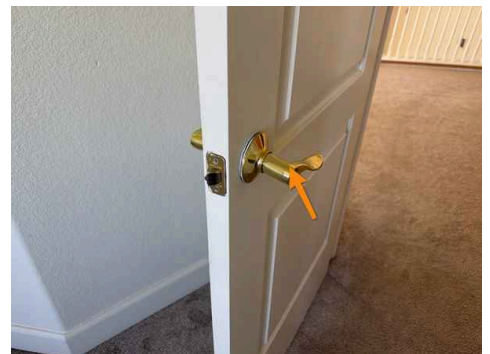
##### UPSTAIRS NORTHEAST BEDROOM DOOR

Damaged handle hardware was present at the referenced area(s). Repairs or replacement of the affected hardware is recommended by a qualified person for proper operation of the door.

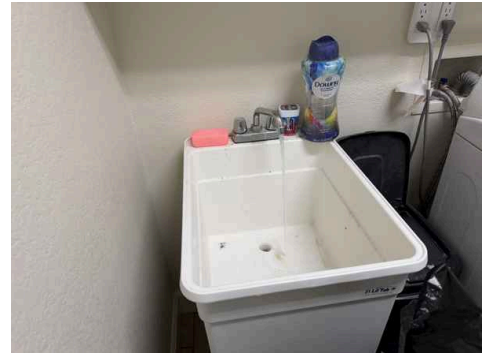
**UNSECURED FREESTANDING SINK**

Marginal Defect

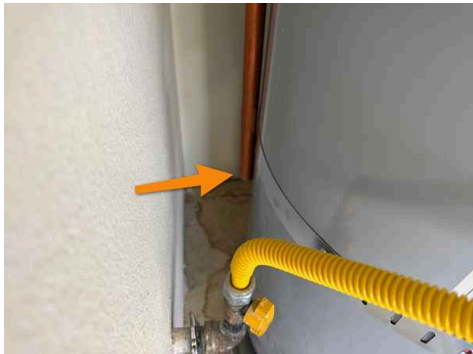
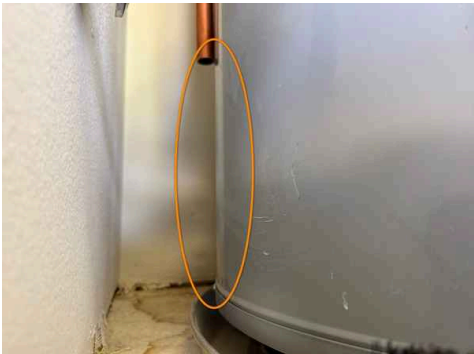
The TPR valve discharge pipe terminated higher than six inches from the floor. The pipe should terminate no higher than 6 inches from the floor due to the possibility of scalding, should a discharge situation occur. The installation of a new pipe with the proper termination height is recommended to be conducted by a licensed plumber.

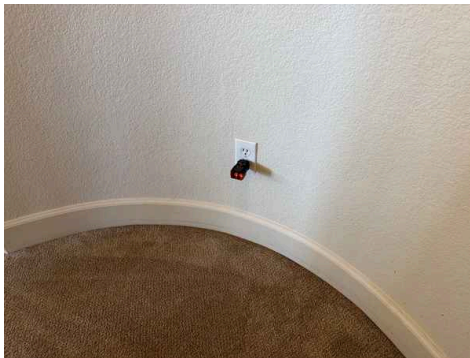
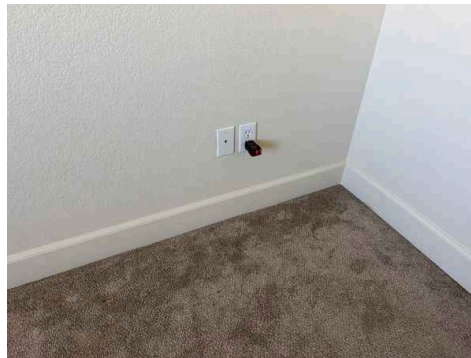
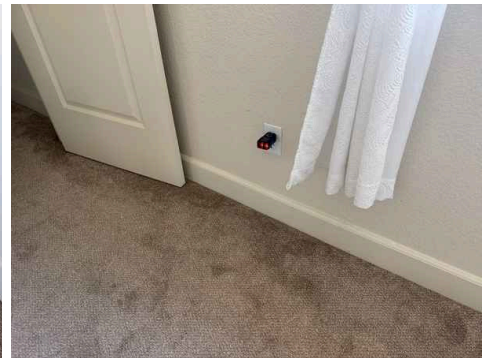
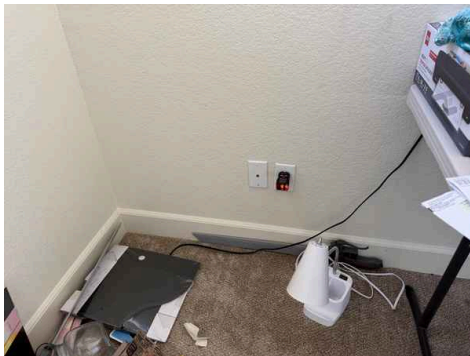
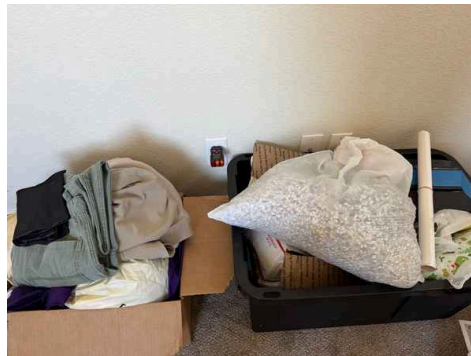
There were interior outlet(s) present that were loose at the wall or their respective electrical box. Proper securing of any loose receptacles is recommended to be conducted by a licensed electrician.

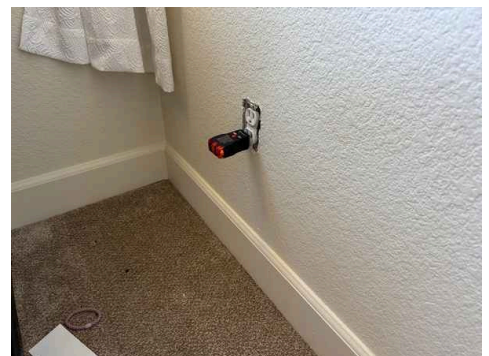
UPSTAIRS NORTHWEST BEDROOM

**SFTY** - The referenced receptacle(s) were missing cover plate(s). This is a safety hazard, as someone could be shocked by touching live wires. The installation of new plates is recommended to be conducted by a qualified person on any and all missing plates throughout the home.

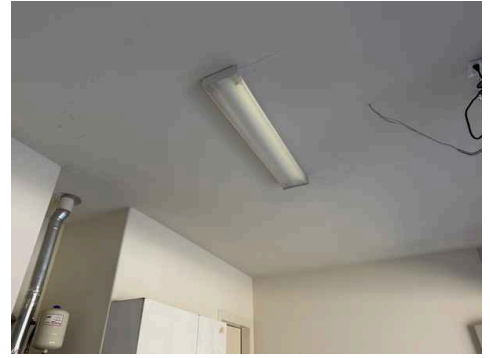
## GARAGE CEILING

The referenced light(s) did not respond to switch(es) at the time of inspection. This could be as simple as burned out or missing bulb(s). This could also be more extensive and represent a deficiency with the fixture, wiring, and/or switch. I recommend having the seller(s) replace the bulb(s) and confirm proper operation prior to the end of your inspection contingency period, if the fixture(s) can not be confirmed to be functional, repairs are recommended to be performed as needed for proper operation by a licensed electrician.

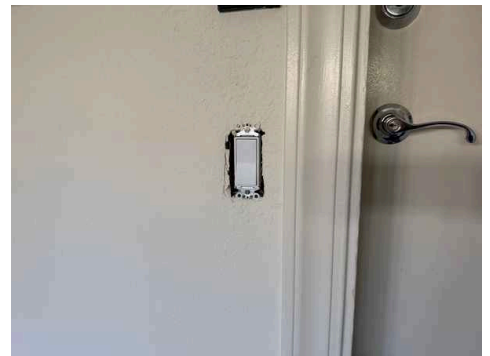
**SFTY** - The referenced switch(s) were missing cover plate(s). This is a safety hazard, as someone could be shocked by touching live wires. The installation of new plates is recommended to be conducted by a qualified person on any and all missing plates throughout the home.

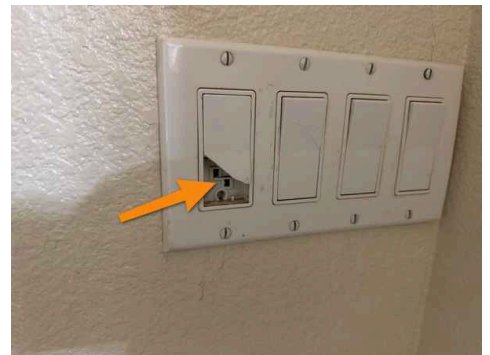
There was a damaged switch at the referenced area(s). This can be a possible electrocution hazard as live wiring could be exposed. Replacement of the switch is recommended to be performed by a licensed electrician.

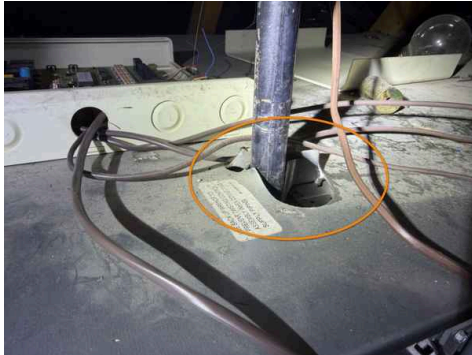
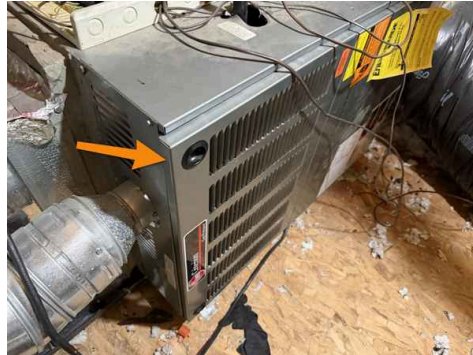
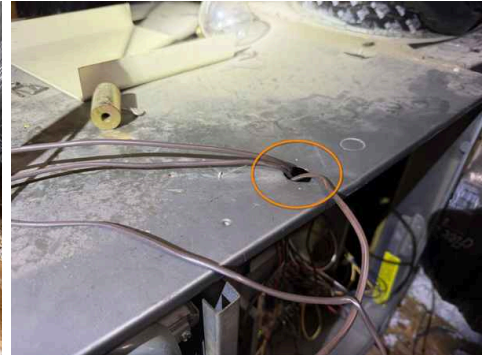
The furnace cabinet was damaged and has sharp edges at the gas line entrance, the cabinet front doors do not seal properly, and the wiring grommet was missing. Recommend evaluation and repairs by a licensed HVAC contractor.

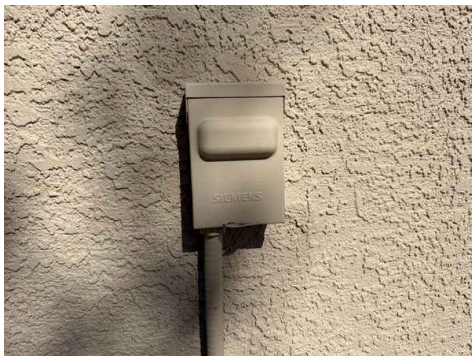
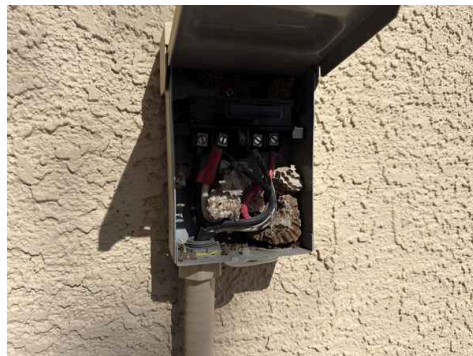
**SERVICE DISCONNECT - MISSING COVER PLATE**

**SFTY** - The service disconnect was missing its inner cover plate, which exposes live wiring. The installation of a proper cover plate is recommended to be performed by a licensed electrician or HVAC contractor.

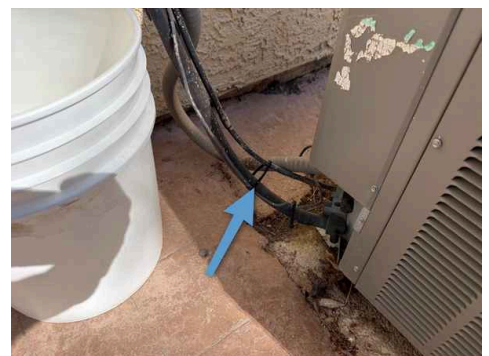
The pipe insulation was damaged or missing on the exterior unit's suction line. Replacement of the insulation as needed is recommended by a qualified person.

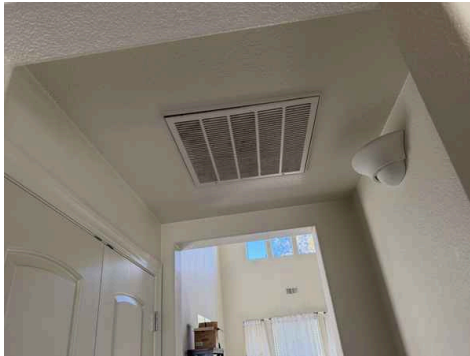
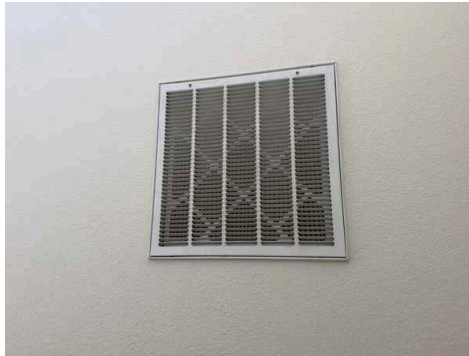
One or more air filters were dirty. Replacement of the filters is recommended to be performed ASAP, as a dirty filter puts additional strain on interior HVAC unit, can shorten the unit's life, and affect the efficiency of the unit.

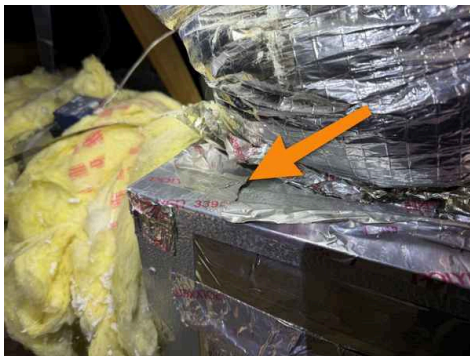
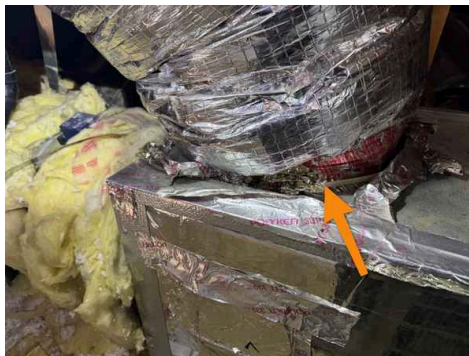
There were visible gaps and/or loose tape present on portions of the ductwork and HVAC cabinet. These areas should be re-taped, sealed, repaired, or replaced as needed for energy efficiency. An evaluation of the ductwork with repairs made as needed is recommended to be performed by an HVAC contractor.

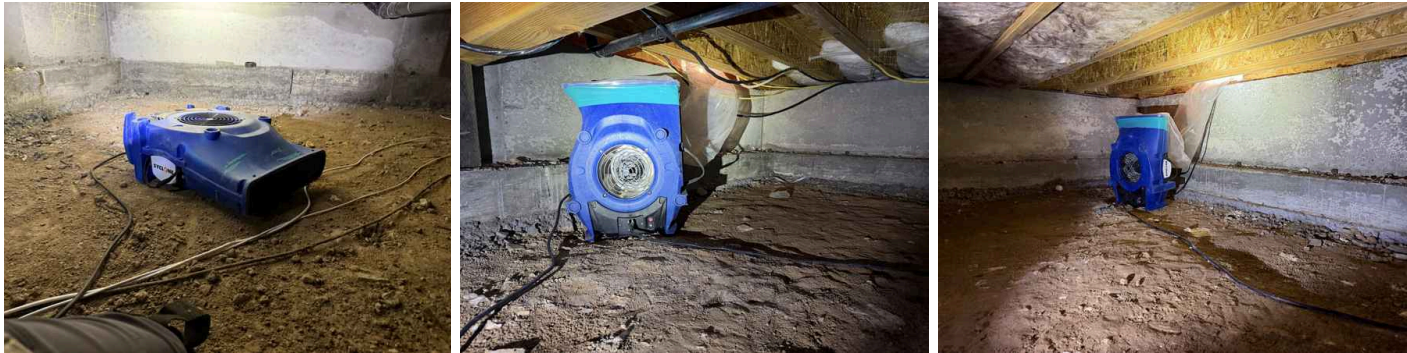
below primary bedroom and kitchen areas

**FYI** - There were dryer fans present in the crawlspace, most likely from a previous plumbing leak. Consult with the seller for further information/disclosures.

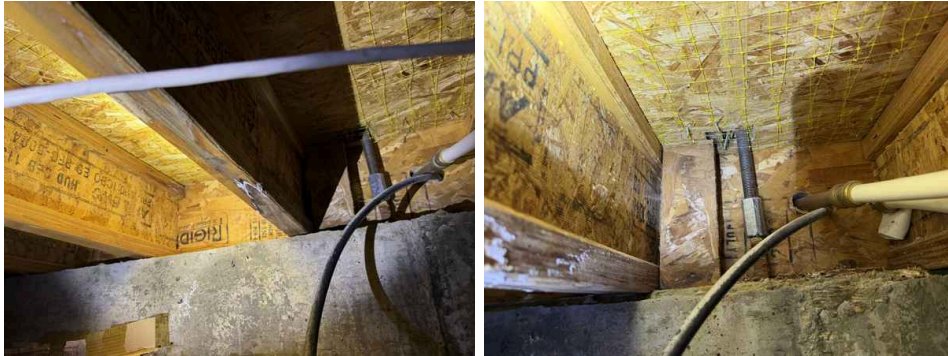
There were stains from previous excess moisture. No wood damage requiring attention was observed, however, not all areas were accessible or viewed and additional faults may exist.

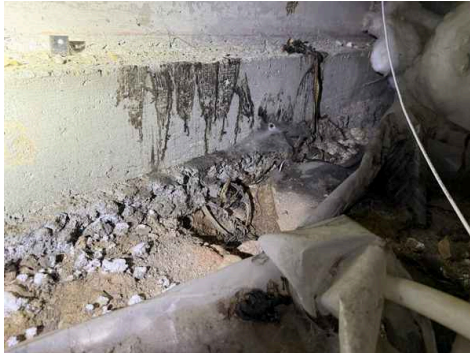
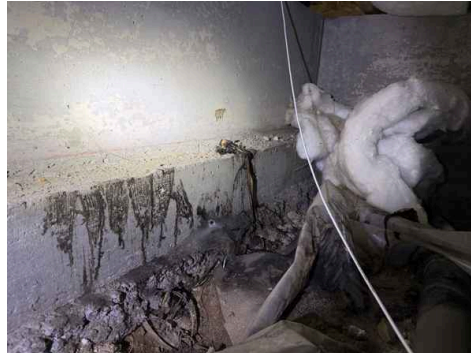
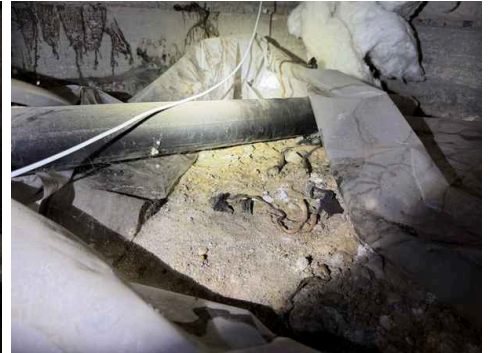
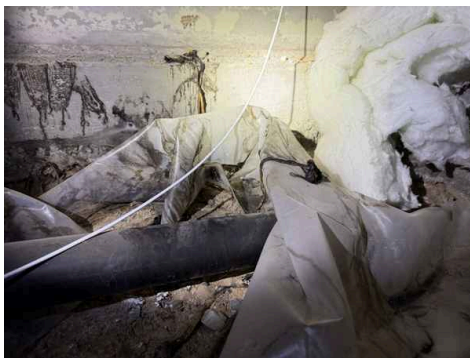
**CRAWLSPACE - ORGANIC GROWTH**

Marginal Defect

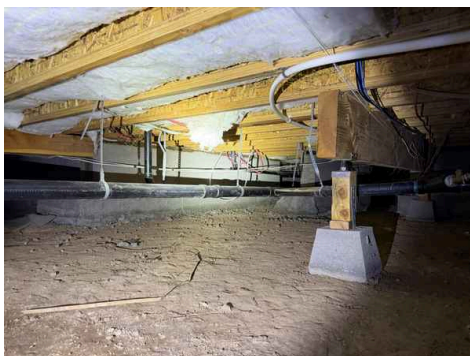
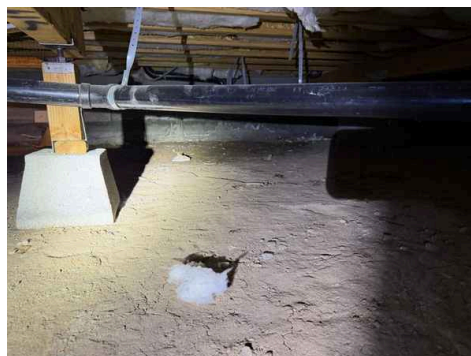
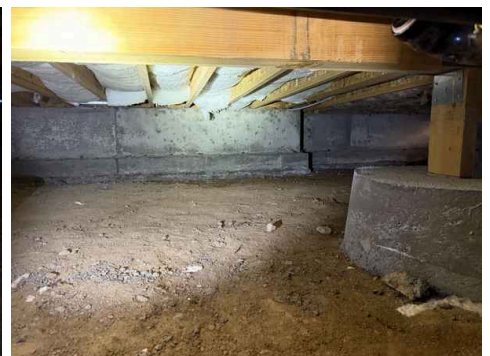
**VAPOR BARRIER - PARTIAL COVERAGE**

Marginal Defect
