## STANDARD GENERAL INSPECTION

**DATE INSPECTION PERFORMED:** July 21, 2026

**INSPECTION ADDRESS:** 3685 Bozeman Dr, Reno, NV 89511

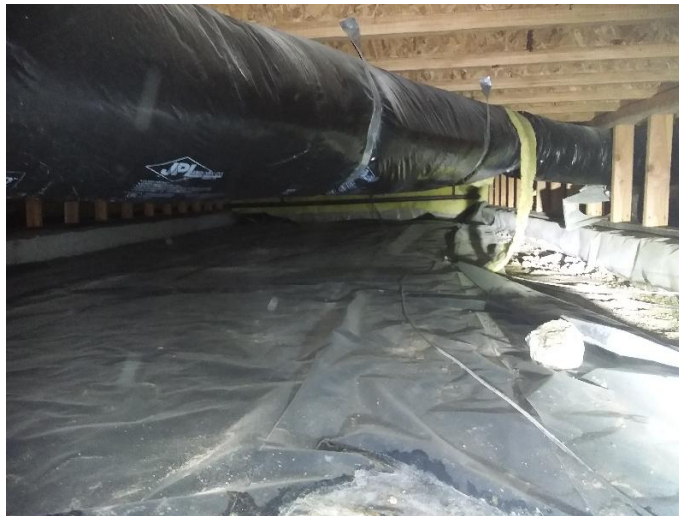
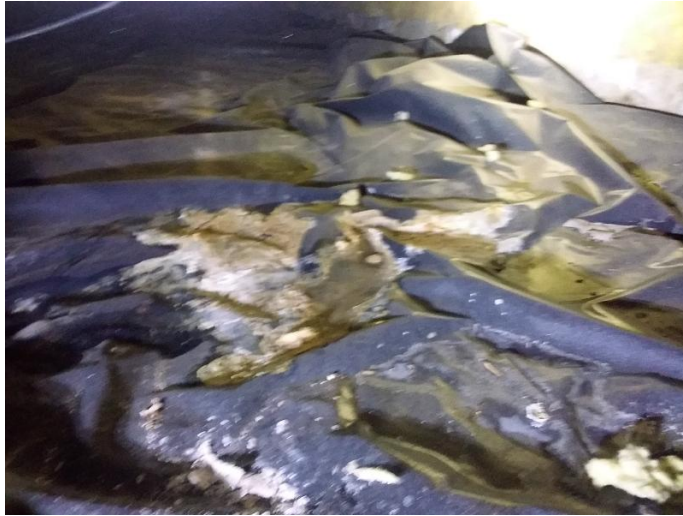
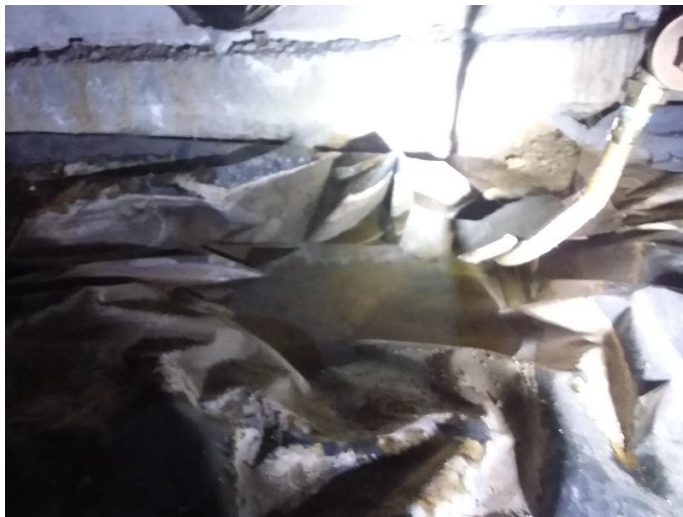
- Crawl space was dry and wet at time of inspection. Noted standing water at main entering crawlspace on Northeast end. Recommend corrections as needed for moisture control. (p 1, p 2, p 3).

- Crawlspace was dry and wet at time of inspection. Noted standing water at main entering crawlspace on Northeast end. Recommend corrections as needed for moisture control. (p 1, p 2, p 3).
- Moisture staining to rim joists in crawlspace. Recommend recommend further evaluation by a licensed pest control company and fungicide treatment performed if needed. (p 4, p 5, p 6).

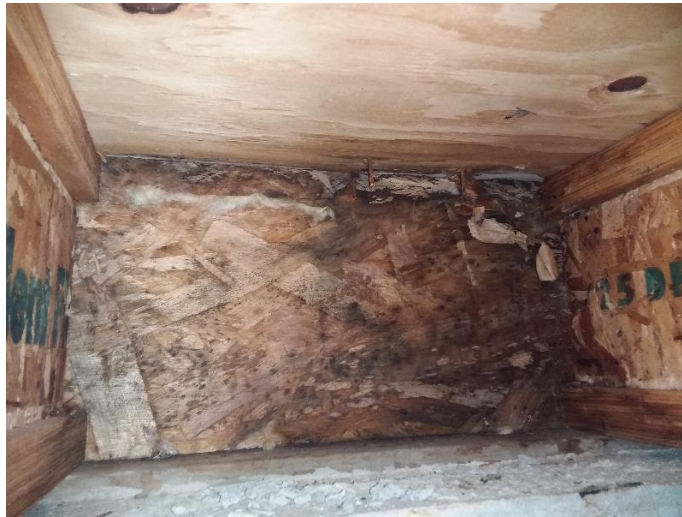
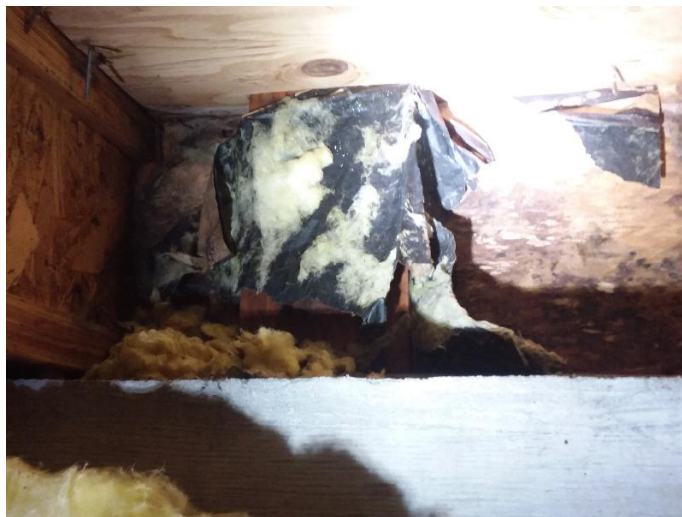
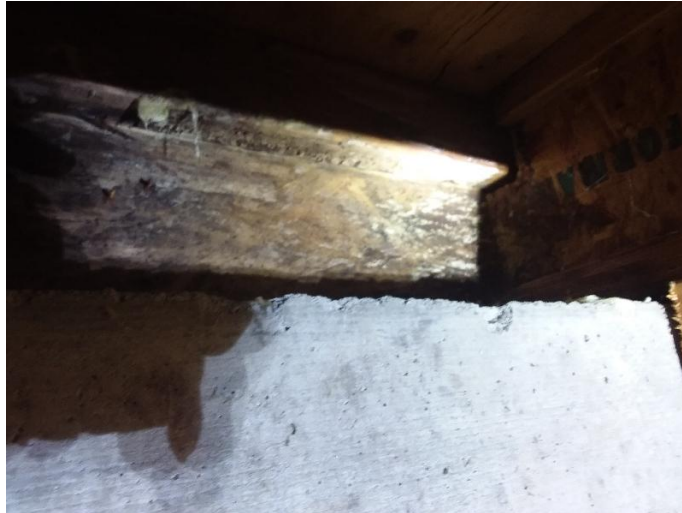
- Moisture staining to rim joists in crawlspace. Recommend further evaluation by a licensed pest control company and fungicide treatment performed if needed. (p 4, p 5, p 6).

\*\* Pest work done 07/26, See Receipt

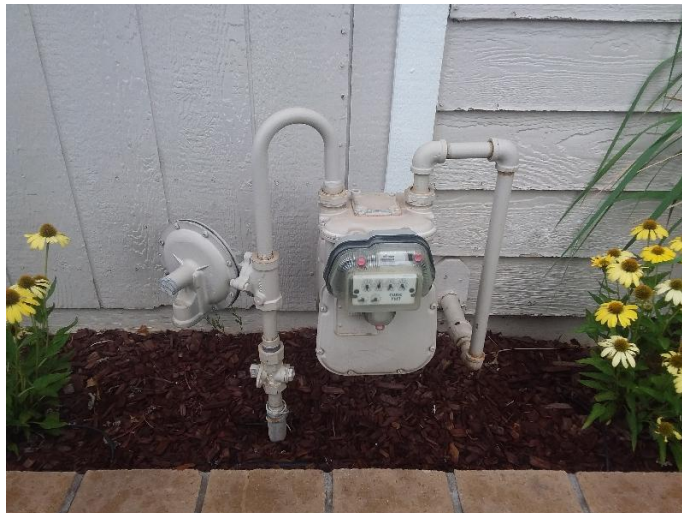
Photo 7

- Gas main is located on Southeast end of structure. (p 7).

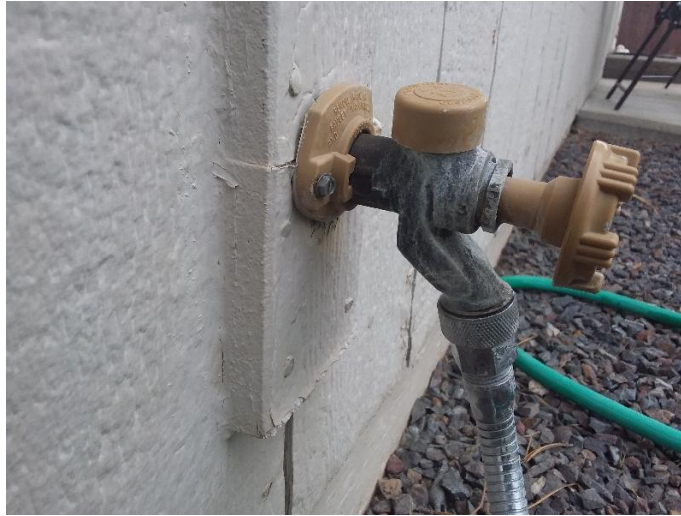
**Photo 8**

- West hose bib leaks while operating. Recommend correction. (p 8).

\* Repair Completed  
09/26, see receipt\*

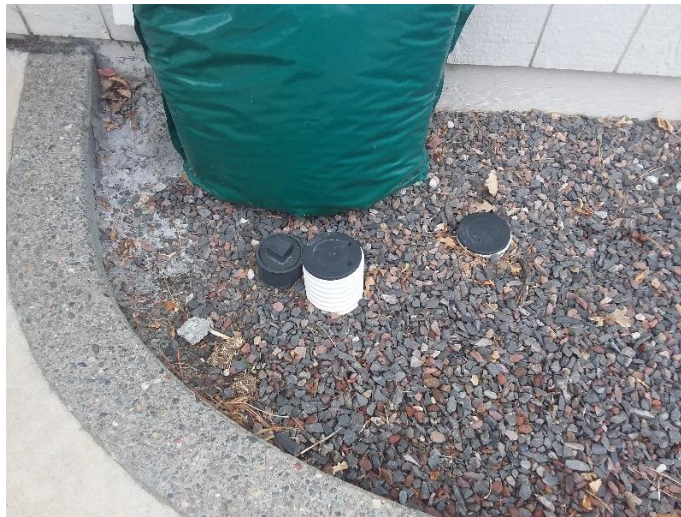
**Photo 9**

- Water main shutoff and clean out are located on North end of structure and clean out is located on Southeast end. (p 9).

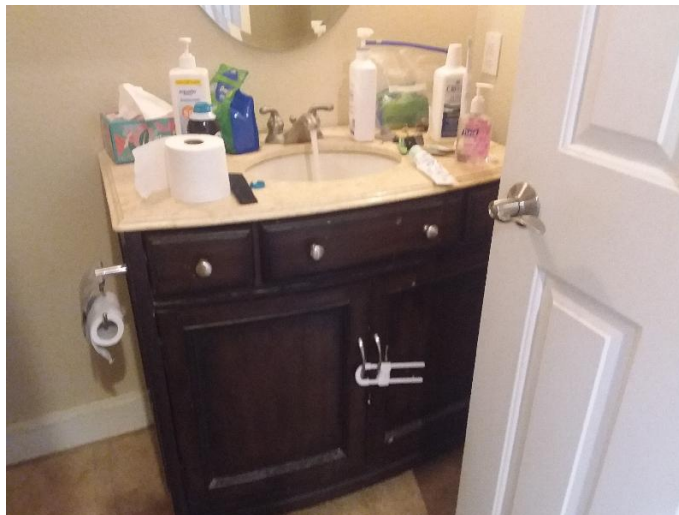
**Photo 10**

- Hall bathroom cabinet is not secured to structure. Correction needed to prevent damage to plumbing lines. (p 10).

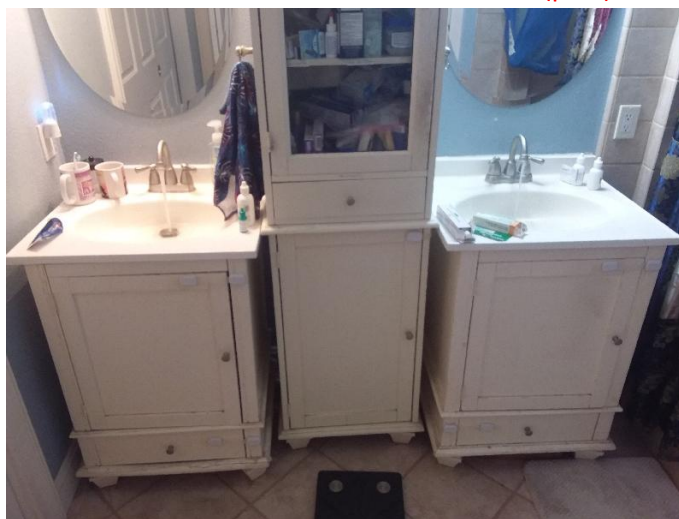
**Photo 11**

- Master cabinets and sinks are not secured. Corrections needed. (p 11).

\* Repairs Completed  
09/26, see receipt\*

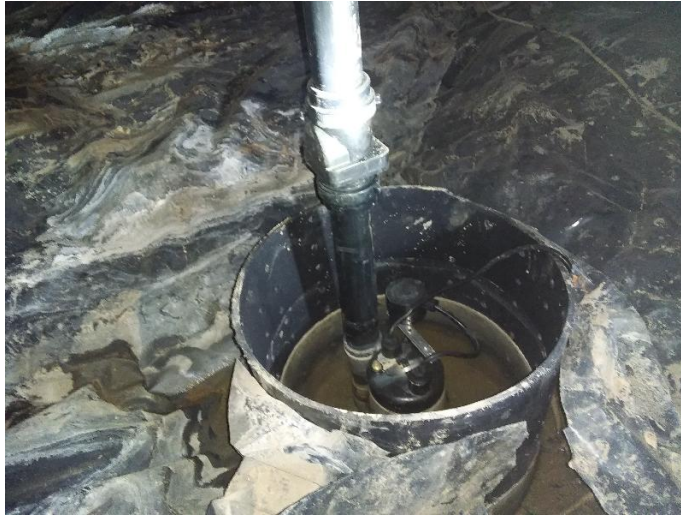
Photo 12

- Sump pump located West of crawlspace access was operated. (p 12).

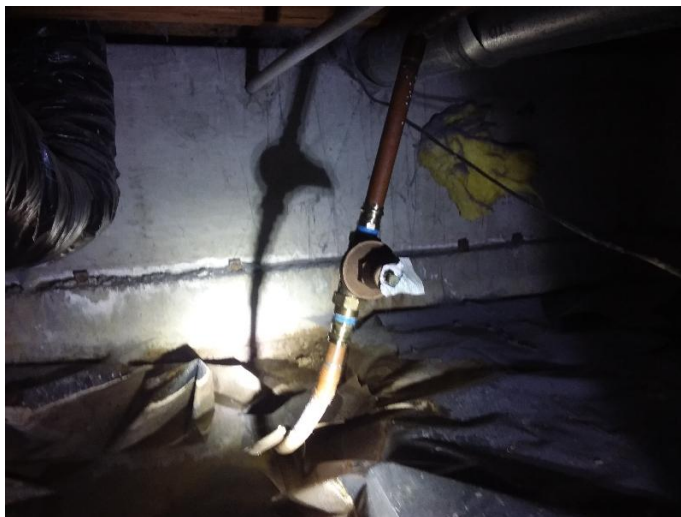
Photo 13

- Water pressure regulator is located on the Northeast end of crawlspace. (p 13).

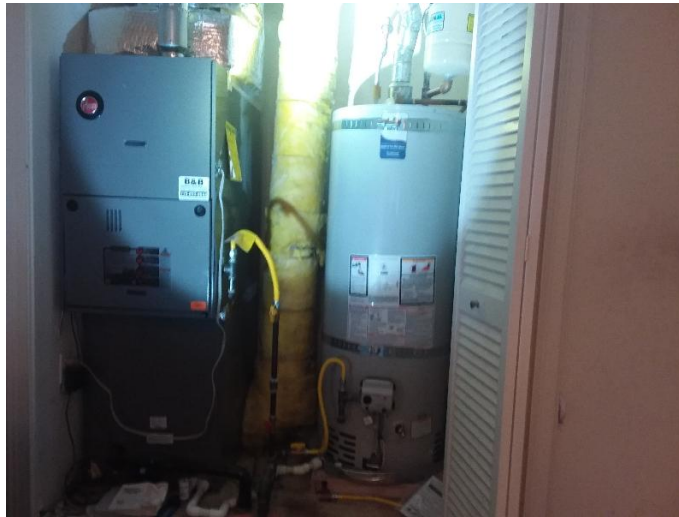
Photo 14

- Recommend insulating the supply lines at top of water heater.
- Unit is manufactured by Bradford White. (p 14).

\* Repair Completed  
09/26, see receipt\*

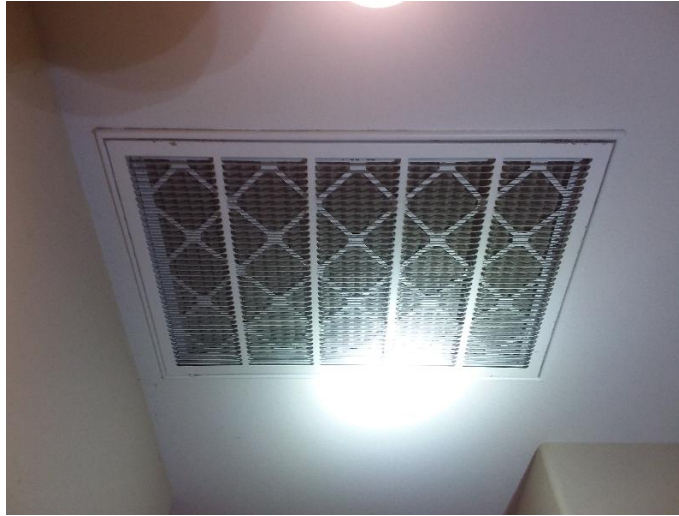
**Photo 15**

- Recommend replacing air filter at return. (p 15).

\* Repair  
Completed 09/26,  
see receipt\*

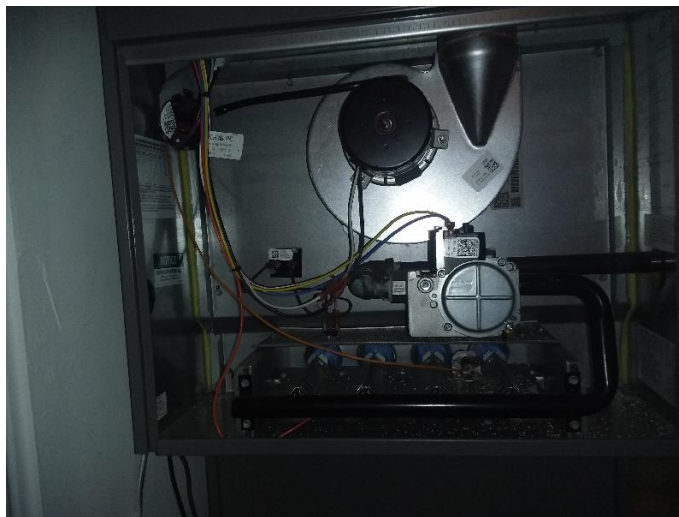
**Photo 16**

- Unit was fired. Manufactured in 2017 by Rheem. (p 16).

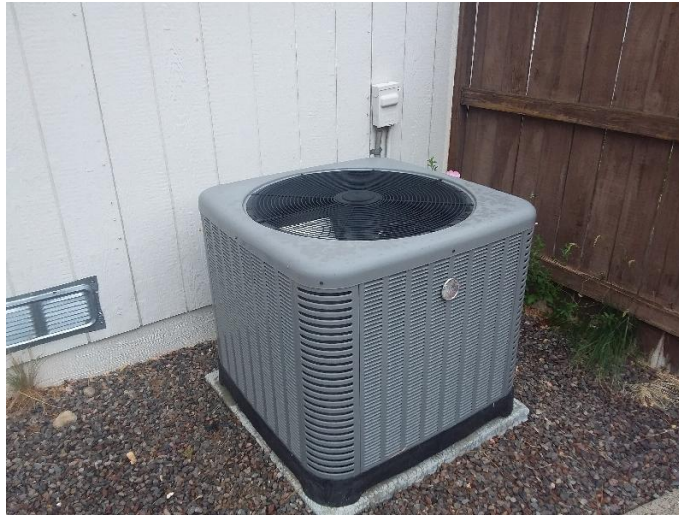
**Photo 17**

- Unit was operated. Manufactured in 2017 by Rheem. (p 17).

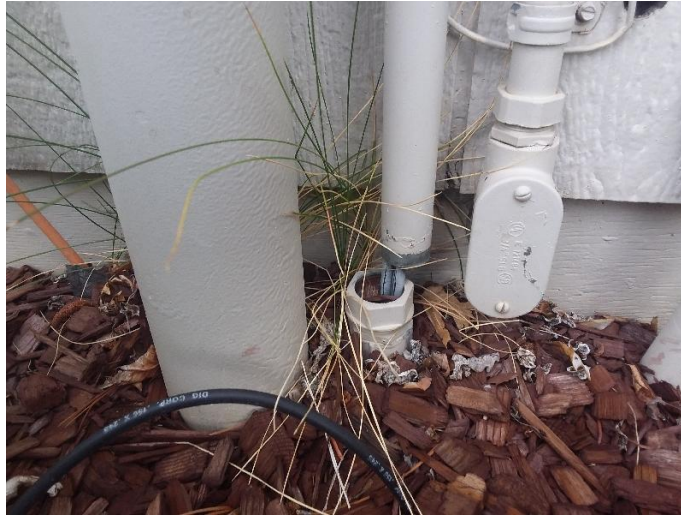
**Photo 18**

- Exposed wiring at conduit connection under electrical main. Correction needed. (p 18).

\* Repair  
Completed  
09/26, see  
receipt\*

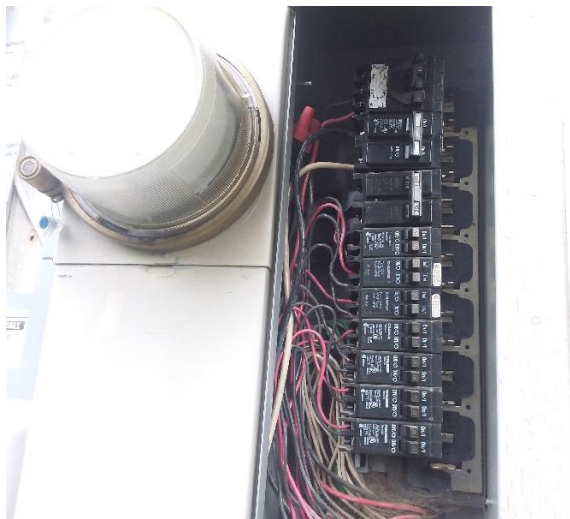
**Photo 19**

- Dead front panel was removed to evaluate for frayed and open ended wiring. No recommendations. (p 19).

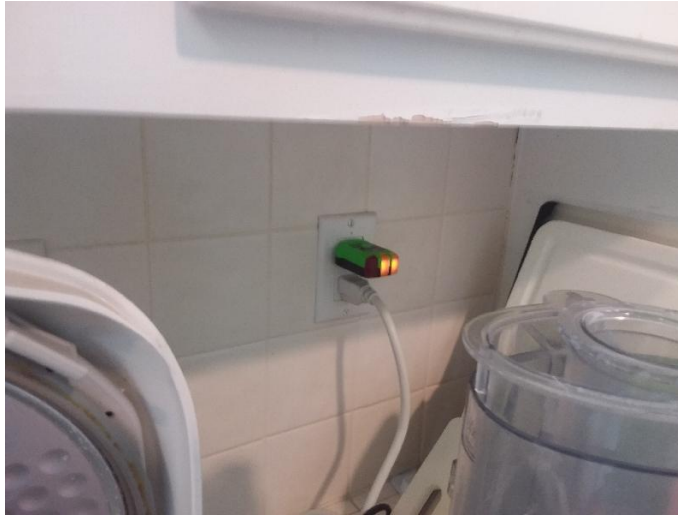
Photo 20

- Southwest kitchen outlet is not secured to junction box. Correction needed. (p 20).

\* Repair Completed  
09/26, see receipt\*

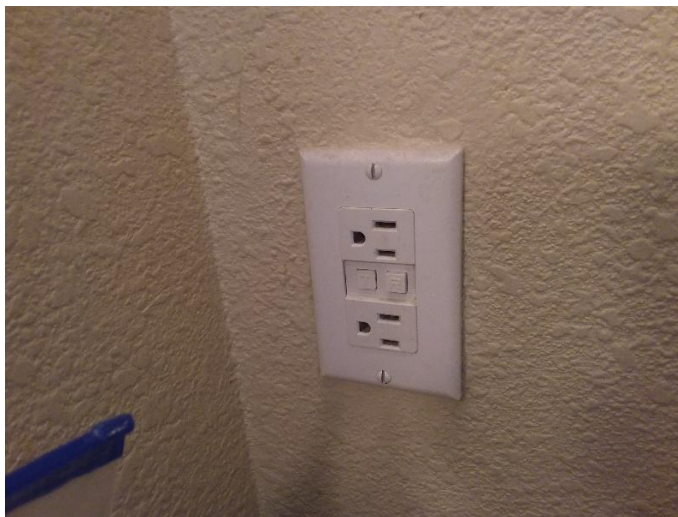
Photo 21

- Master bathroom sink electrical outlets are GFCI protected by unit located in hall bathroom. (p 21).

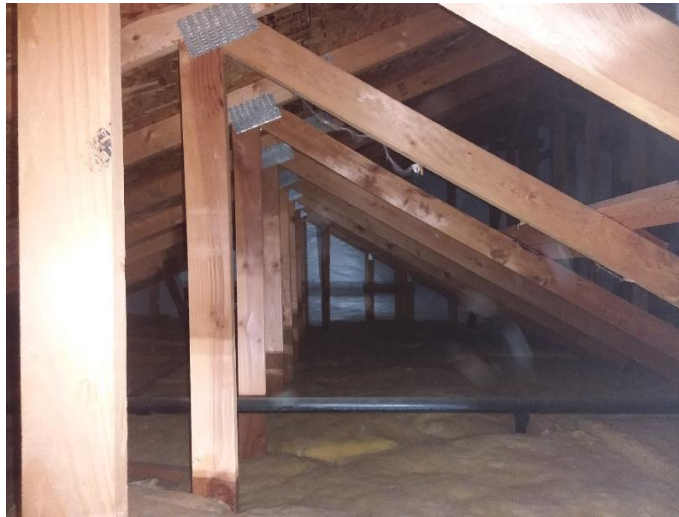
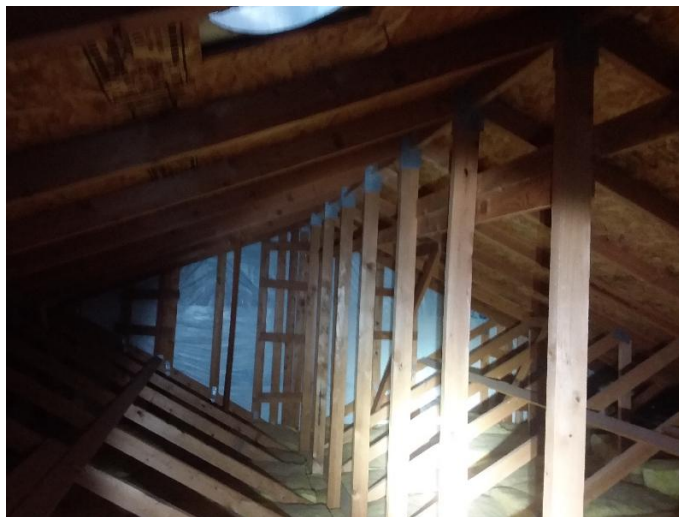
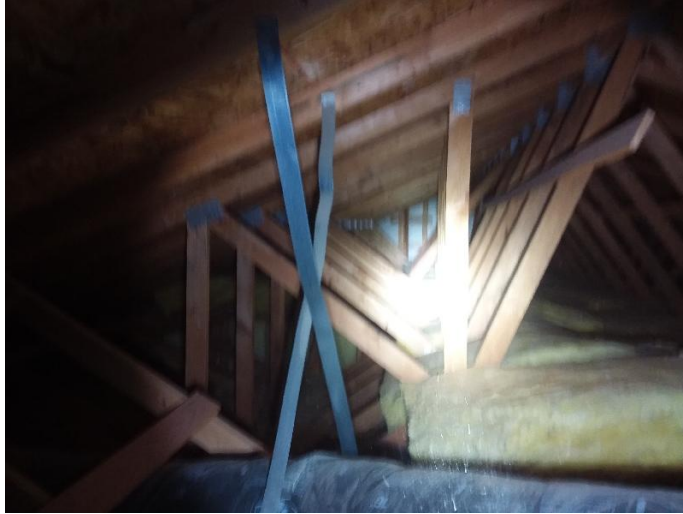
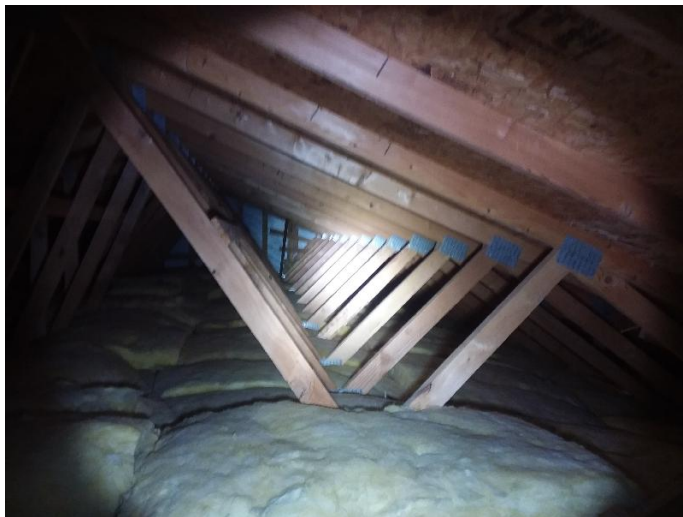
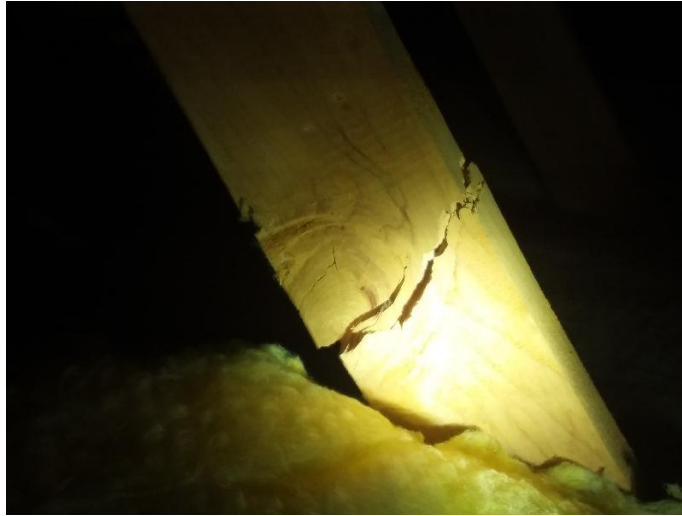
- Attic framework. Cracked truss member South of attic access. Recommend evaluation by licensed professionals and repairs made as needed. (p 22, p 23, p 24, p 25, p 26).

**\*\* Truss repair completed 08/26. See receipt \*\***

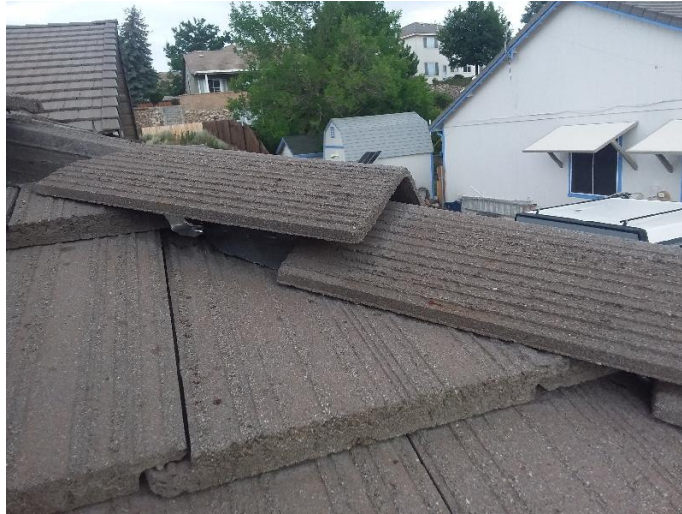
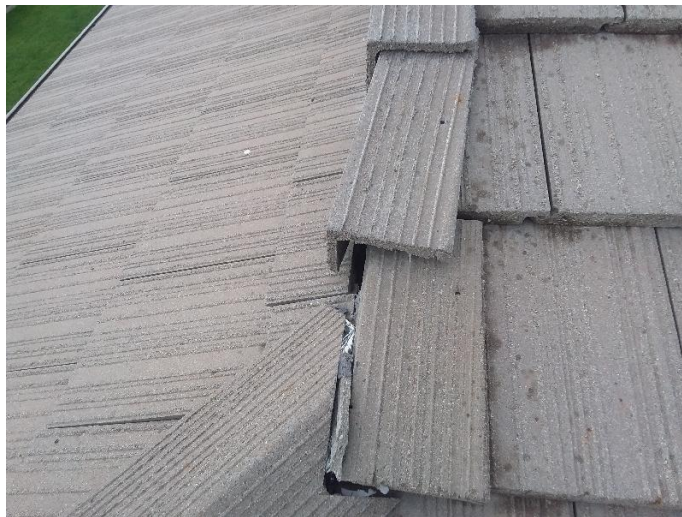
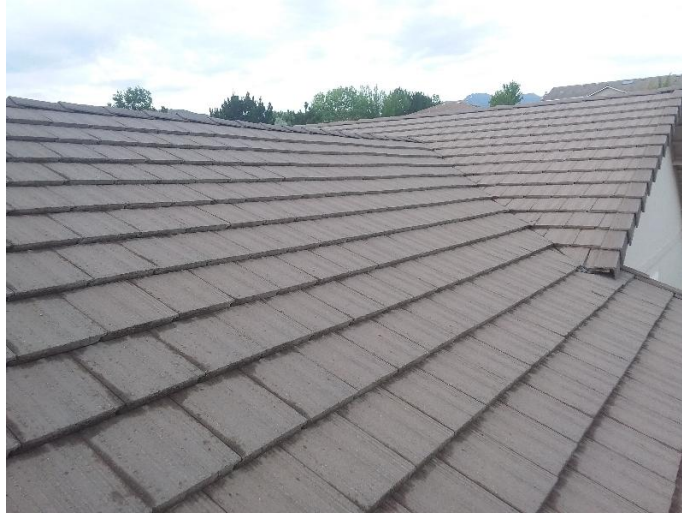
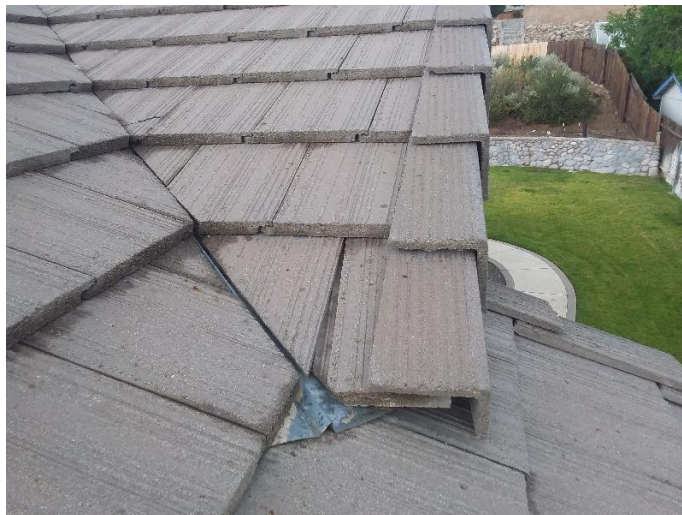
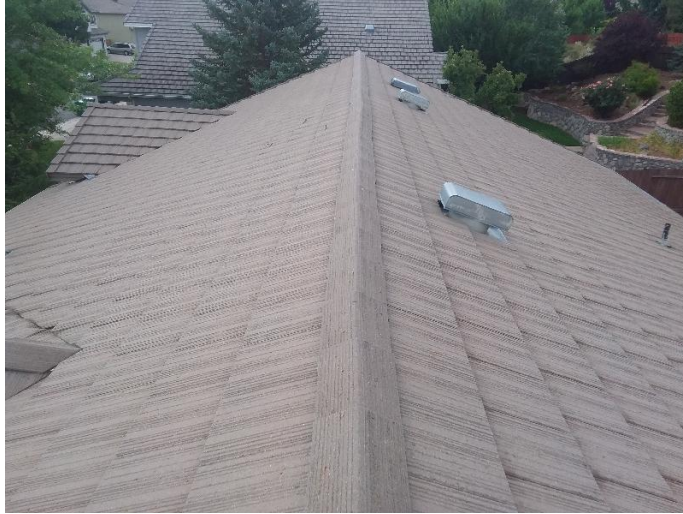
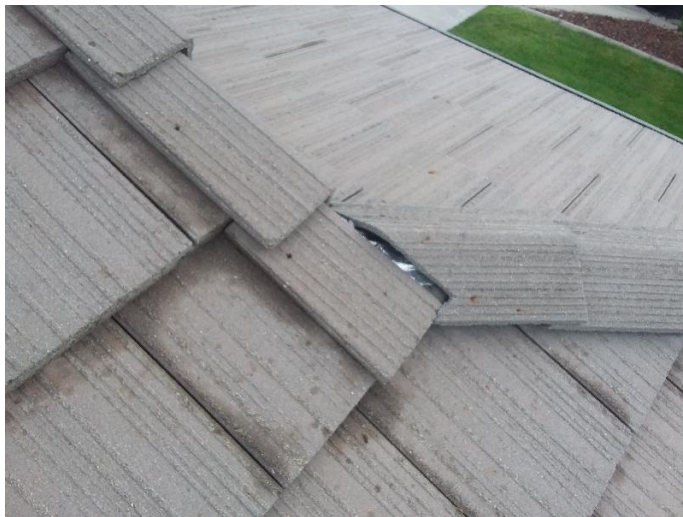
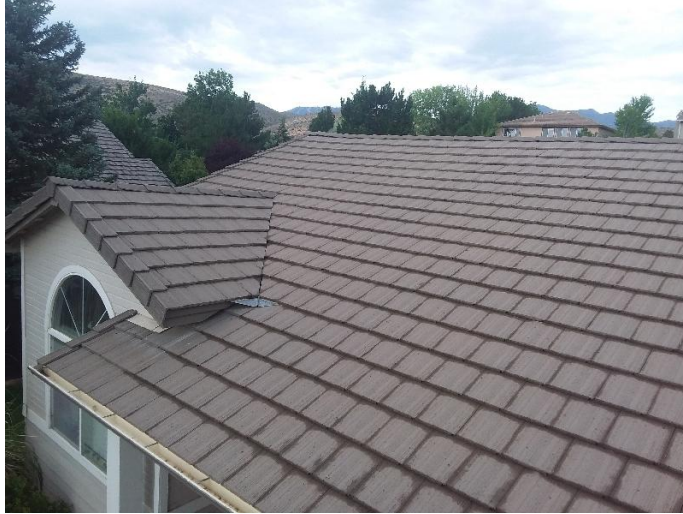
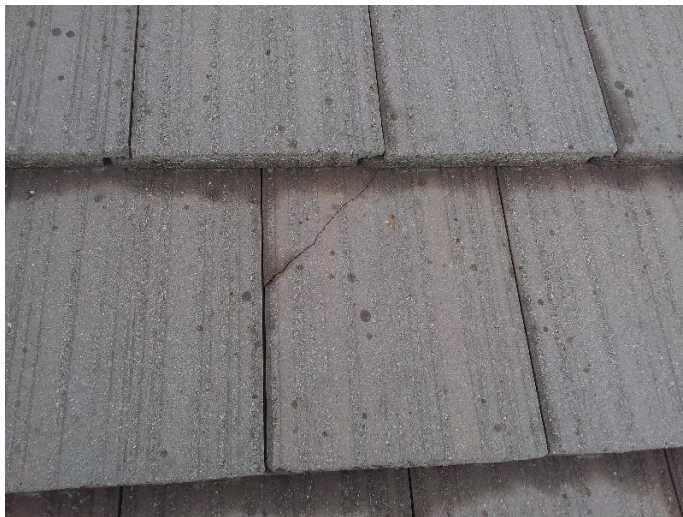
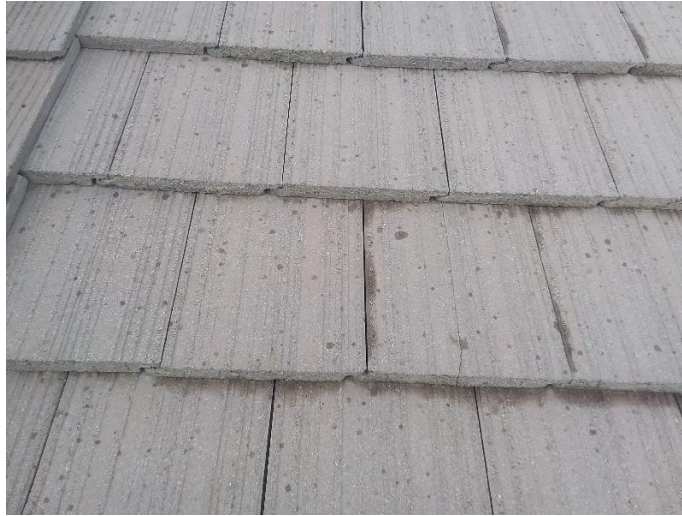
- Roof tiles are in fair condition. Northeast ridge and rake tiles are not secured and sealant is deteriorating or missing at various locations. Dislodged on North end. Cracked tile on East and Southeast ends. Recommend evaluation of roof by a licensed roofing contractor and repair as needed. (p 27, p 28, p 29, p 30, p 31, p 32, p 33, p 34, p 35).

\*\* Roof repairs completed 07/26, see receipt

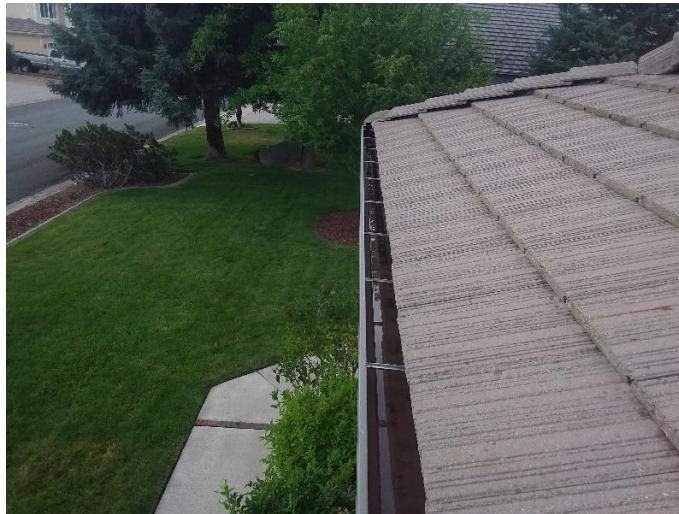
**Photo 36**

- East rain gutter above garage is holding water. Recommend correction. (p 36).

\* Repair Completed  
09/26, see receipt\*

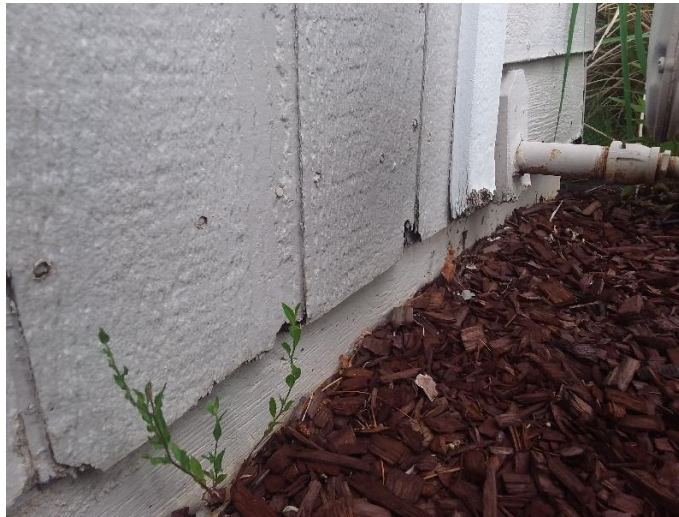
**Photo 37**

- Moisture damage to siding and trim board on Southeast and North ends. Recommend corrections as needed. (p 37).

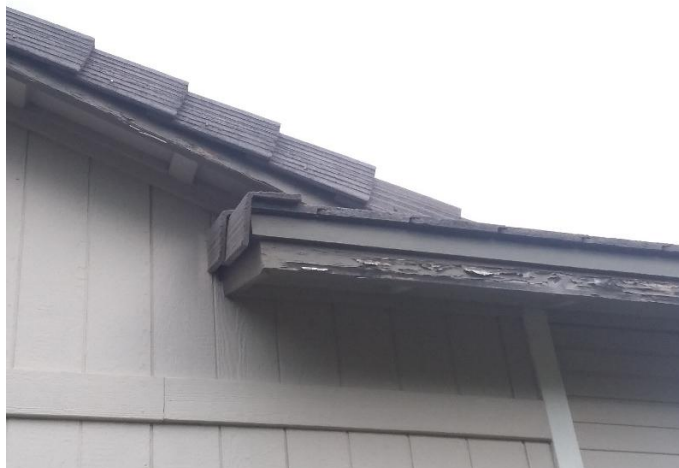
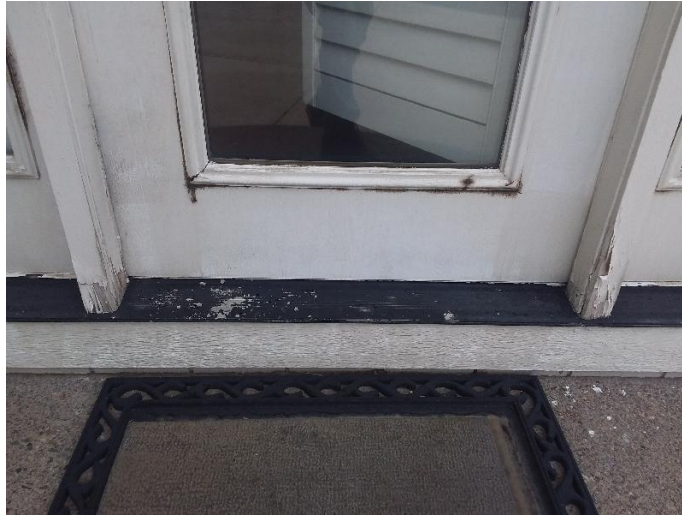
- Paint is deteriorating to fascia and trim boards. Recommend applying paint where needed. (p 38, p 39).

\* Repair  
Completed  
09/26, see  
receipt\*

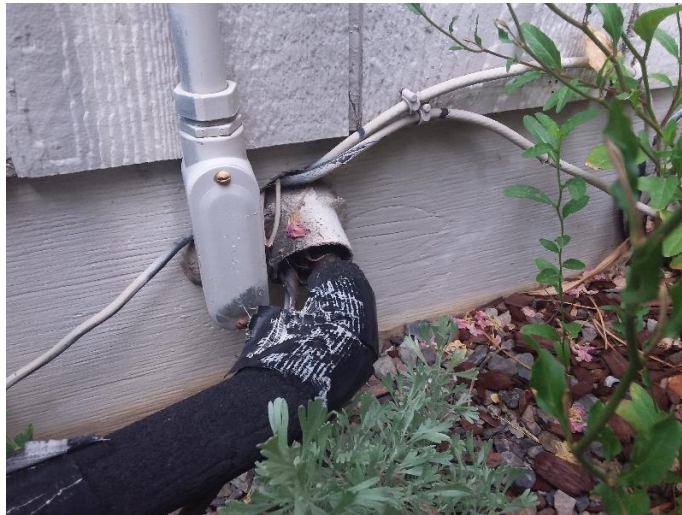
**Photo 40**

- Recommend sealing line set entering structure to prevent pest activity. (p 40).

\* Repairs  
Completed  
09/26, see  
receipt\*

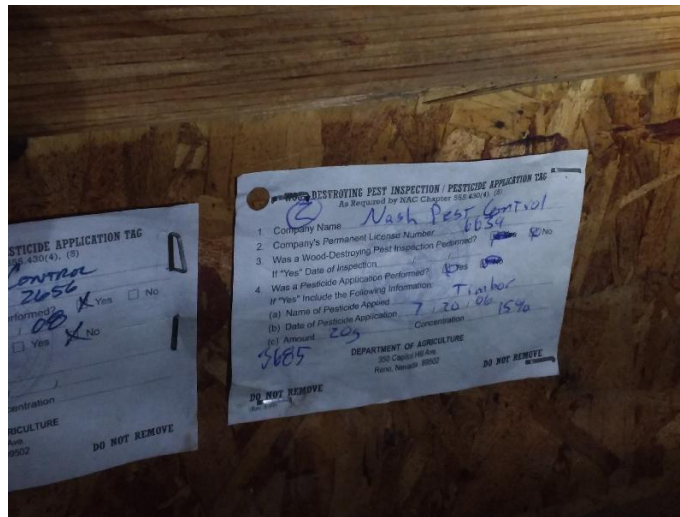
Photo 41

- Recommend a visqueen vapor barrier be re-spread and added as needed.
- Fungicide treatment was performed in 2006 in crawlspace. Recommend monitoring. (p 41).

\* Pest work  
completed  
07/26 \*

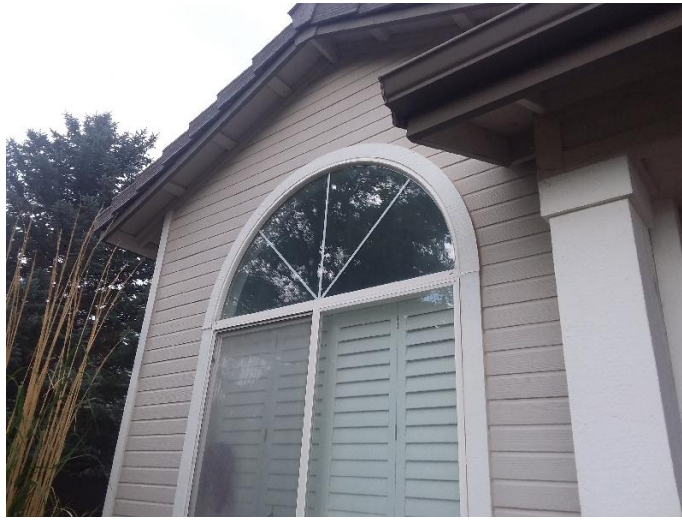
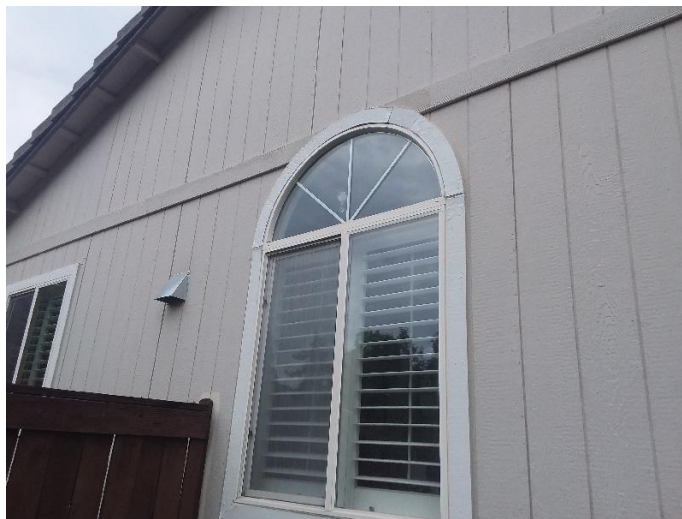
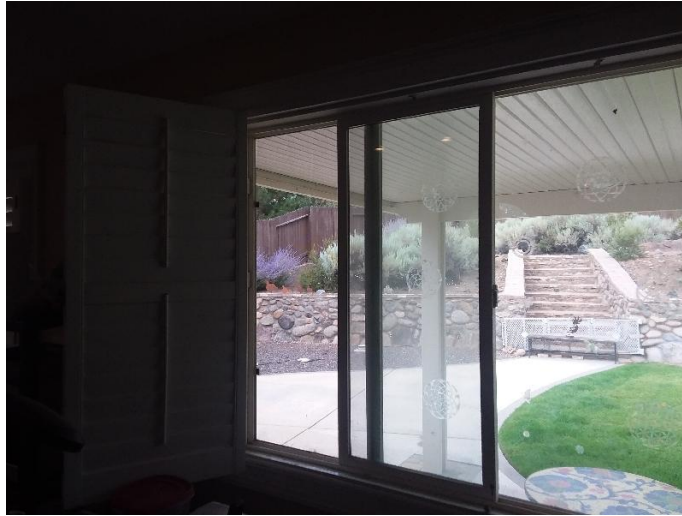
- Southeast and Southwest windows appear to have failed thermoseals. Recommend evaluation and corrections made as needed for energy efficiency. (p 42, p 43, p 44).

\* Repairs  
Completed  
09/26, see  
receipt\*

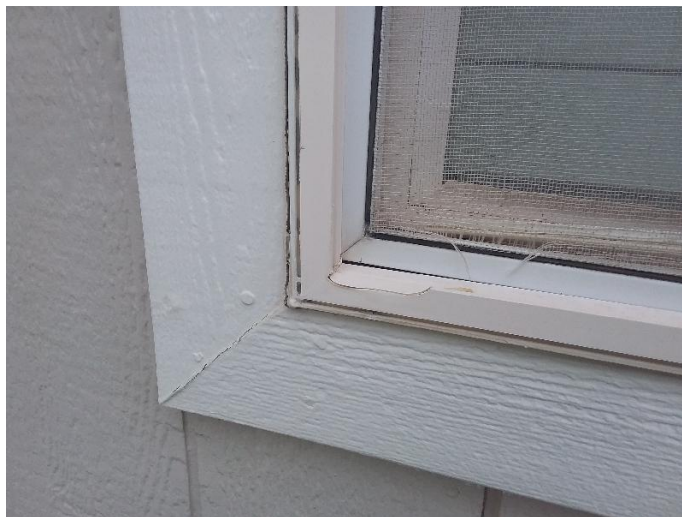
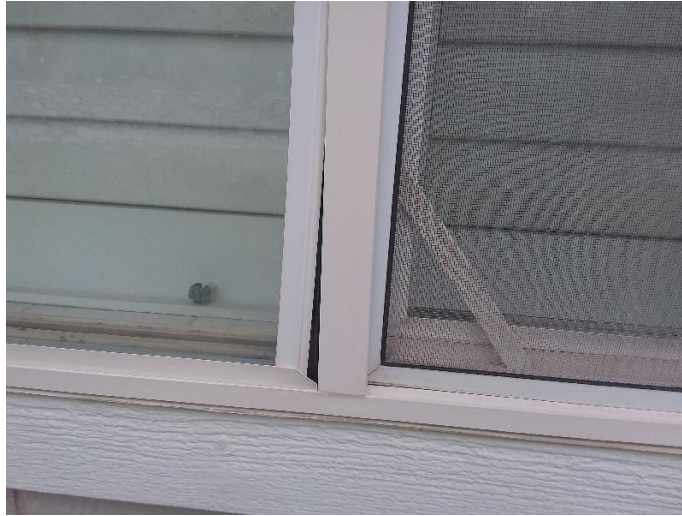
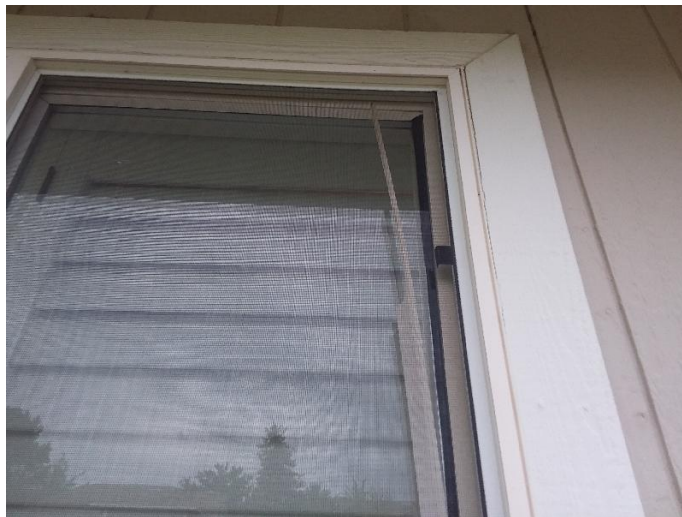
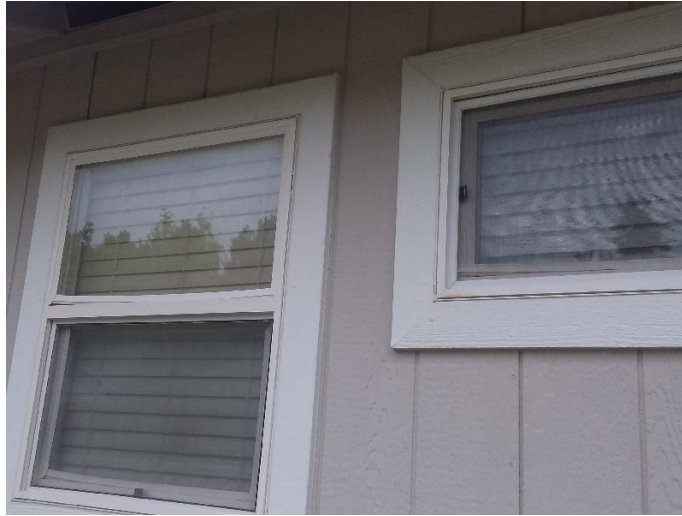
- Bead strips are damaged or not secured to various West windows. Recommend corrections. (p 45, p 46, p 47, p 48).

\* Repairs  
Completed  
09/26, see  
receipt\*

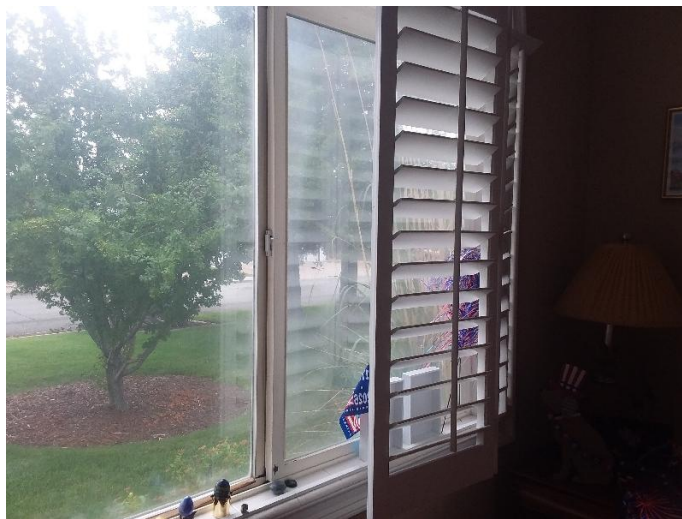
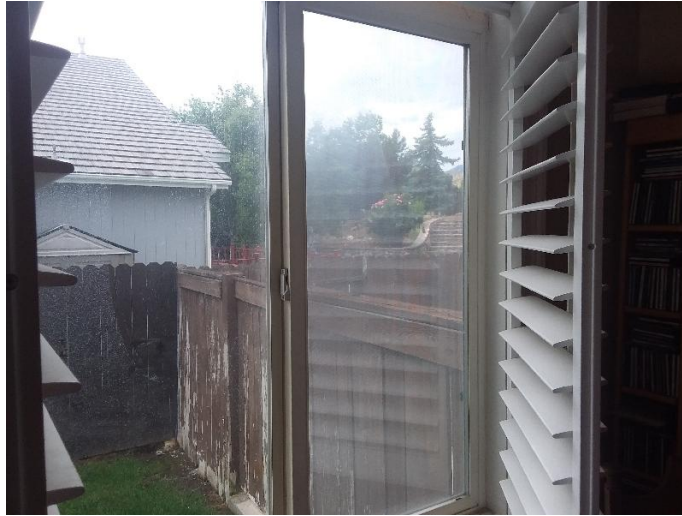
- Southeast window frames are not secured to glass panes. Recommend reglazing to prevent damage. (p 49, p 50).

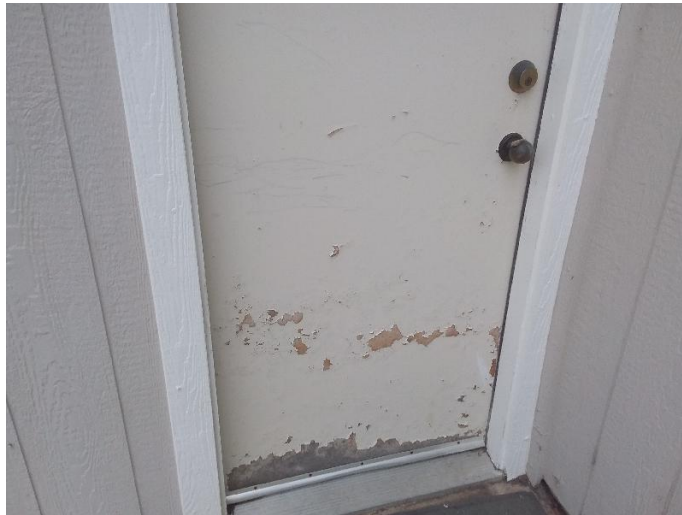
**Photo 51**

- Paint is deteriorating to garage man door. Recommend correction. (p 51).

\* Repair  
Completed  
09/26, see  
receipt\*

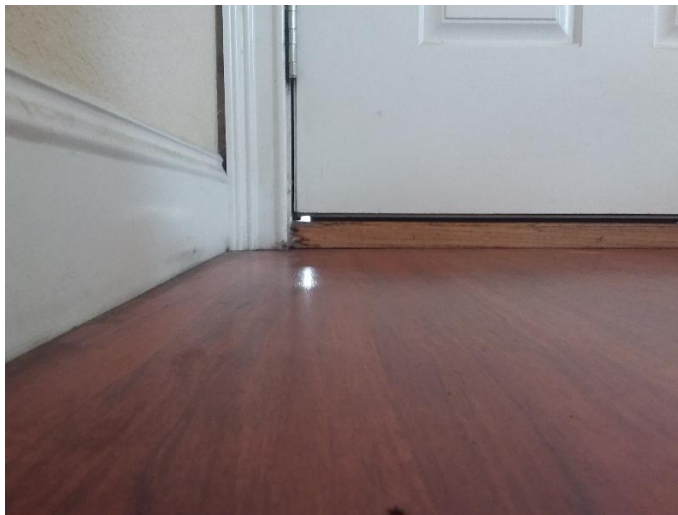
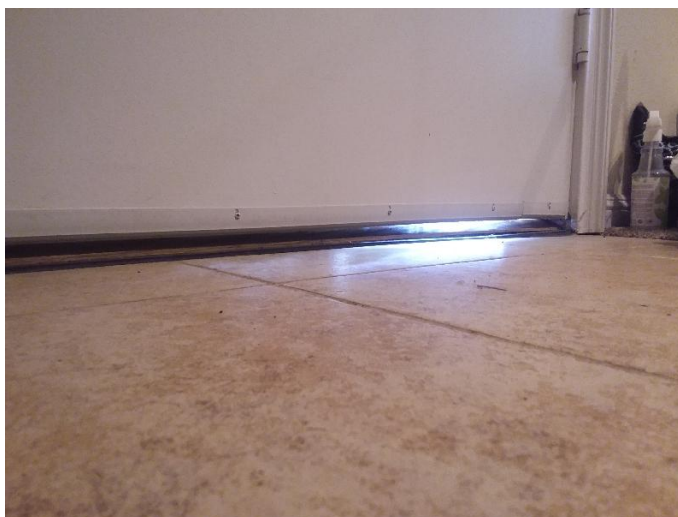
- Daylight can be seen at front, kitchen and garage fire door sweeps. Recommend correction to prevent pest activity. (p 52, p 53).

\* Repair  
Completed  
09/26, see  
receipt\*

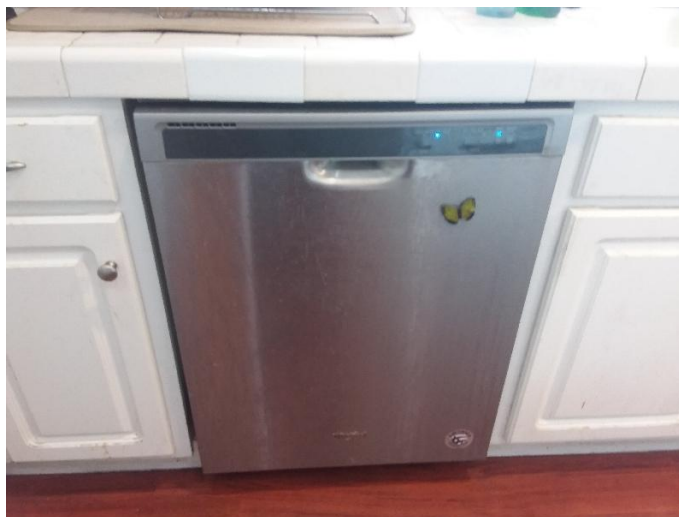
**Photo 54**

- Dishwasher is not secured to cabinet. Recommend correction. (p 54).

\* Repair  
Completed  
09/26, see  
receipt\*

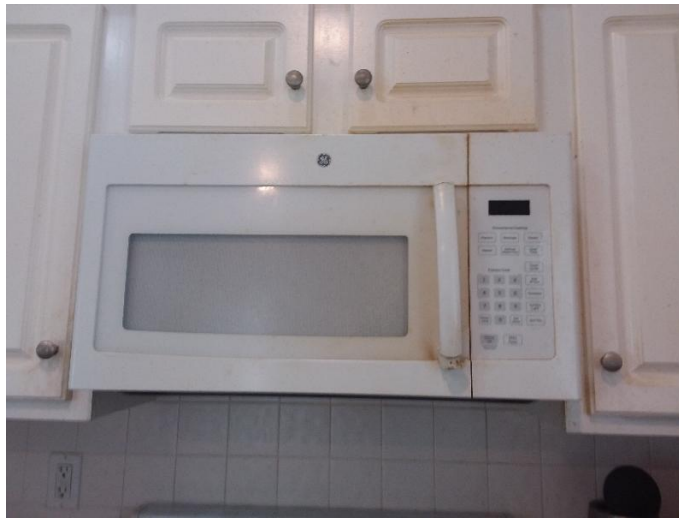
Photo 55

- Microwave door is damaged and unit did not operate. (p 55).

\* Microwave  
Replaced  
09/26 \*

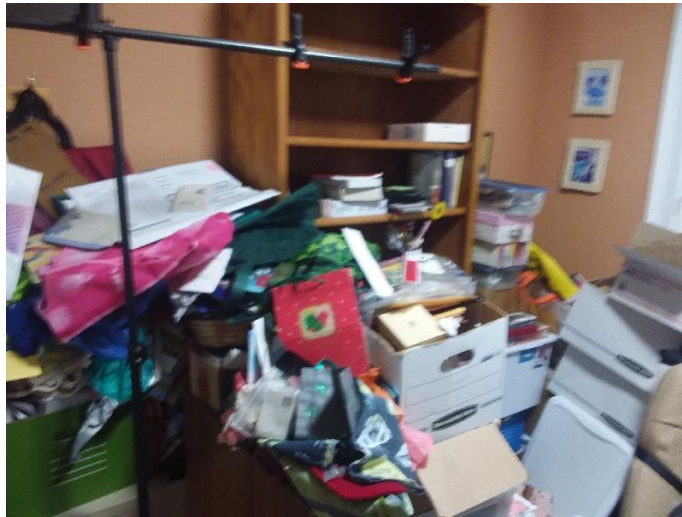
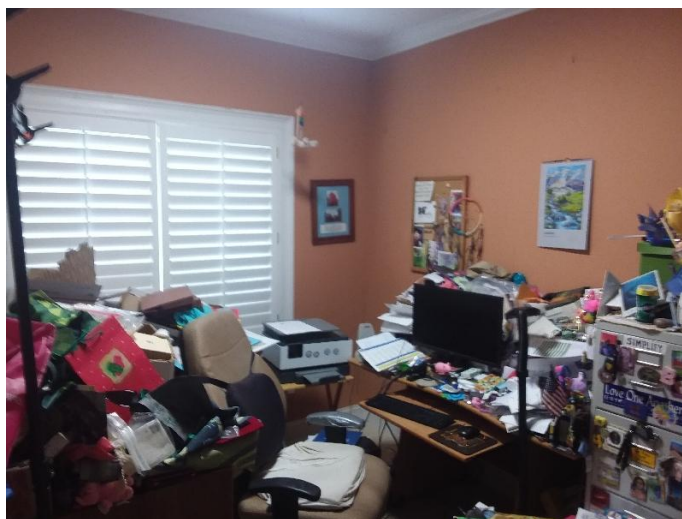
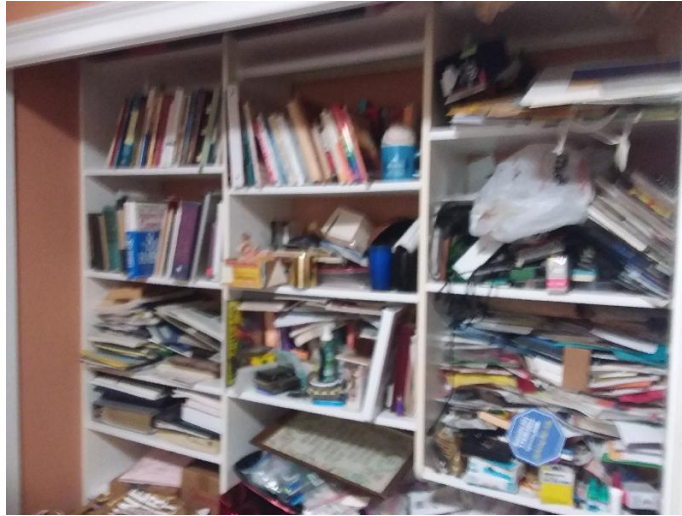
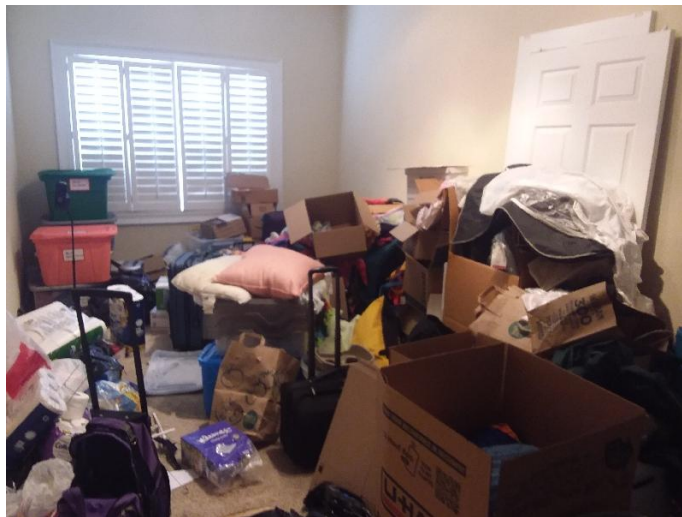
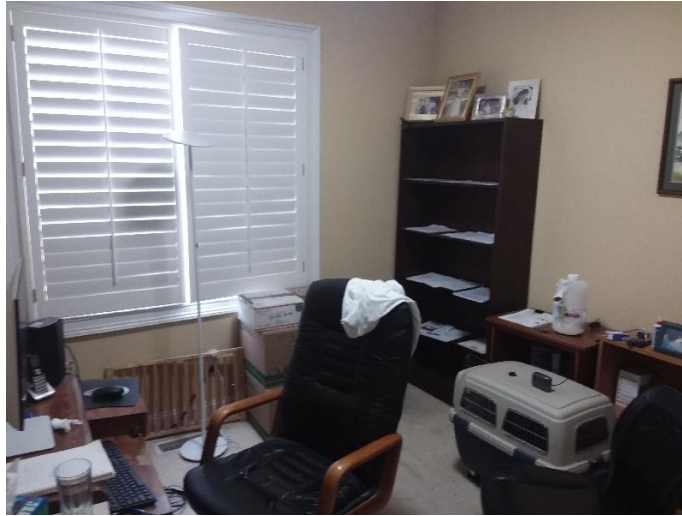
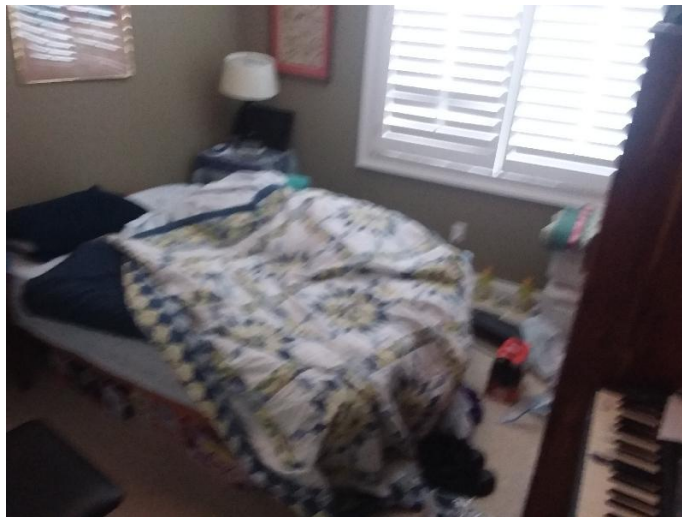
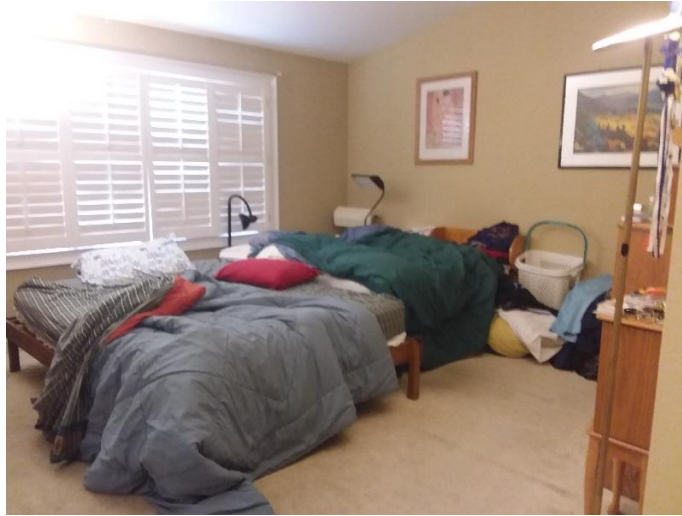
- Limited access in rooms. Noted closet doors are missing in East bedroom. (p 56, p 57, p 58, p 59, p 60, p 61, p 62).
