**Armstrong**  
INSPECTION SERVICES, INC.

## INSPECTION REPORT

Property Inspection Address: **12500 Campo Rico Ln Sparks NV 89441**

Inspection Date: **August 27th, 2026**

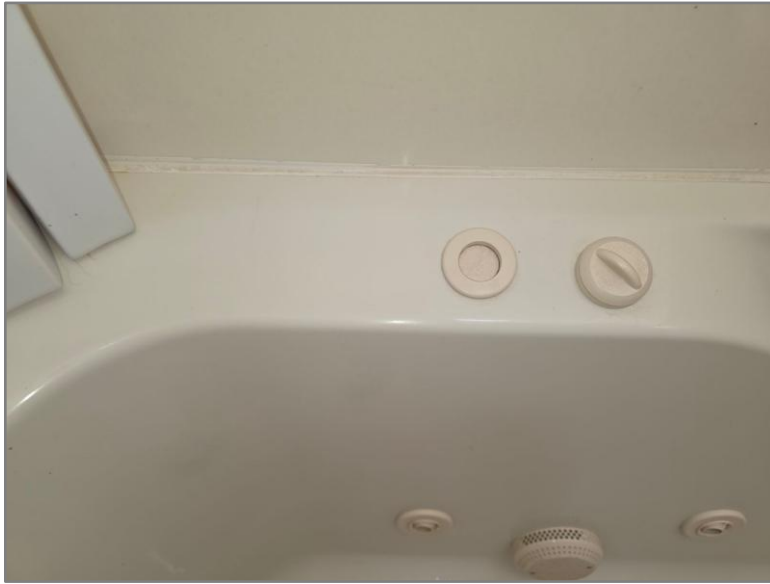
Plumbing-1

→ The hallway bathroom spa tub air switch button is stuck, recommend repair.

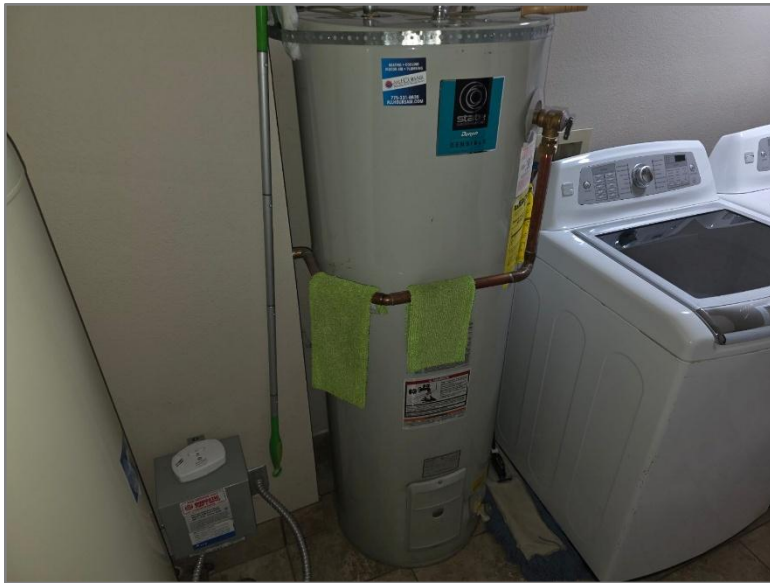
WaterHeater-1

Overall condition: **Poor to Fair**

→ Electric water heater located in the laundry room. The unit was manufactured in 1996 and is not equipped with the currently required equipment. Recommend consideration be given to evaluating further and adding the currently required equipment, the reason for the poor to fair rating is based on the age of the unit and not the appearance.

→ Electric water heater located in the laundry room. The unit wasn't manufactured in 1996 and is not equipped with the currently required equipment. Recommend consideration be given to evaluating further and adding the currently required equipment, the reason for the poor to fair rating is based on the age of the unit and not the appearance.

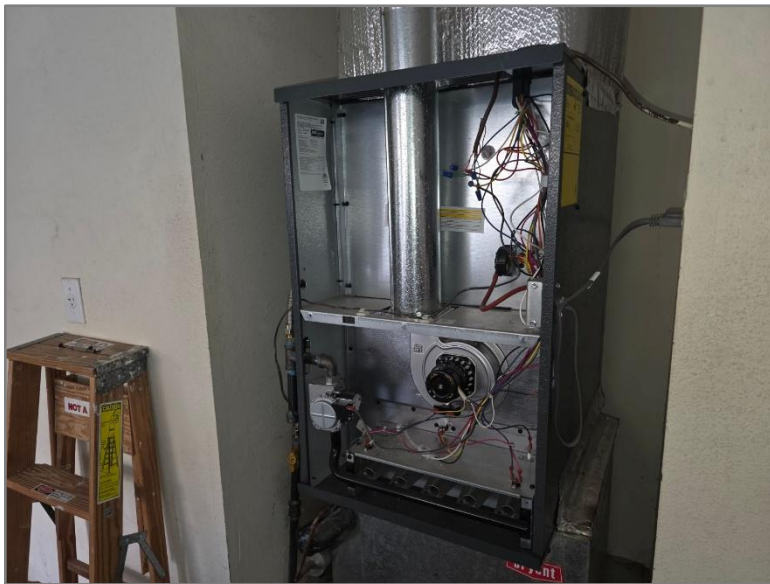
Heating-1

→ Gas-fired furnace located in the garage. The unit was manufactured in 2023.

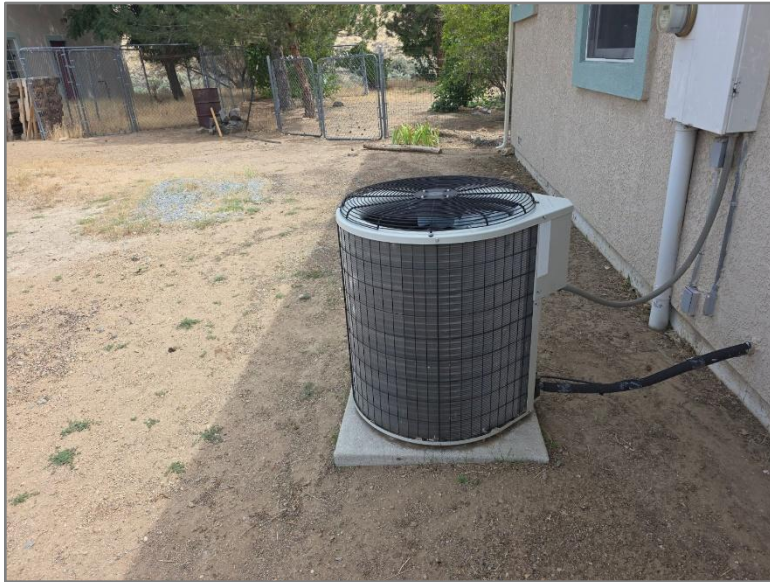
A/C-1

→ Air conditioning unit located on the north side. The unit was manufactured in 2003. The estimated service life of an air conditioner is between 20 and 25 years.

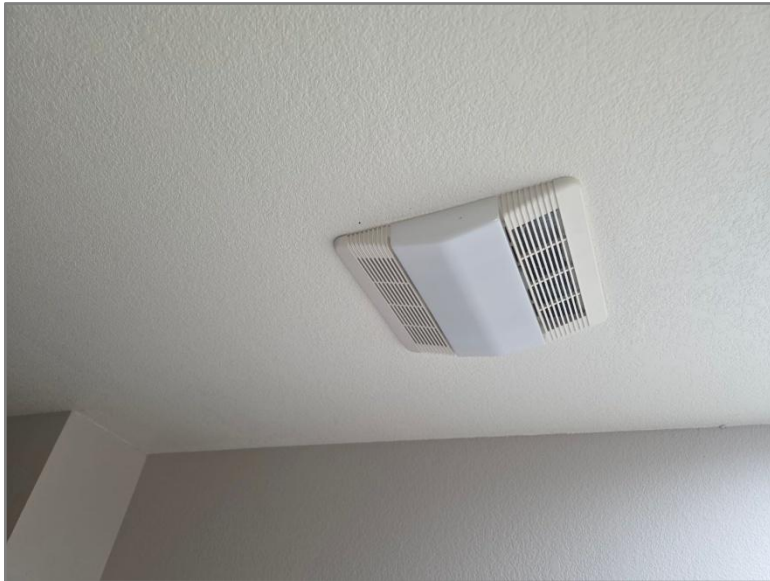
Electrical-1

→ The laundry room exhaust fan light is out, recommend installing a new bulb and evaluating further.

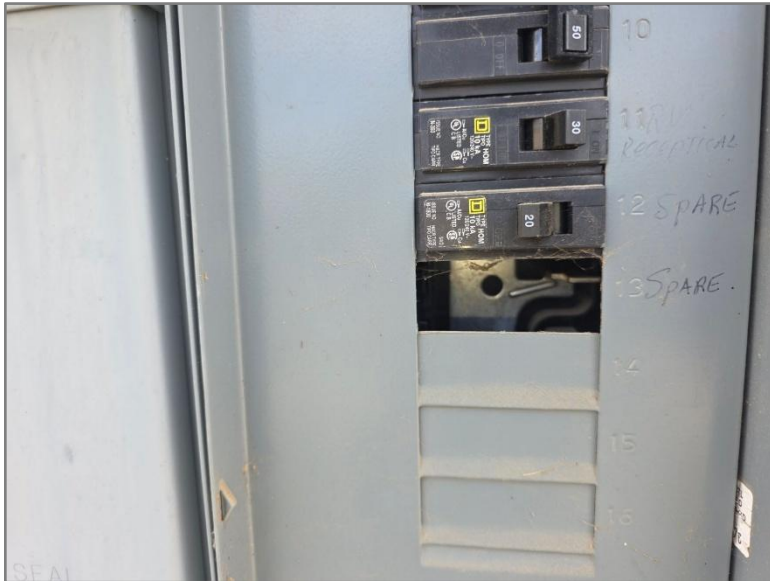
Electrical-2

→ Open space in the detached garage electrical panel recommend covering.

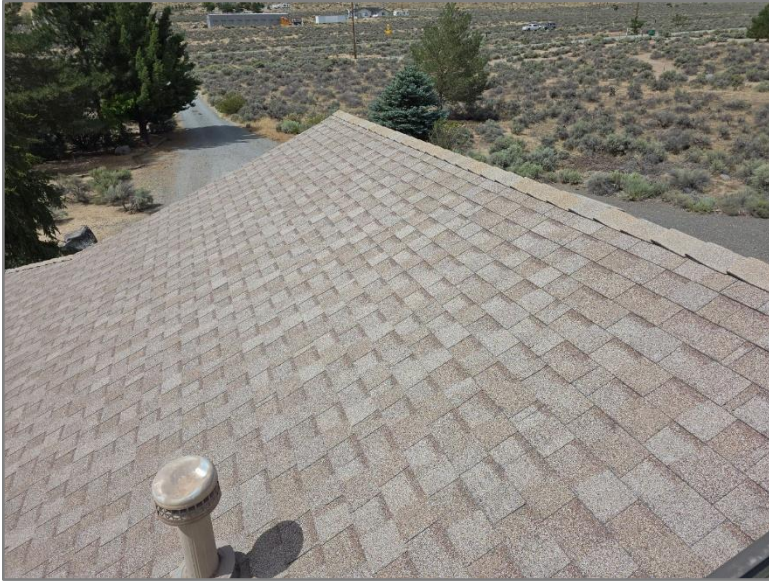
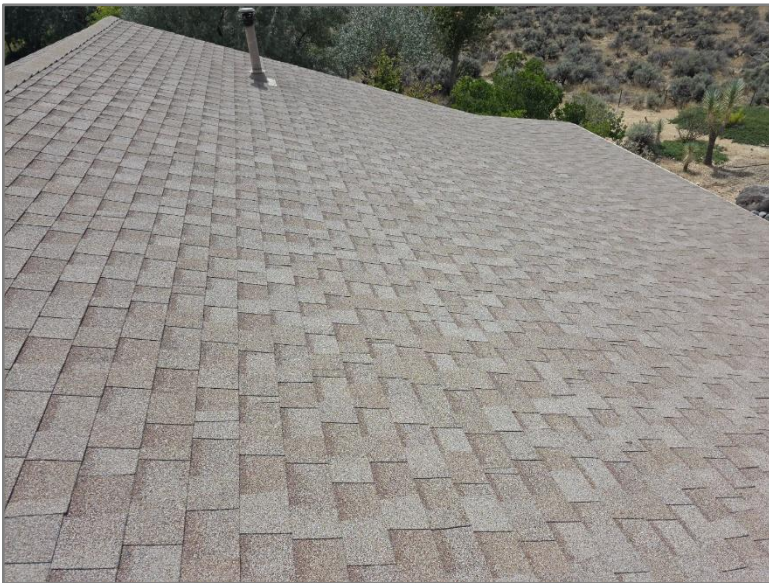
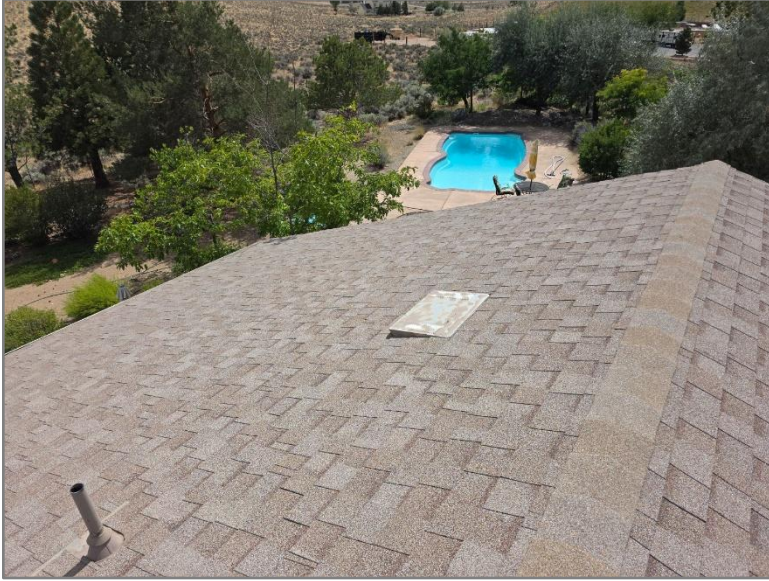
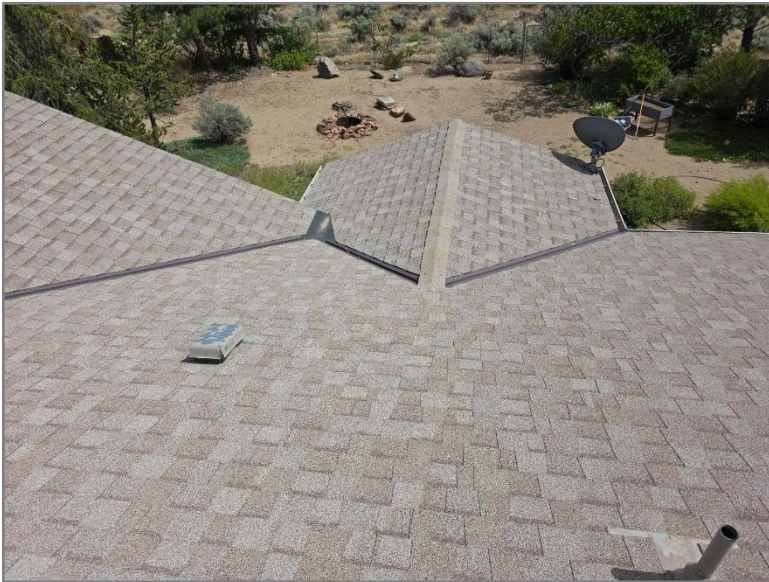
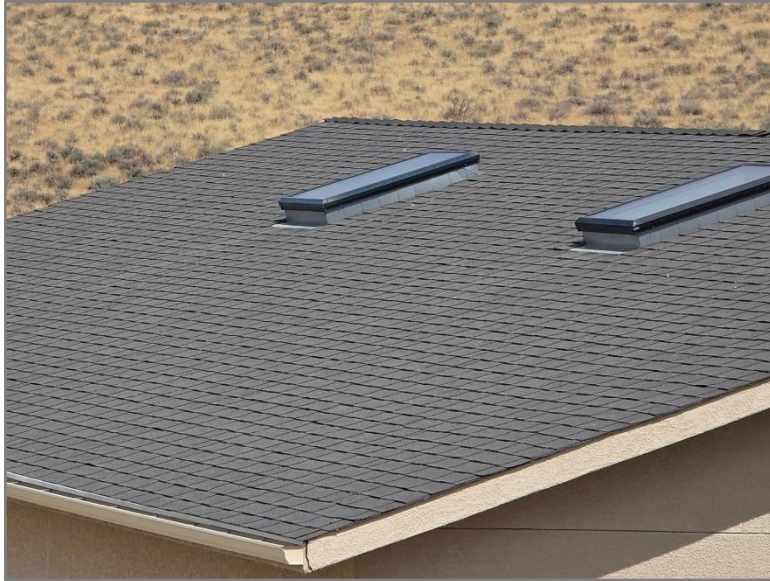
→ The main house roof appears to be in good condition, and the detached garage roof appears to be in fair condition.

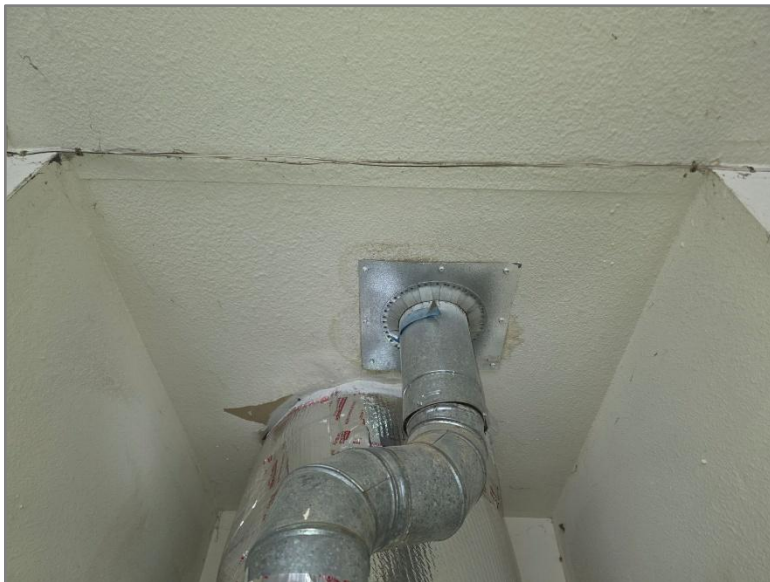
Interior-1

→ Some staining was observed around the furnace flu pipe. A thermal scan did not reveal current moisture

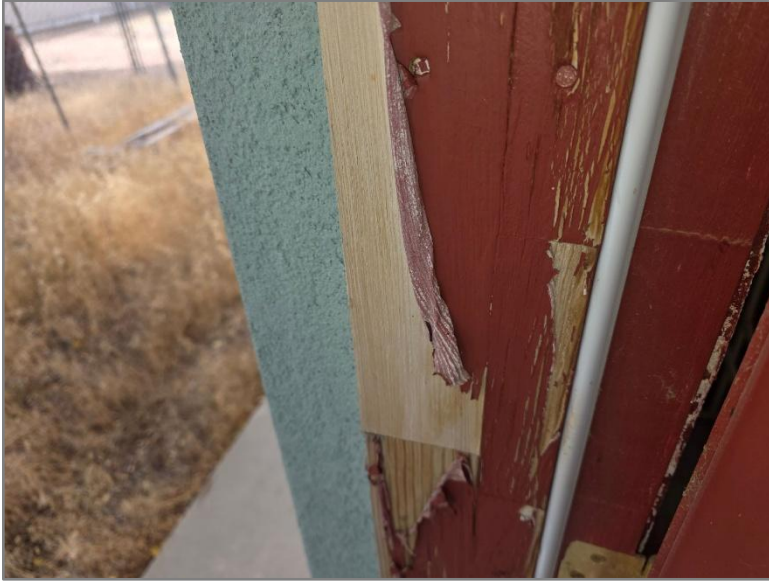
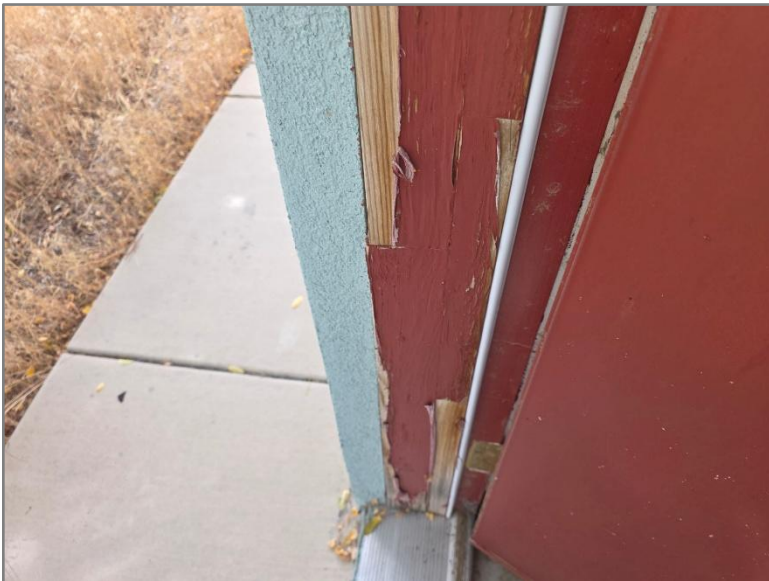
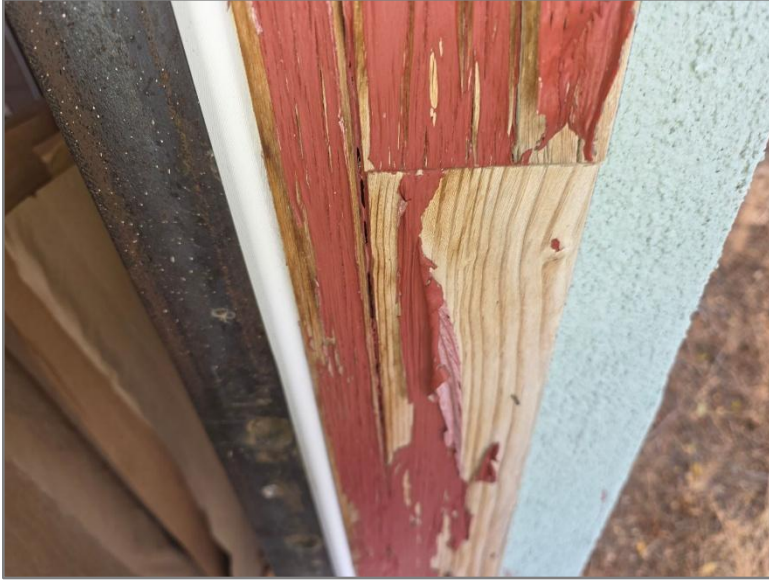
→ Peeling paint observed on the detached garage man door jamb, recommend sealing.

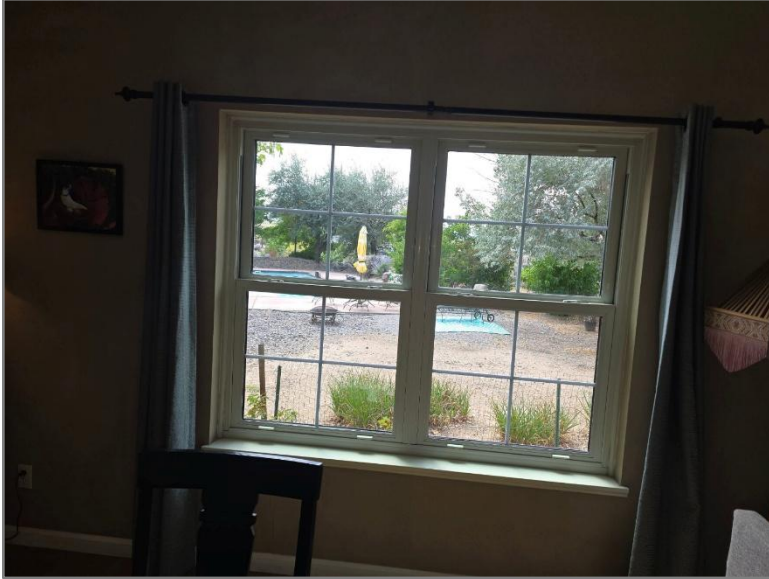
Windows-1

→ The south dining room window on the left is difficult to operate, recommend adjusting.

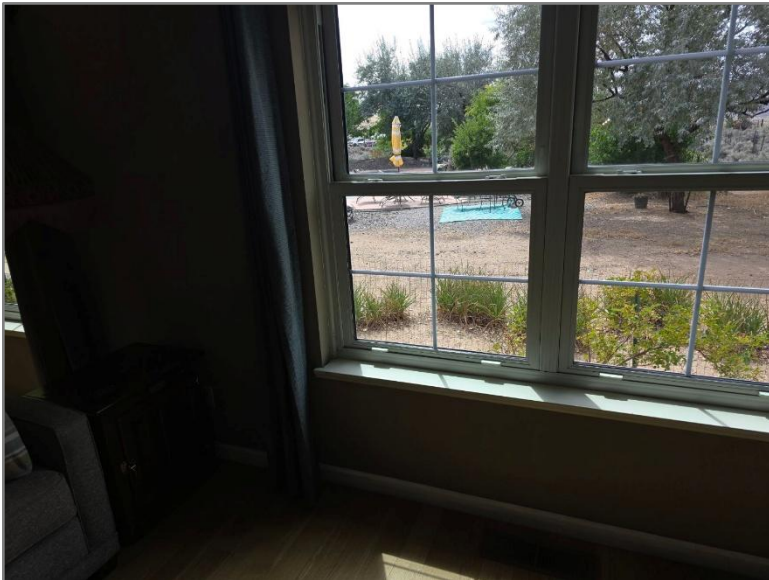
Windows-2

→ The left south family room window doesn't stay in the track when opening, recommend repair.

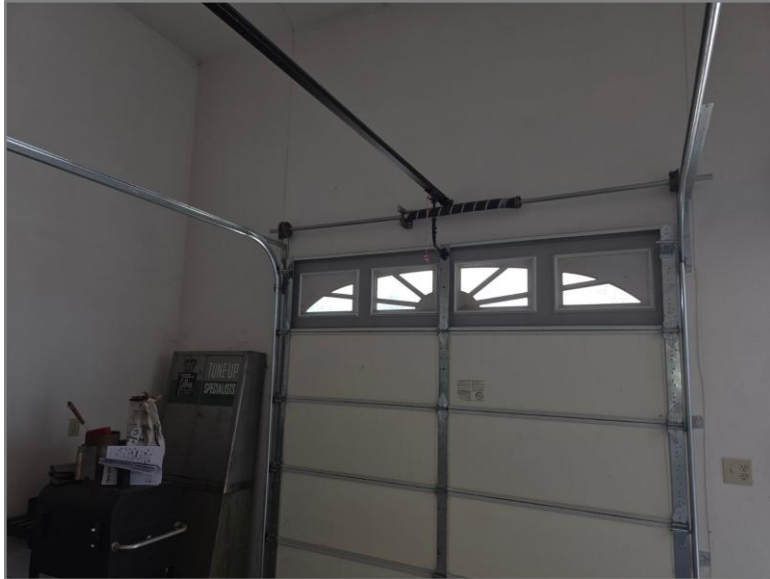
Doors-1

→ The south garage door in the detached garage is damaged at the top panel and is rough operating, recommend further evaluation.

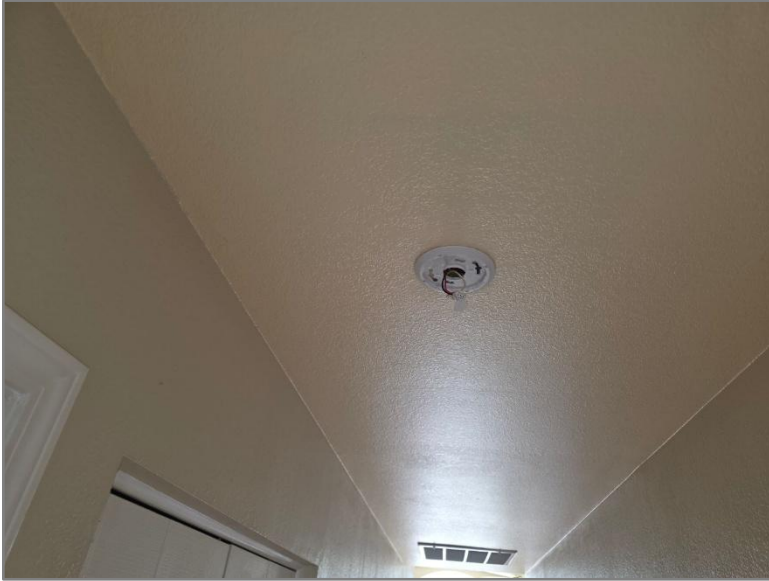
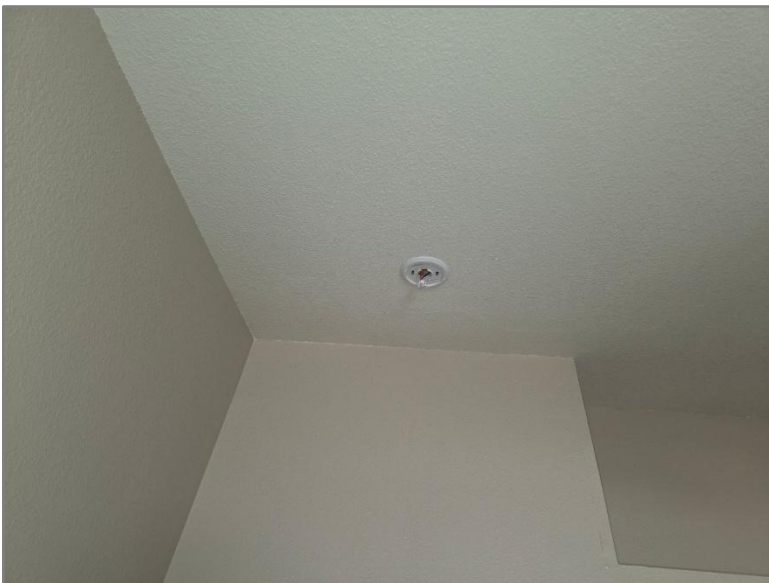
→ Missing smoke detectors observed, recommend replacing.
