### Supplemental Disclosure Regarding Prior Inspections

| Inspection Type (General, Roof, etc) | Name of Inspector or Inspection Co. | Date of Inspection |
|---|---|---|
| General | Marc Bebout Armstrong Inspection Services, Inc. | 09/09/2026 |

## INSPECTION REPORT

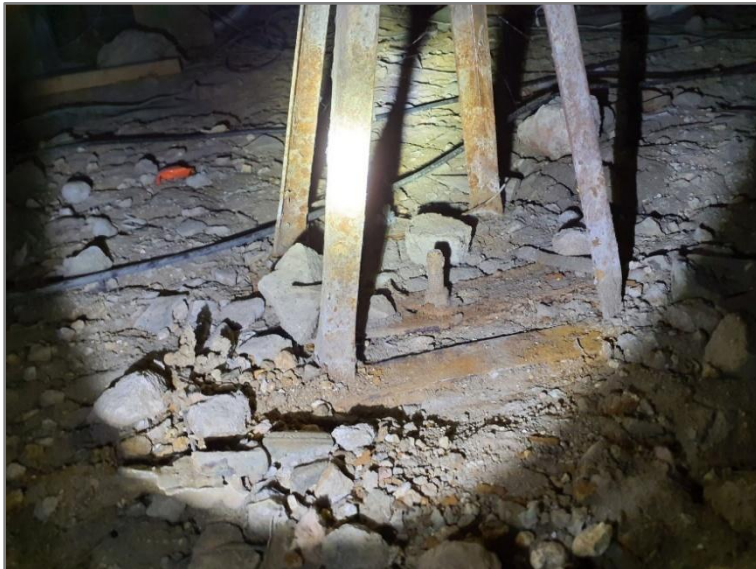
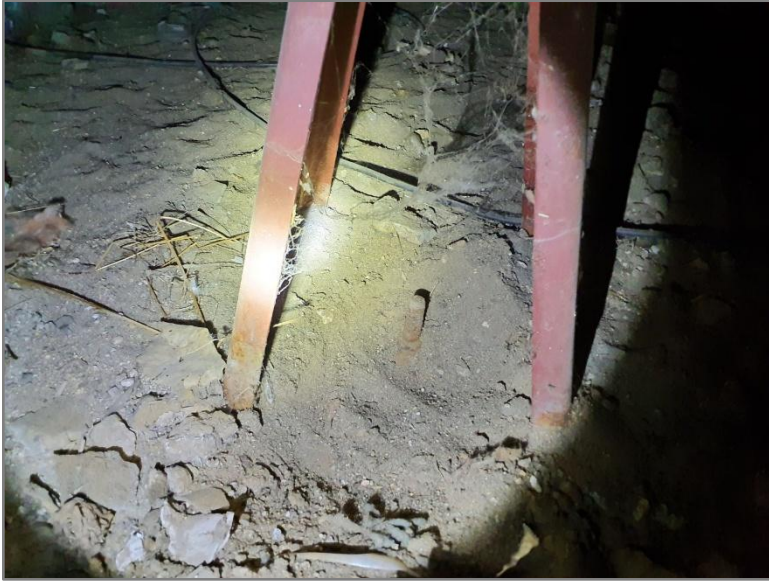
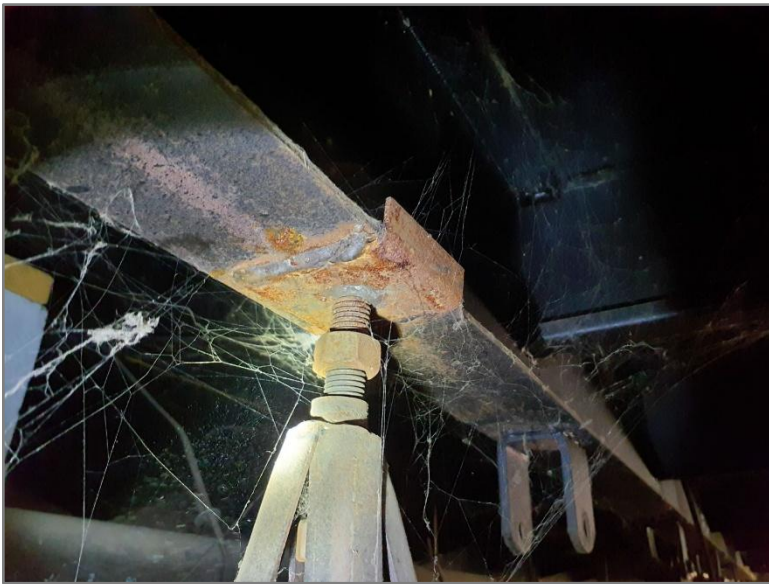
→ The metal screw jacks at the corners and middle of crawl space are bolted down and welded to the frame.

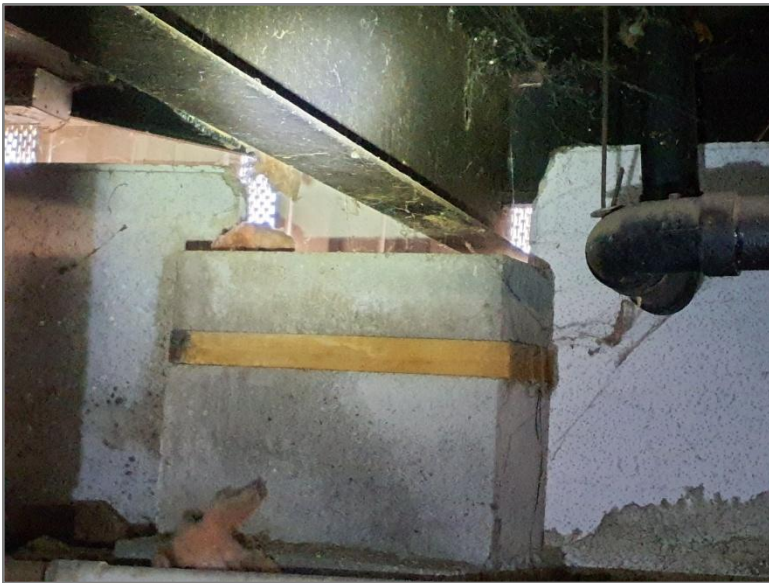
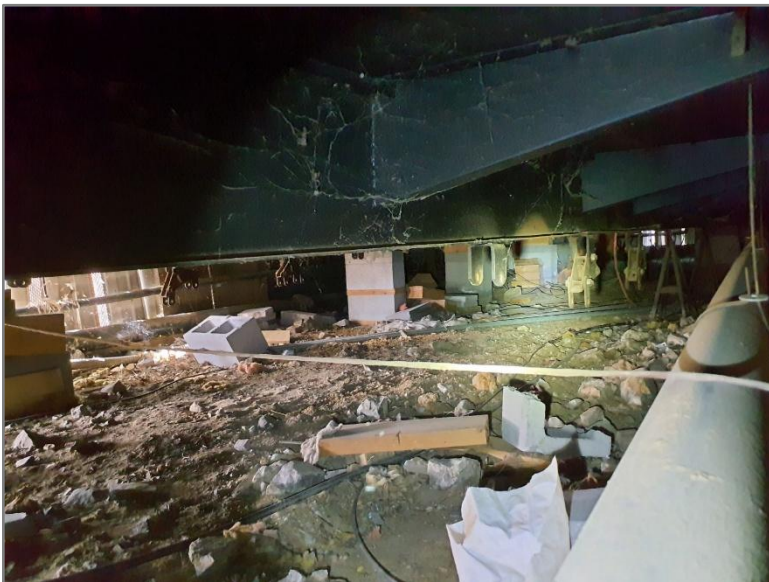
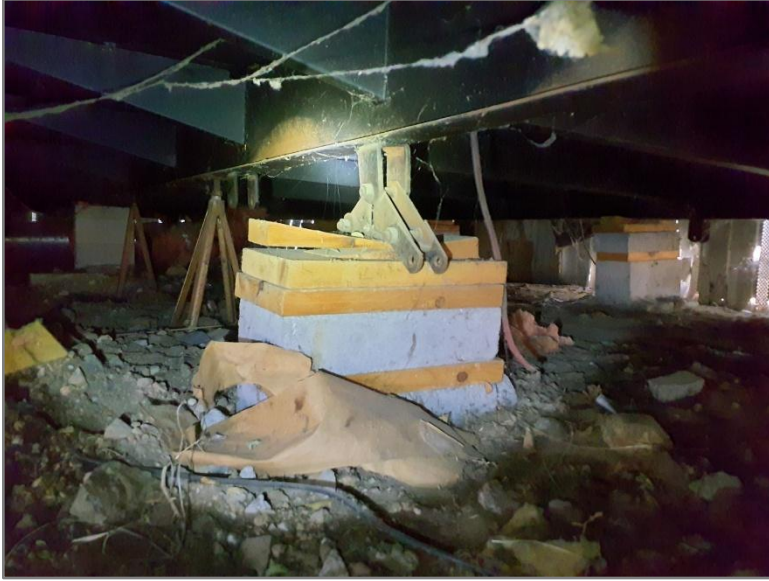
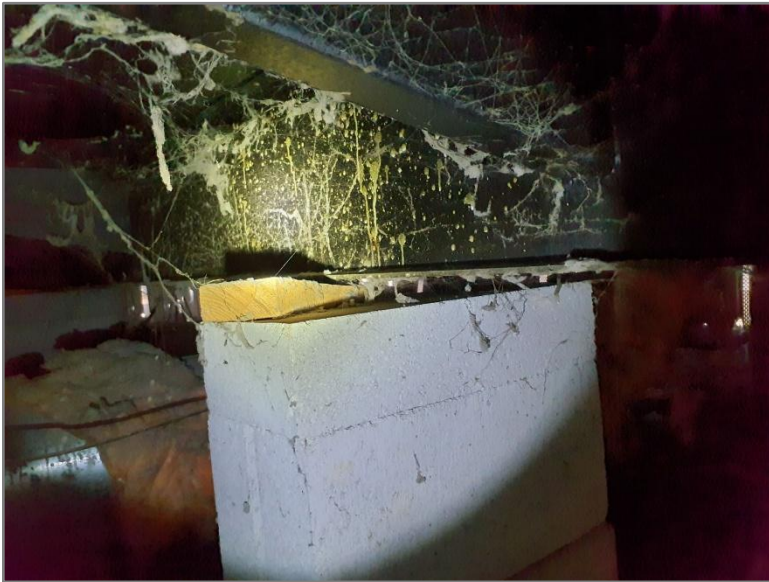
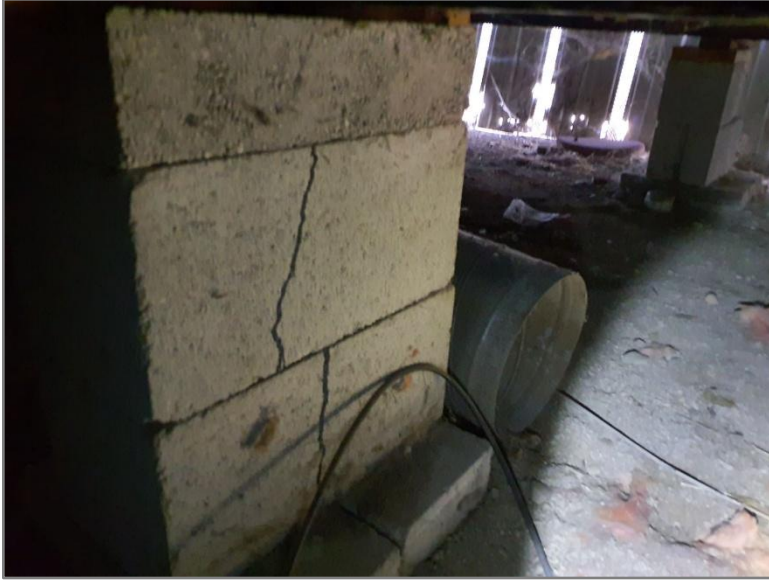
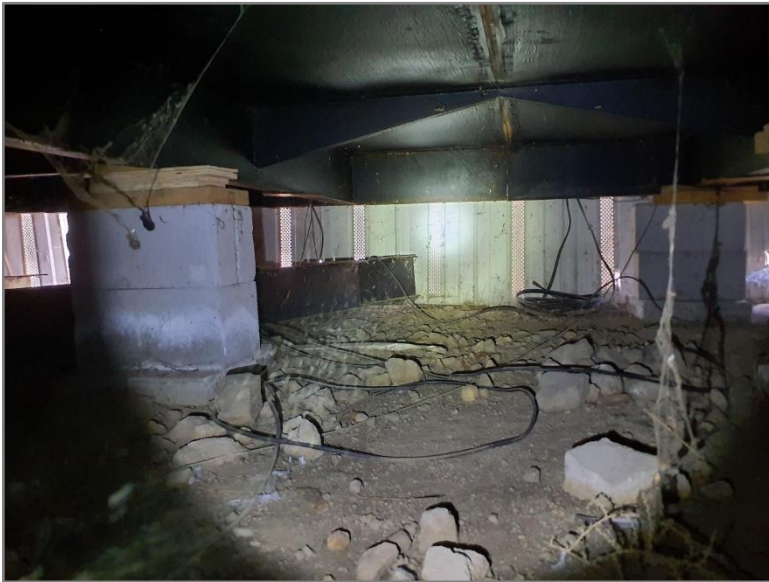
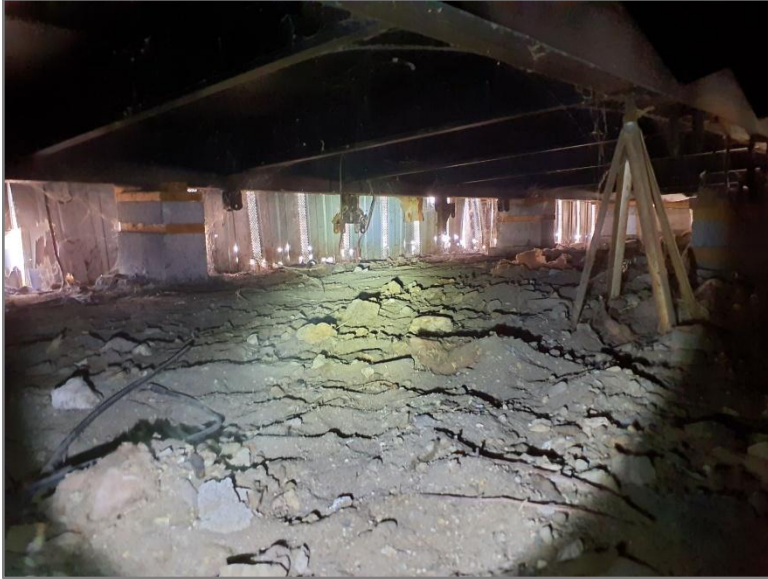
→ The foundation supports do not appear to be properly installed. There appears to be missing supports and some supports are spanned too far. Additionally cracked blocks were observed and supports that are not properly supporting the frame. Further evaluation and repairs are needed.

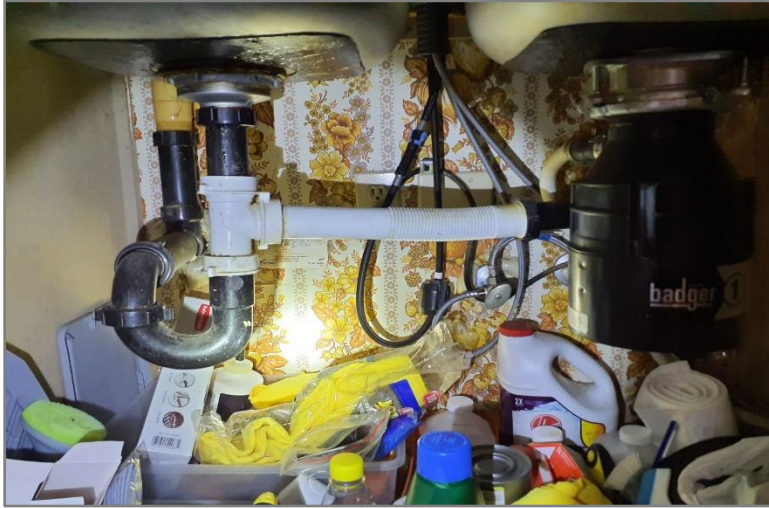
Plumbing-1

→ The kitchen sink drain from the disposal runs uphill. Recommend corrections.

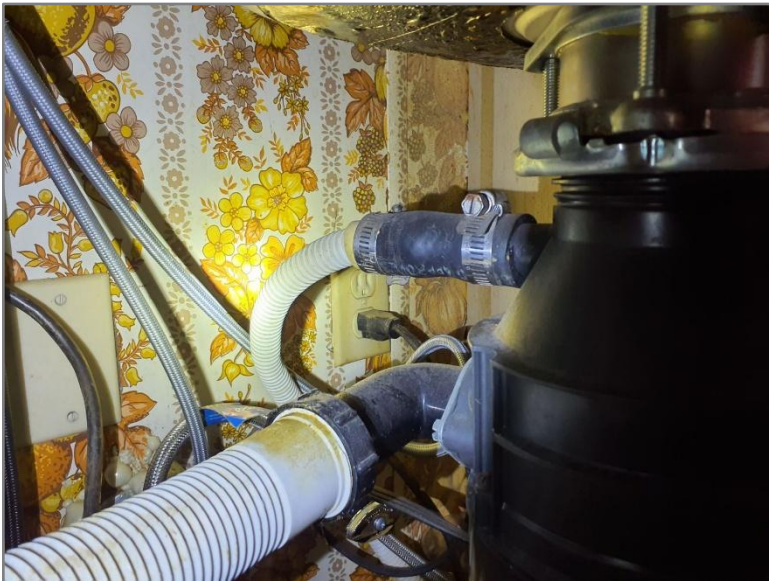
Plumbing-2

→ A high loop or air gap device is needed for the dishwasher drain.

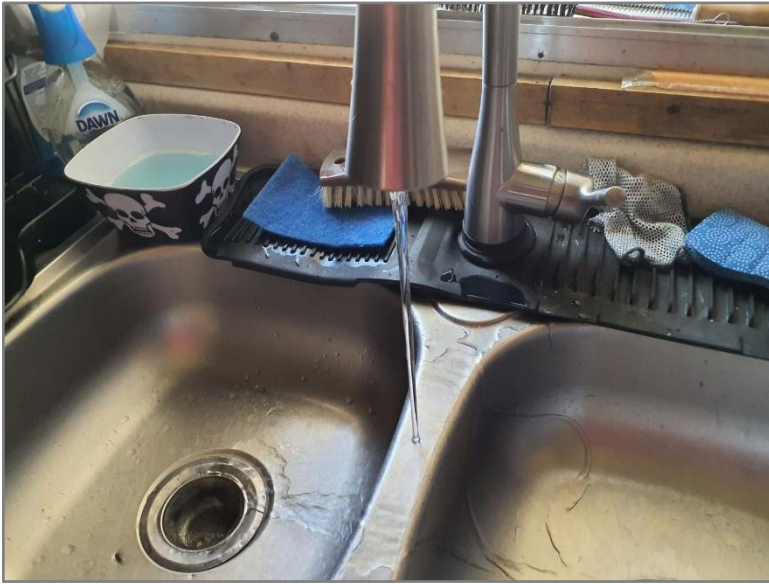
Plumbing-3

→ Low water pressure was noted at the kitchen sink faucet on the cold side. Recommend further evaluation.

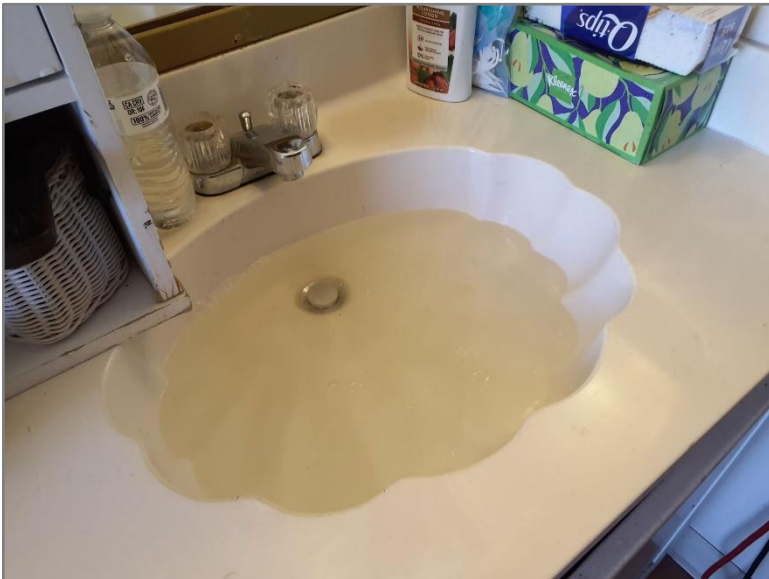
Plumbing-4

→ The right side master bathroom sink is slow to drain. Repairs are needed

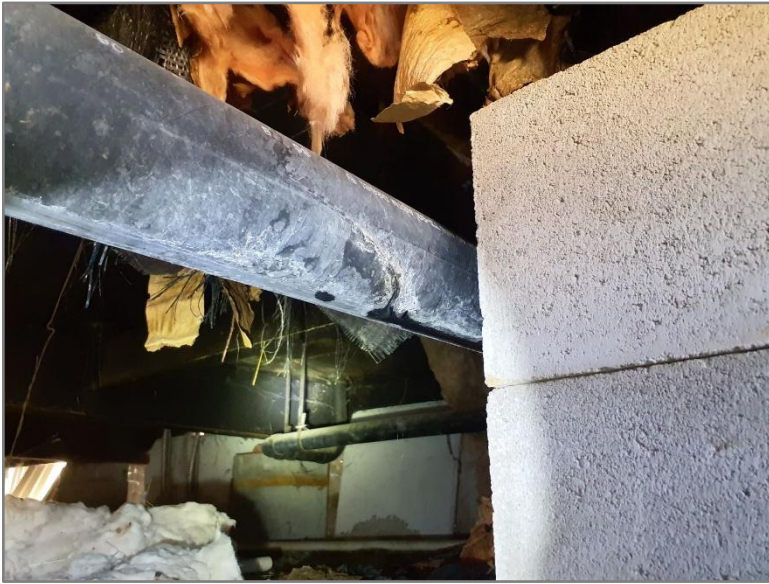
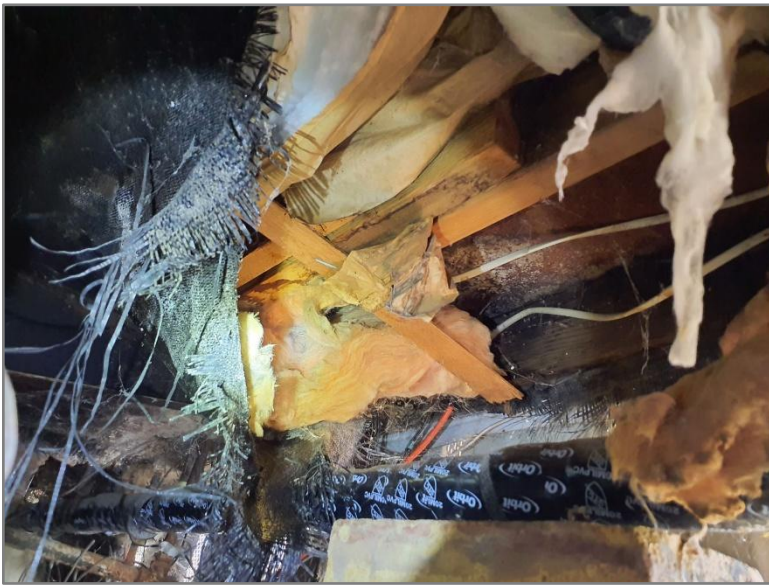
→ The sub floor below the master tub was currently wet and rotted out. Further evaluation and repairs are needed.

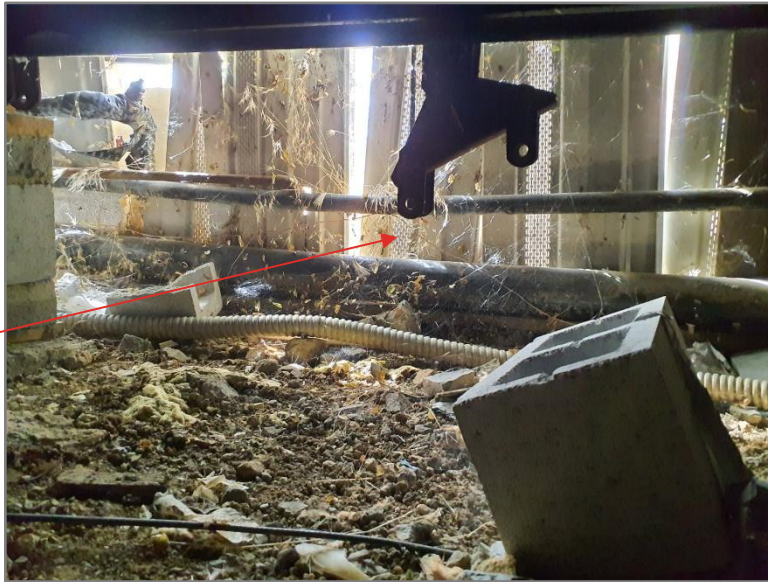
Plumbing-7

→ The kitchen sink drain is sagging in the crawl space. Recommend properly supporting drain line.

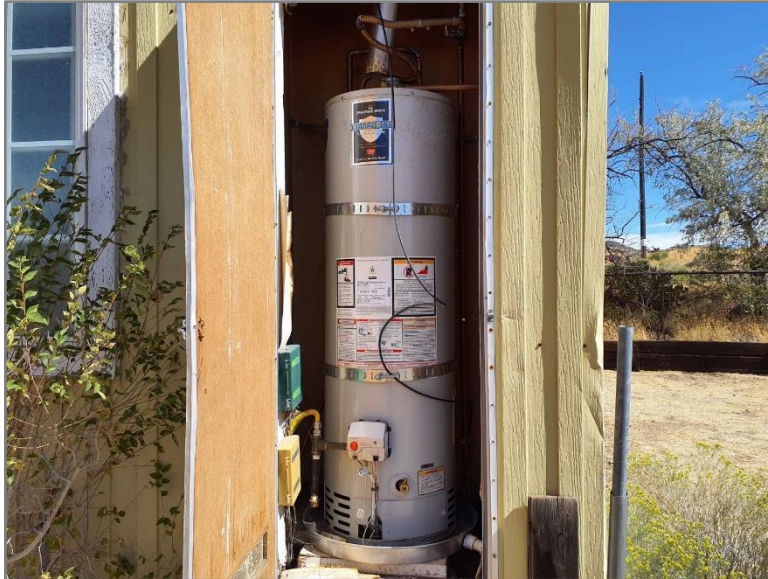
WaterHeater-1

→ The water heater is manufactured in 2018.

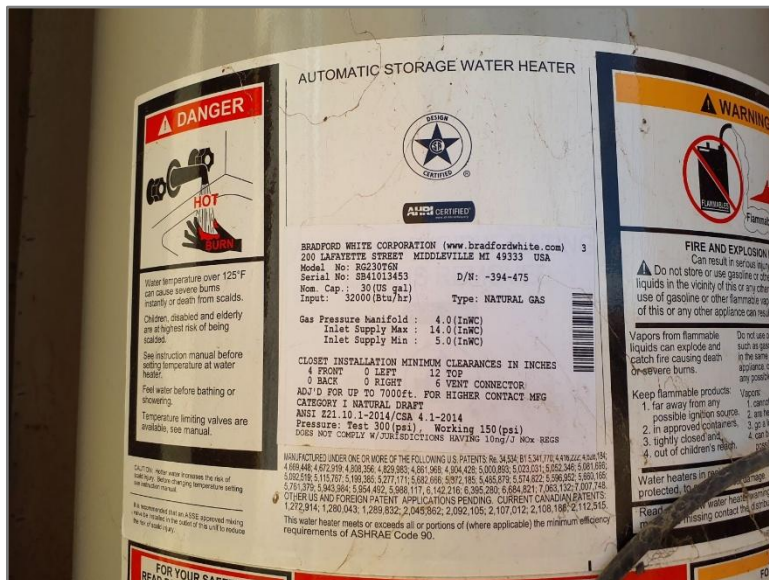
WaterHeater-2

→ The water heater is not approved for installation in a manufactured home and the flue pipe is disconnected. Recommend further evaluation and repairs or replacement by a licensed plumbing contractor.

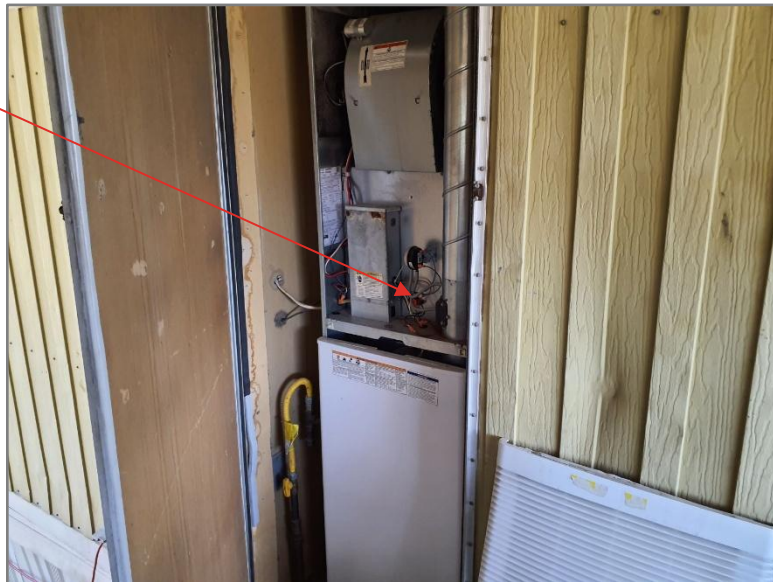
Heating-1

→ The furnace is manufactured by Coleman in 2015. The general life expectancy of a furnace is 20-25 years.

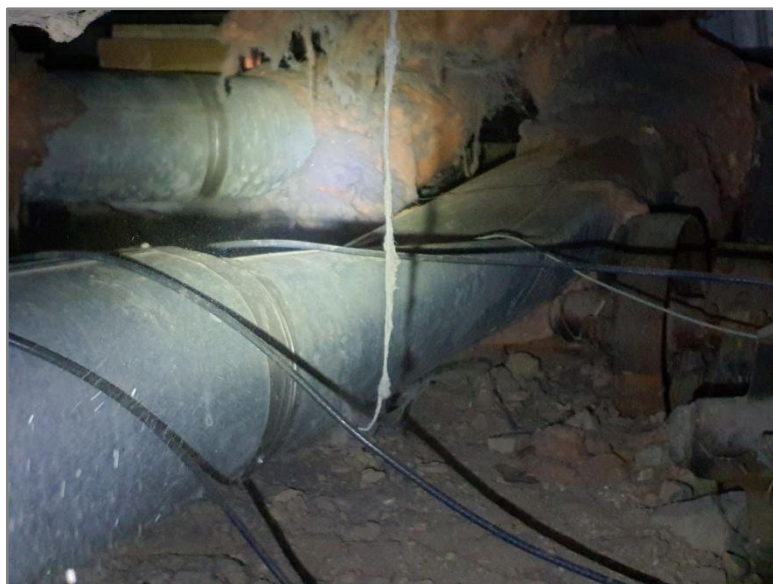
Heating-2

→ The ducting below the laundry room area is dented which will reduce air flow. Repairs are needed.

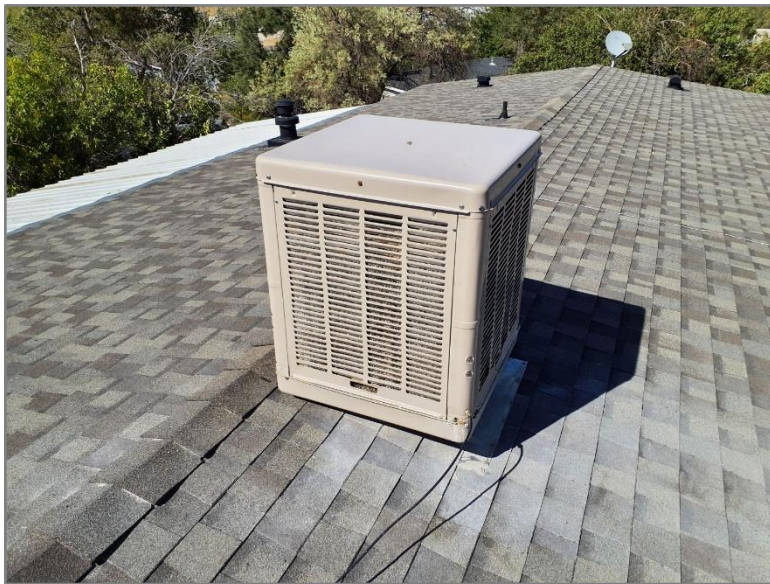
EvCooling-1

→ The evaporative cooler was operating at time of inspection.

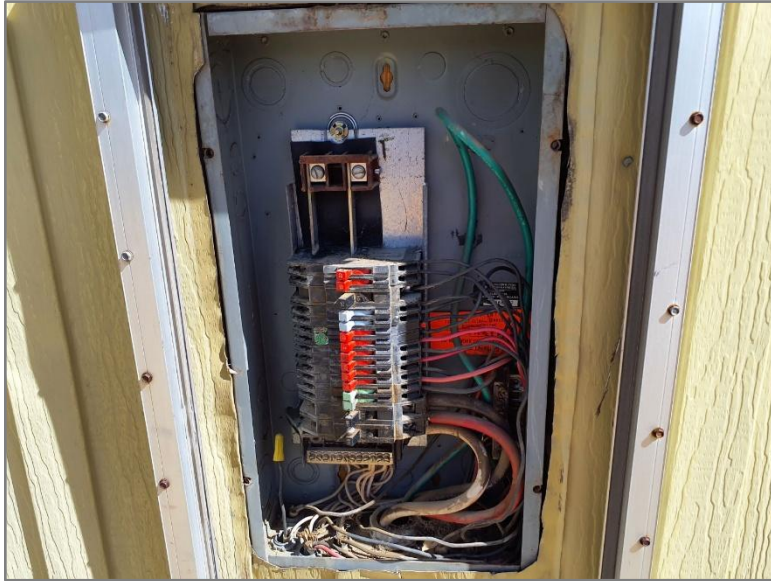
Electrical-1

→ The interior of the electrical panel is adequate and the breakers are labeled.

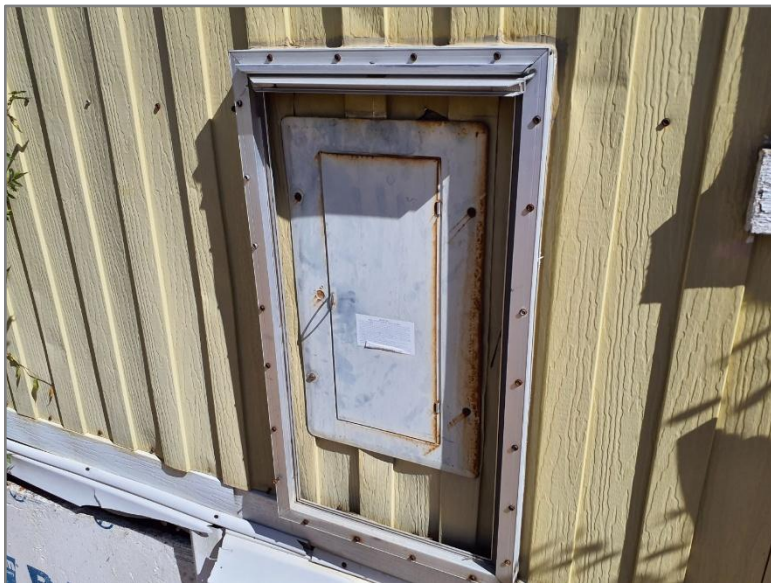
Electrical-2

→ The exterior panel door is missing over the electrical panel. The electrical panel is not rated for direct exterior exposure. Recommend corrections.

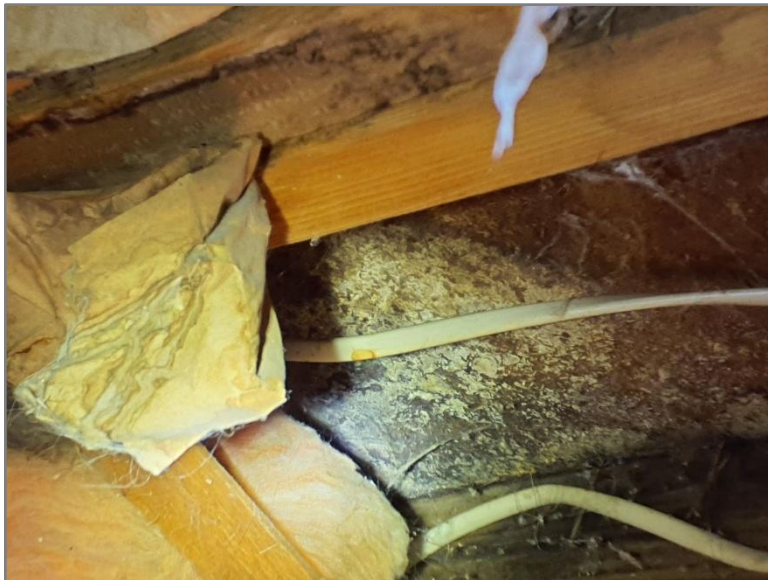
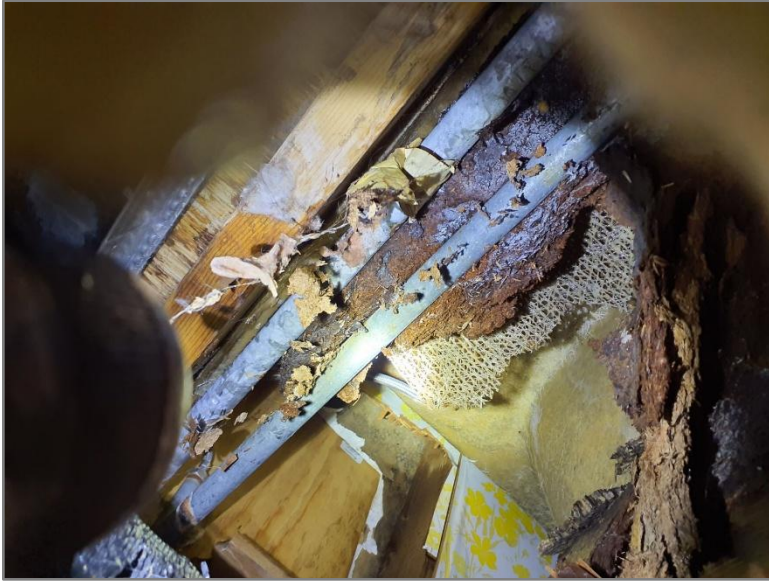
→ The subfloor below the master bathtub was wet and is completely rotted out. Further evaluation and repairs are needed.

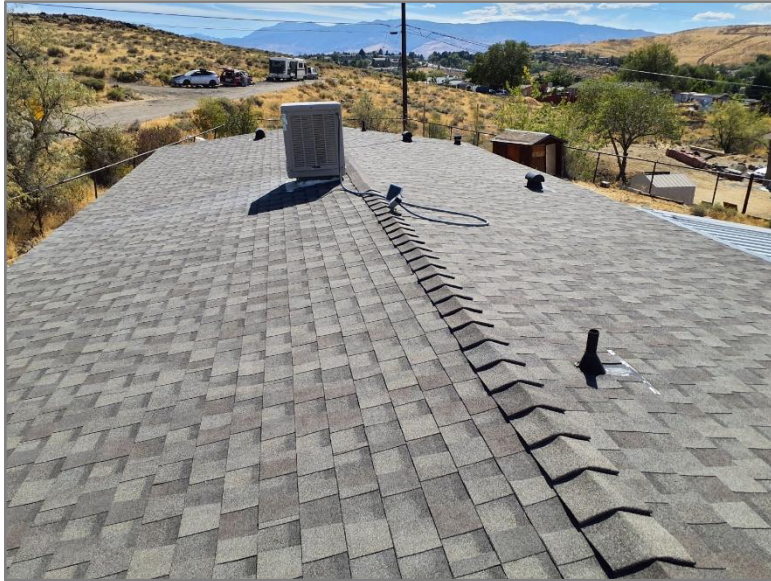
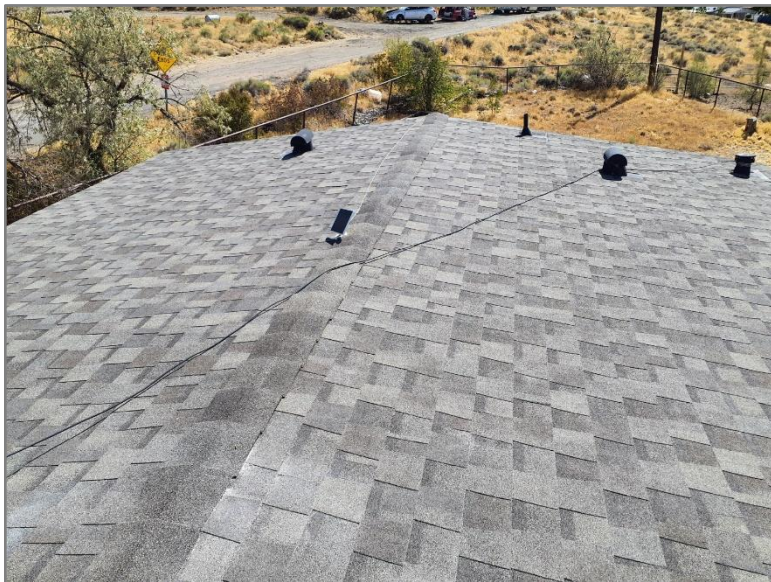
→ The roofing material is in good condition.

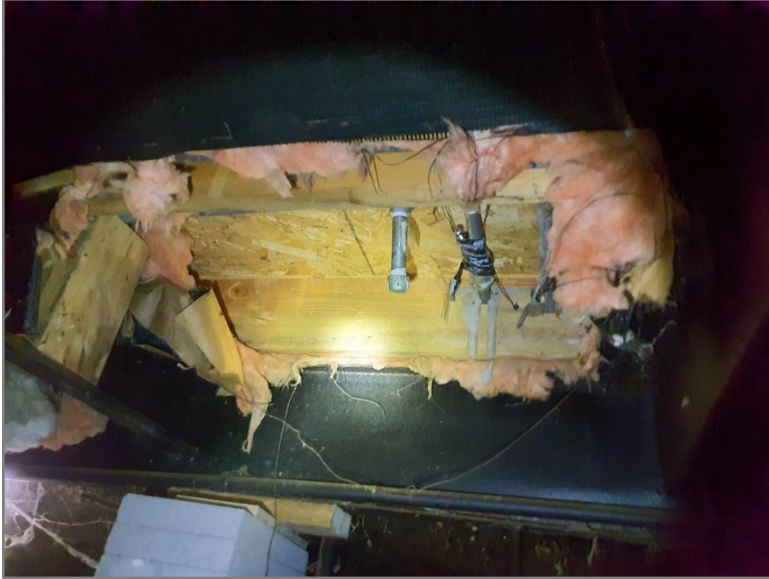
Insulation-1

→ Recommend replacing all of the floor insulation where the insulation has been removed or damaged.

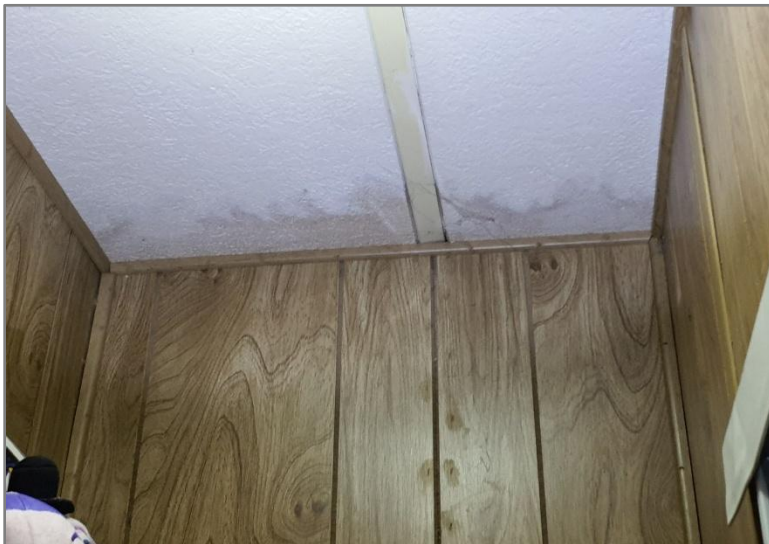
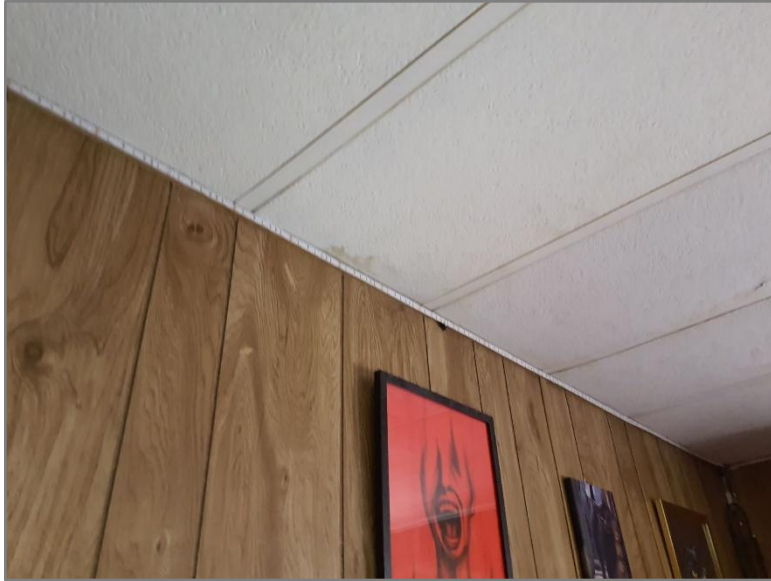
→ Moisture staining was observed in the ceiling of the northwest bedroom and closet.

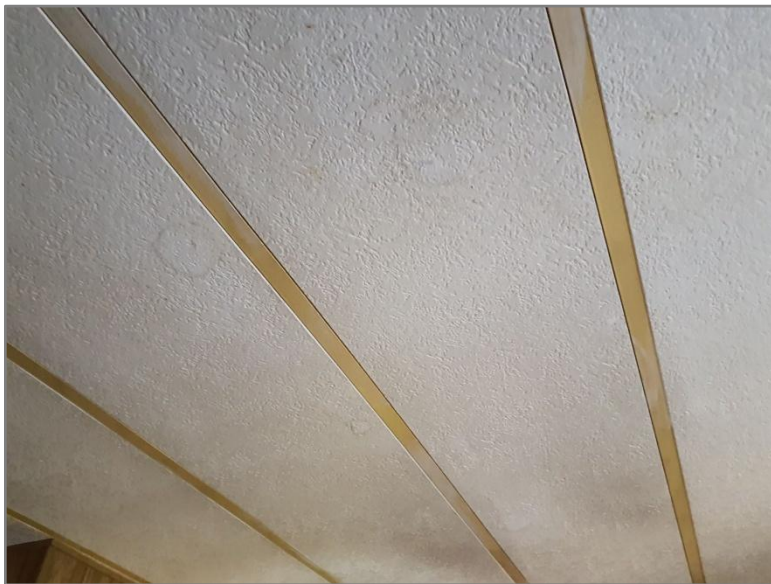
Interior-3

→ Moisture staining was observed in the northeast bedroom ceiling.

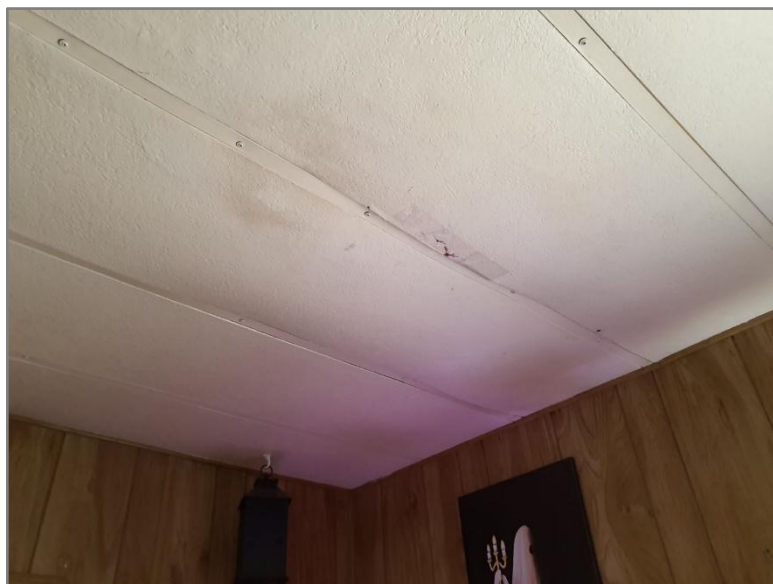
Interior-4

→ Moisture damage was observed in the ceiling in the family room.

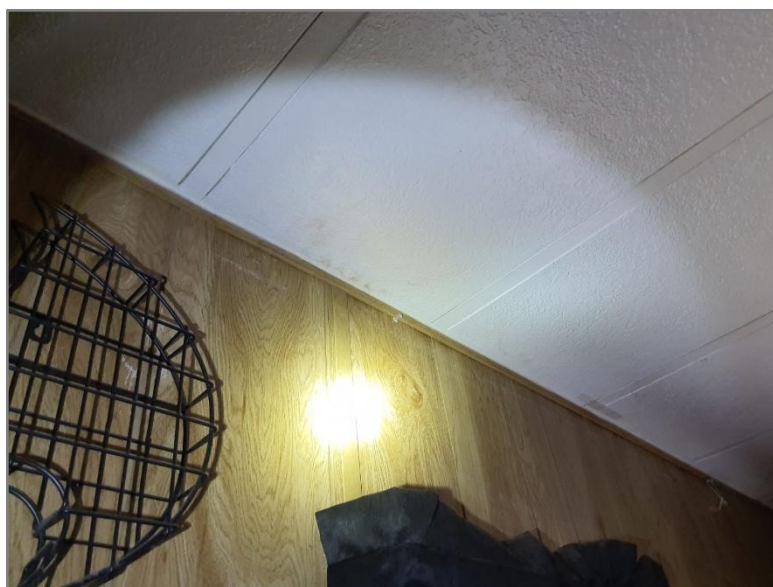
Interior-5

→ Moisture staining was observed in the dining room ceiling.

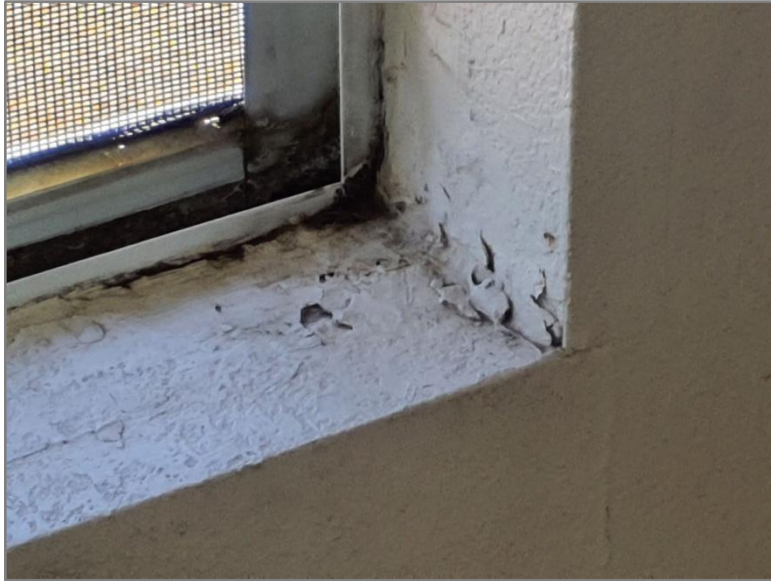
Interior-6

→ Moisture damage was observed at the master bathroom window opening.

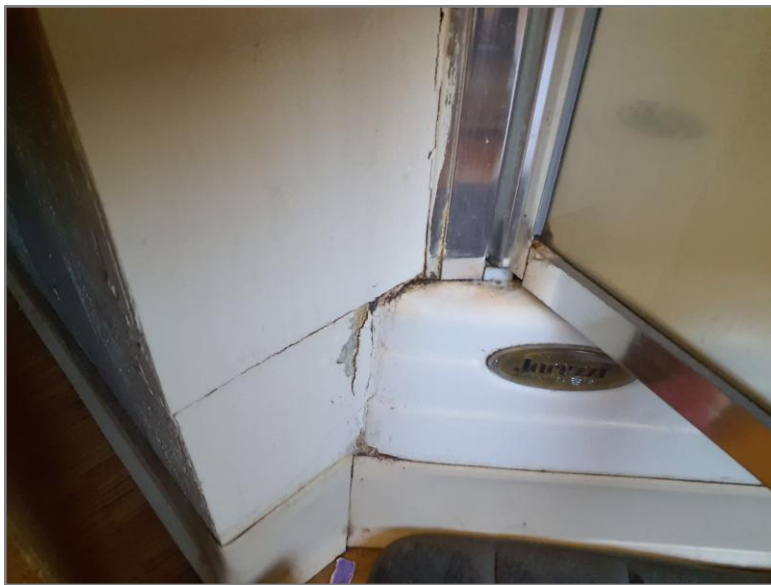
Interior-7

→ Moisture damage was observed outside of the master bathroom shower enclosure.

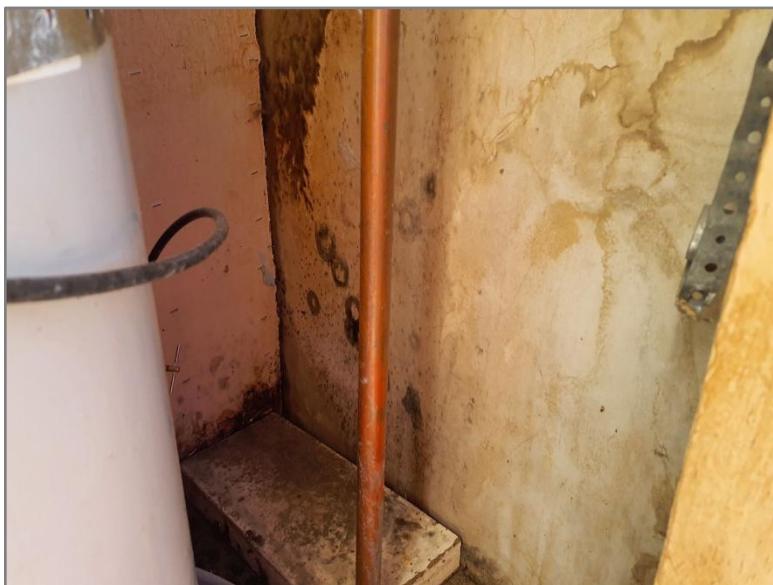
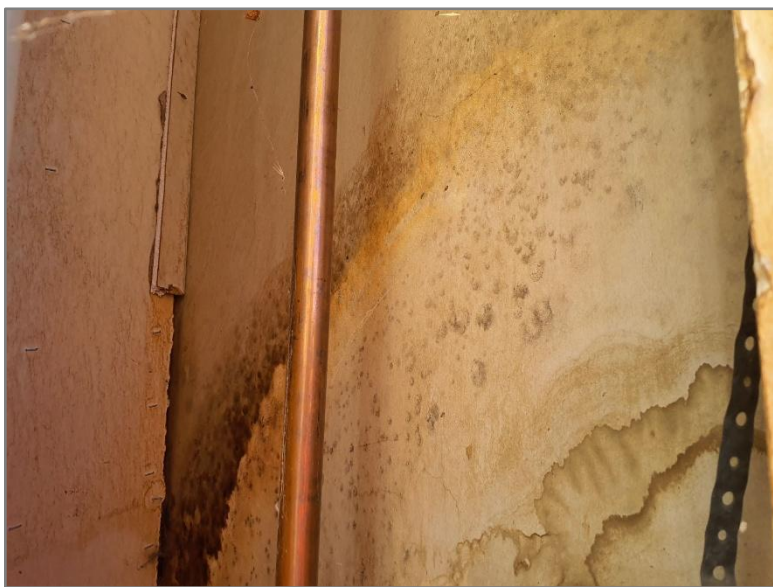
→ Moisture staining and growth were observed inside the water heater closet.  
Recommend repairs.

→ Moisture staining and growth were observed inside the water heater closet. Recommend repairs.

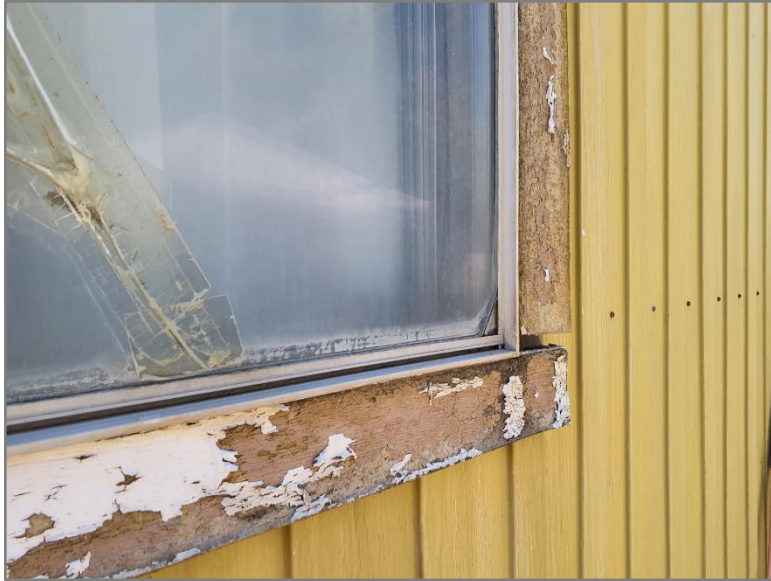
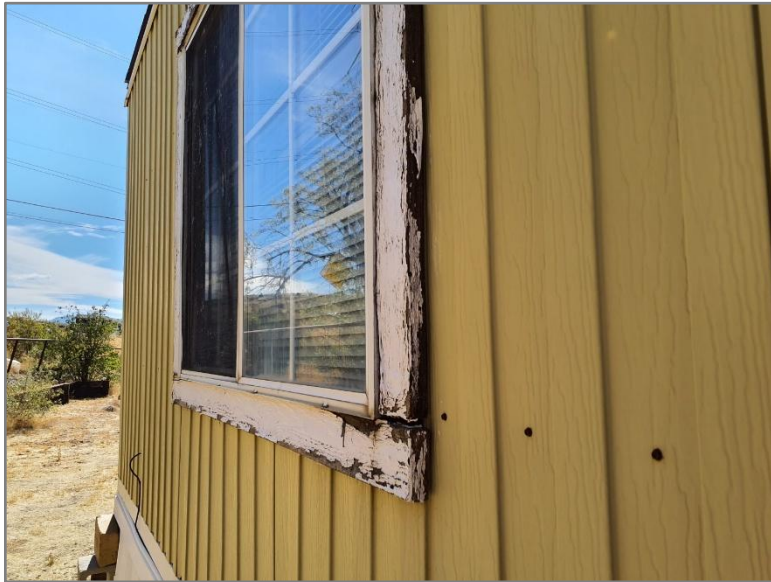
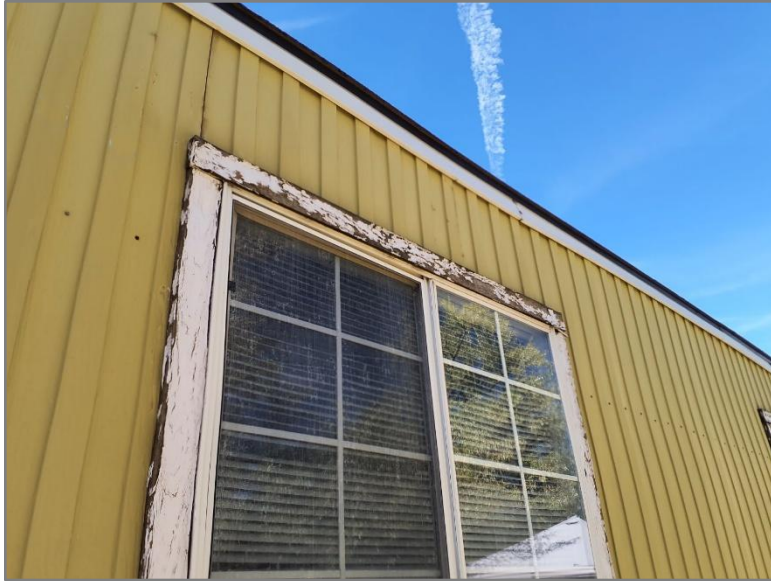
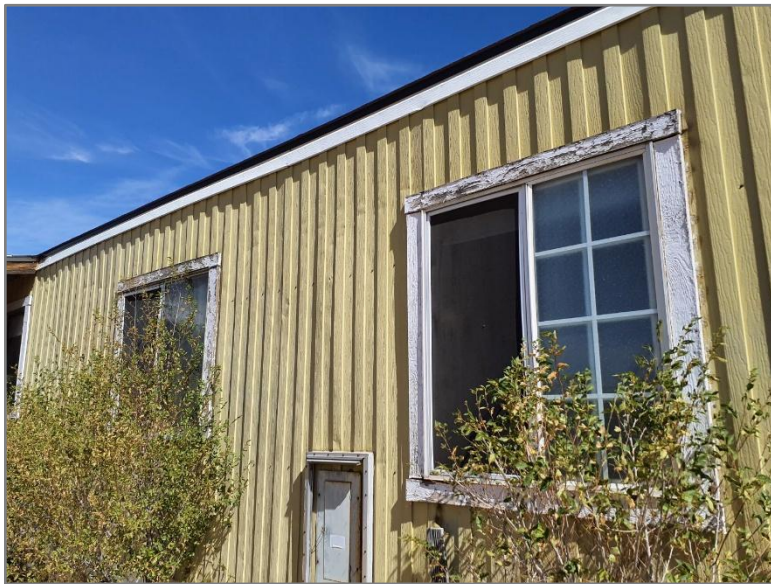
→ All of the window trim is deteriorated and in need of repairs, paint or replacement.

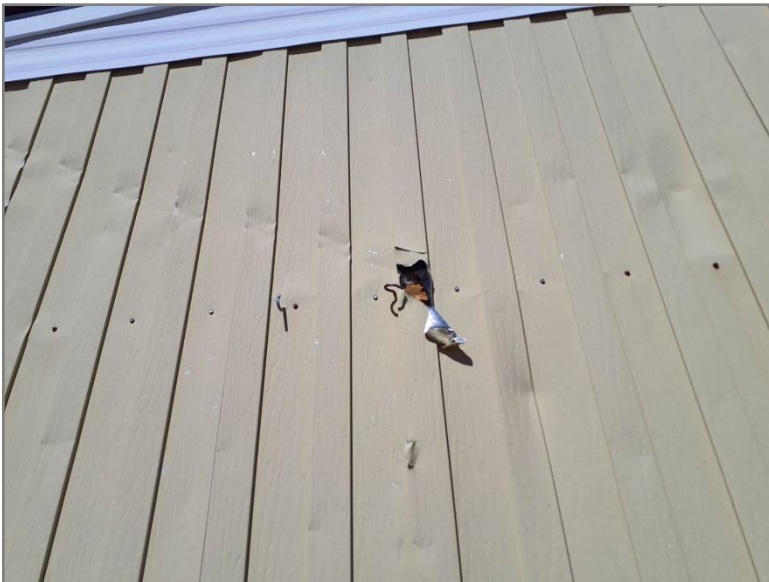
Exterior-6

→ The siding on the south side is damaged and the framing is exposed. Repairs are needed.
