### Supplemental Disclosure Regarding Prior Inspections

| Inspection Type (General, Roof, etc) | Name of Inspector or Inspection Co. | Date of Inspection |
|---|---|---|
| General | Marc Bebout Armstrong Inspection Services, Inc. | 09/09/2026 |

## INSPECTION REPORT

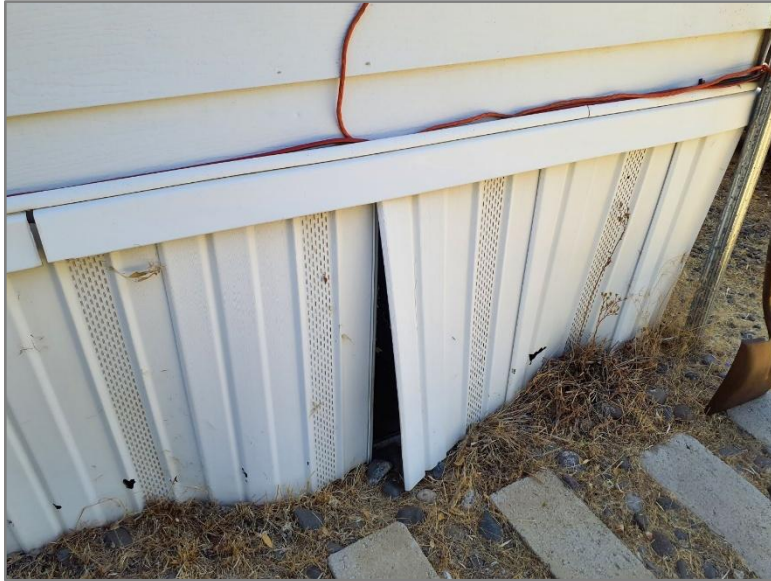
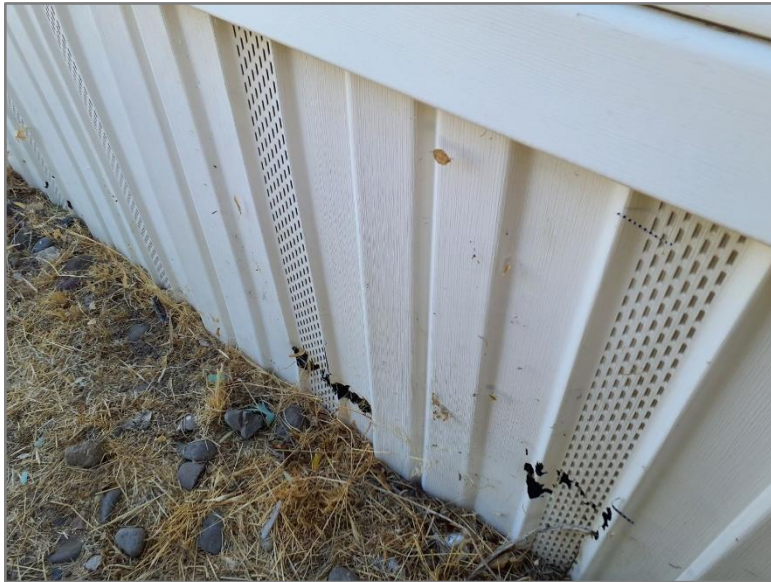
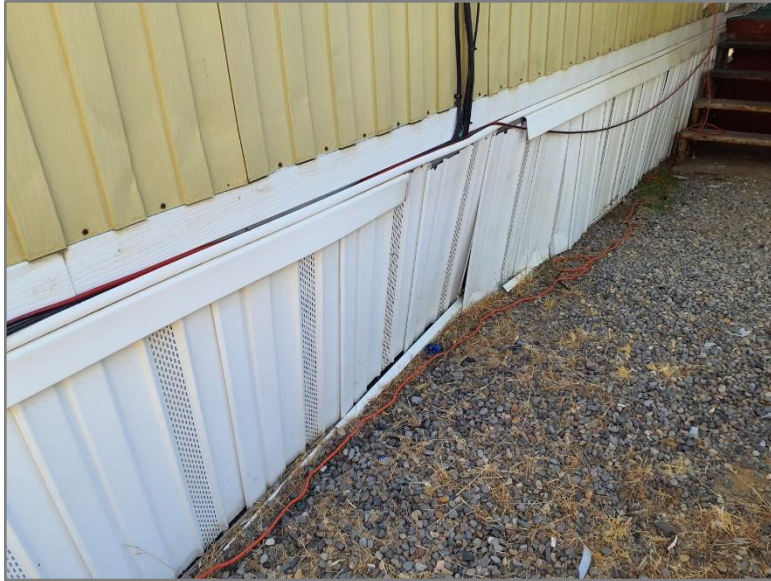
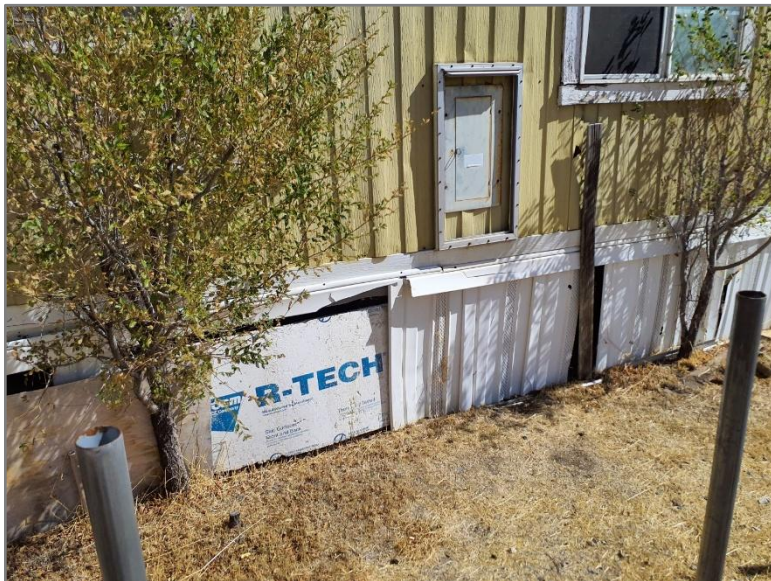
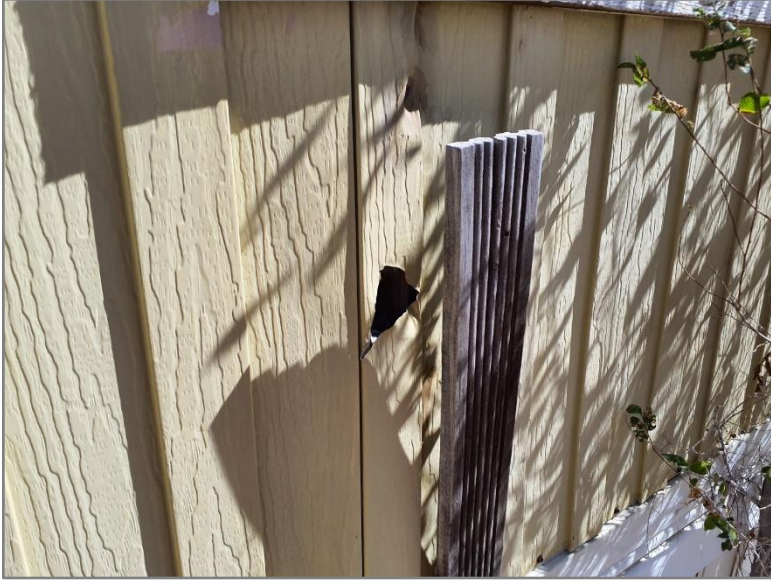
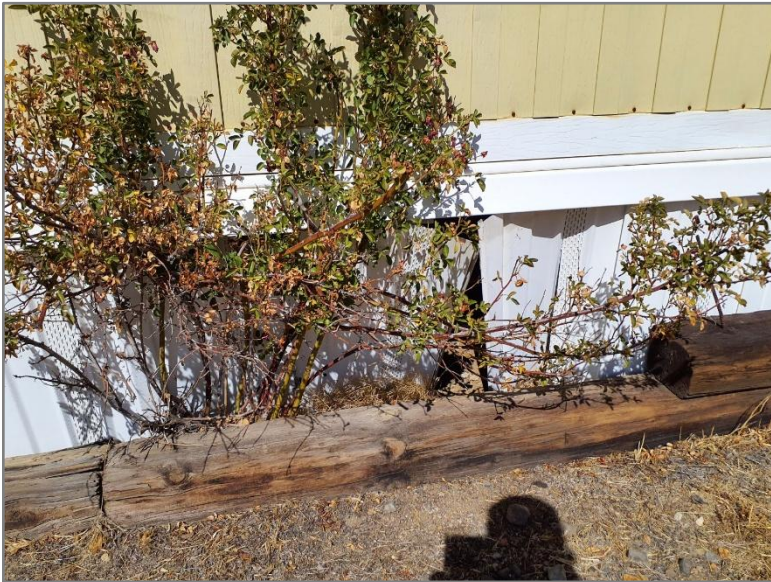
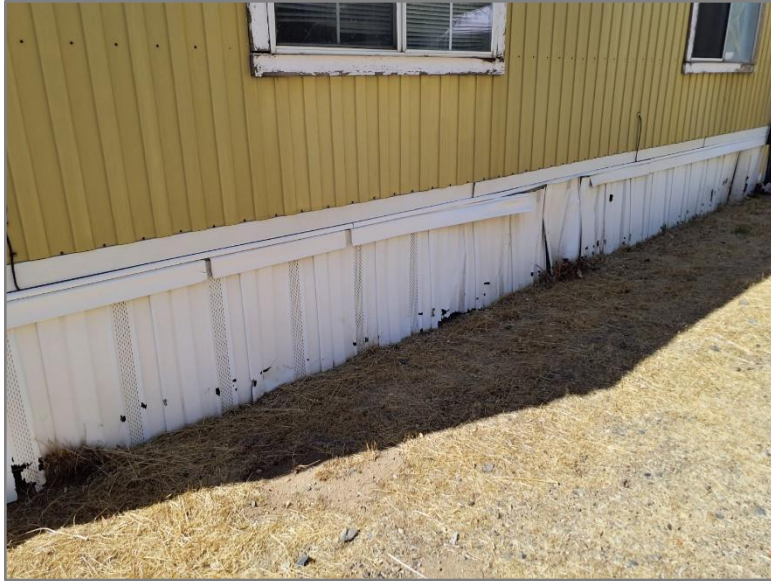
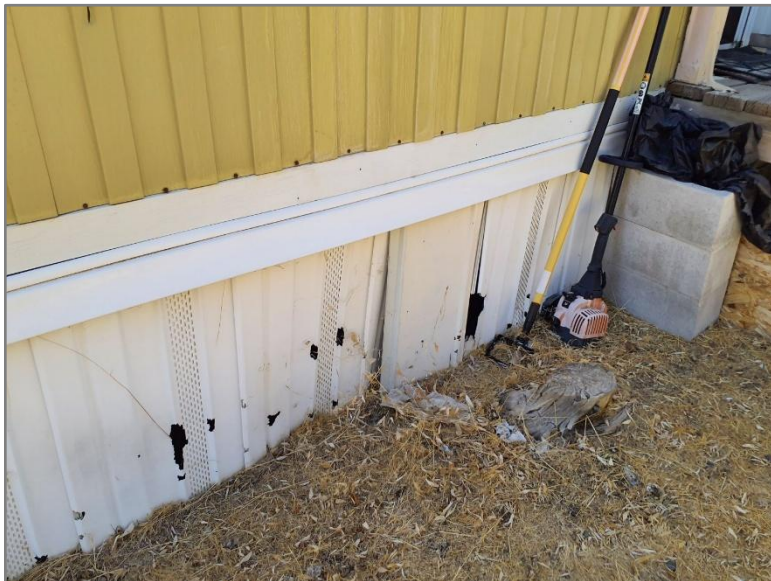
→ The exterior skirting is damaged and leaning. Repairs are needed.

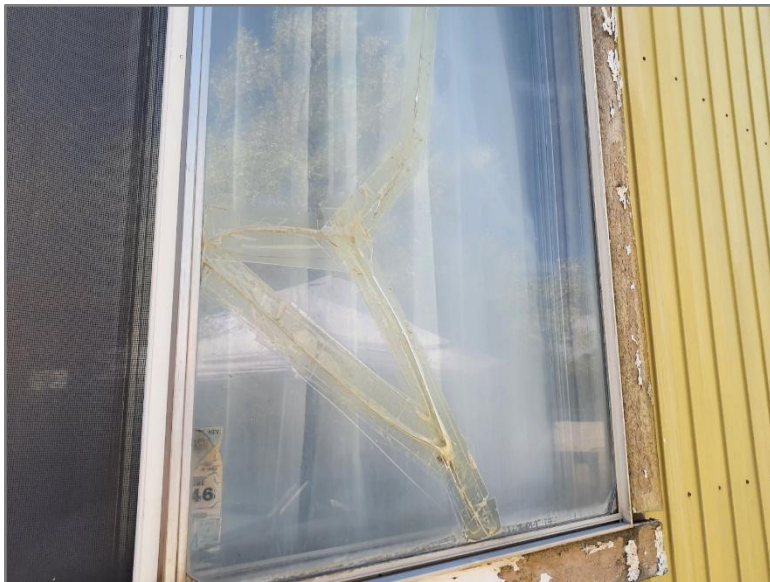
Windows-1

→ The family room window is cracked. Recommend replacement.

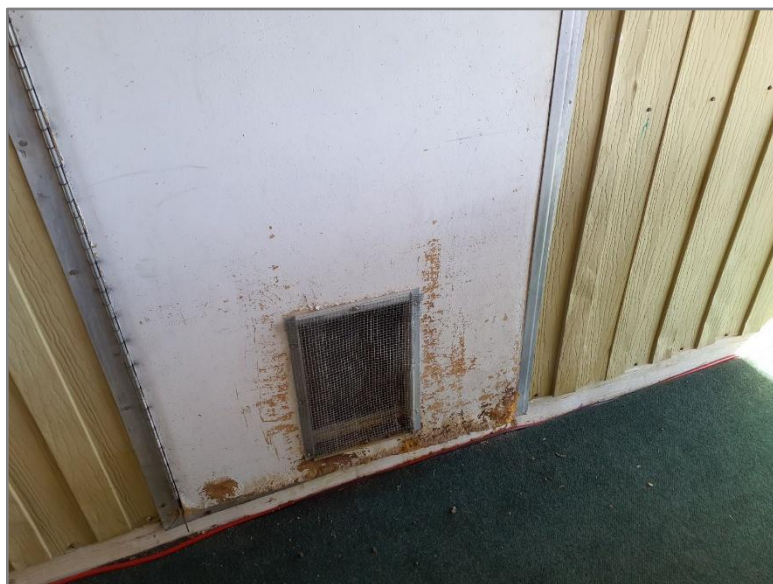
Doors-1

→ The back patio door is damaged and delaminating. Recommend replacement.

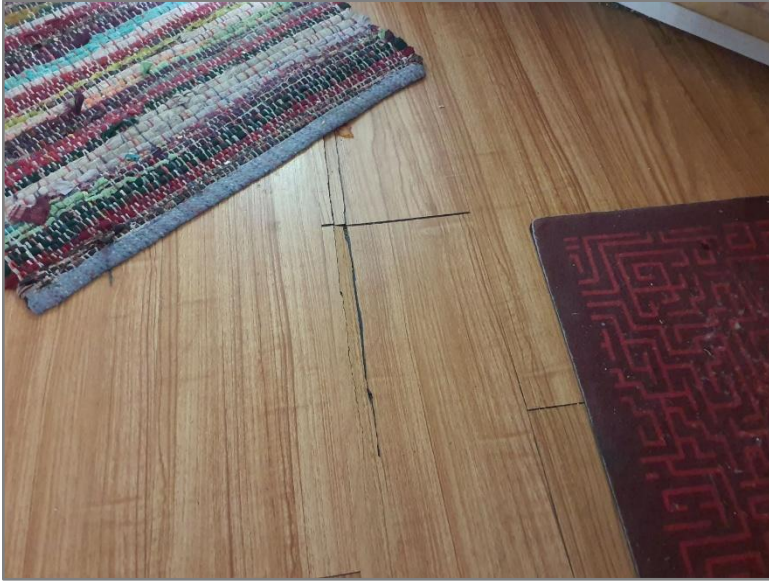
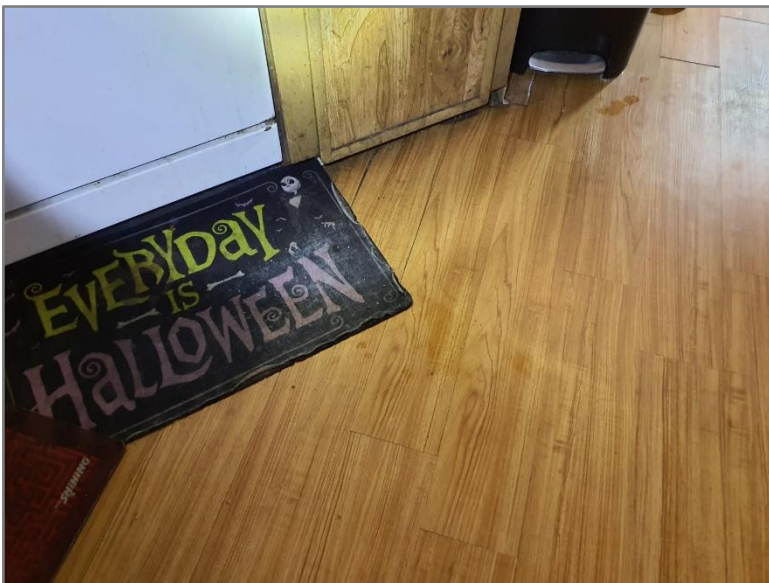
→ The kitchen floor is soft in front of the sink and dishwasher. Recommend removing flooring to evaluate the sub-floor and making necessary repairs.

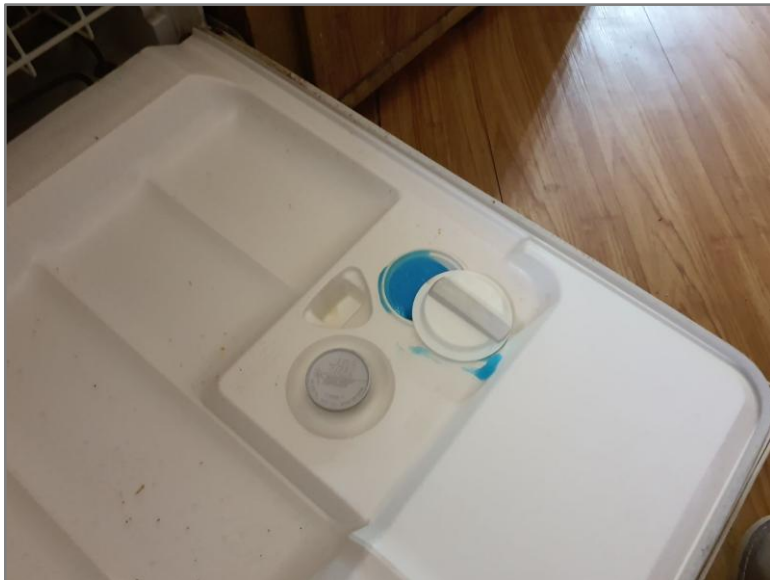
Appliance-1

→ The soap dispenser in the dishwasher does not latch.

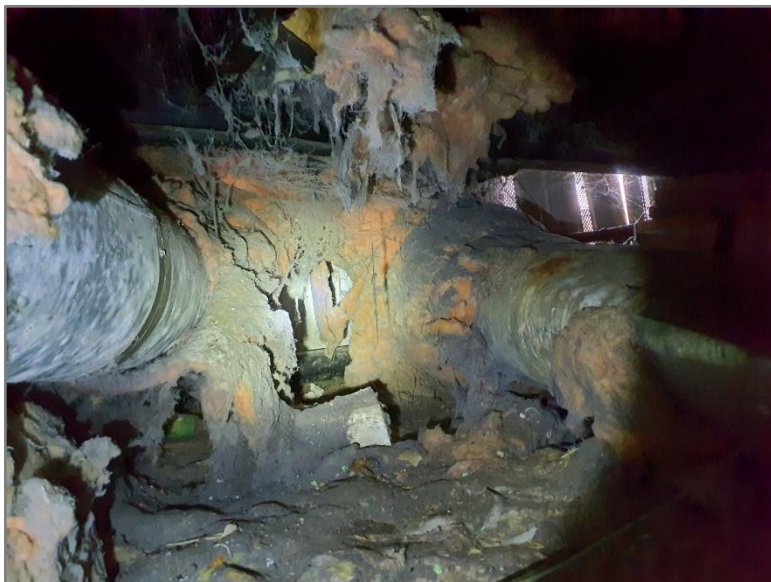
Appliance-2

→ The dryer vent is terminating into the crawl space. The dryer ducting should terminate to the exterior.

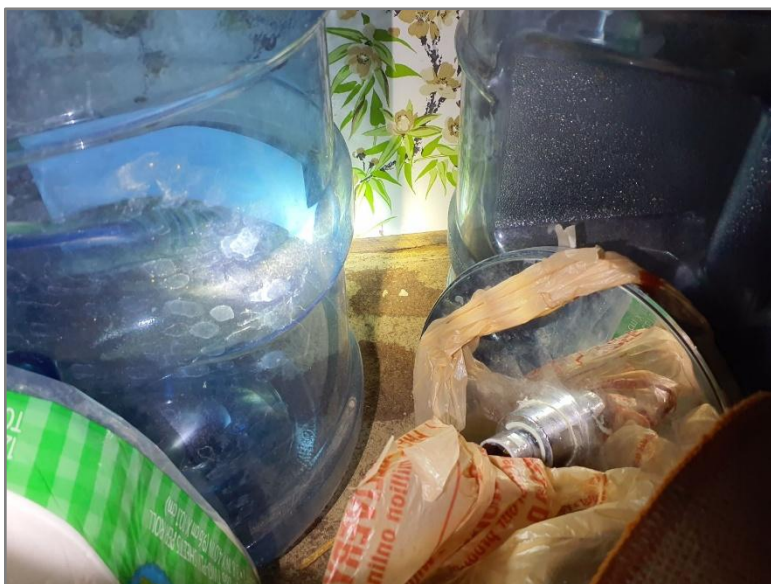
General-10

→ Moisture damage was observed inside the north bathroom sink vanity.

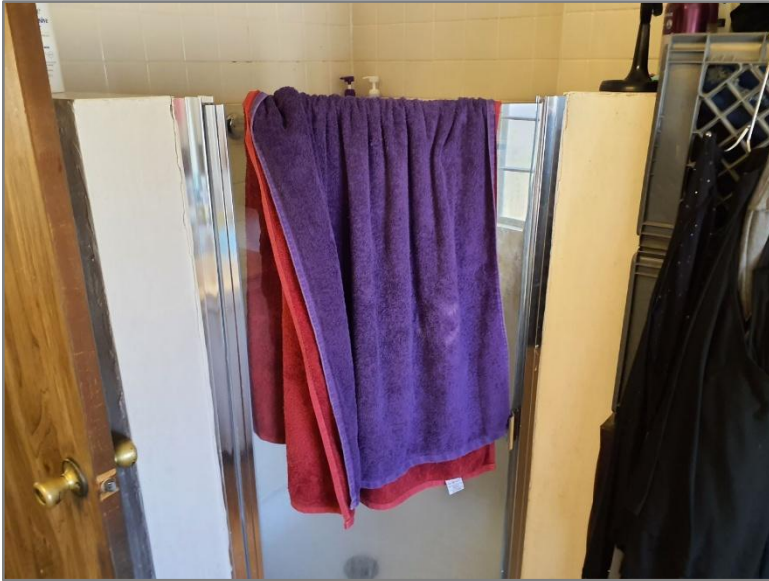
General-11

→ The rails on the master bathroom shower door are loose. Recommend repairs.

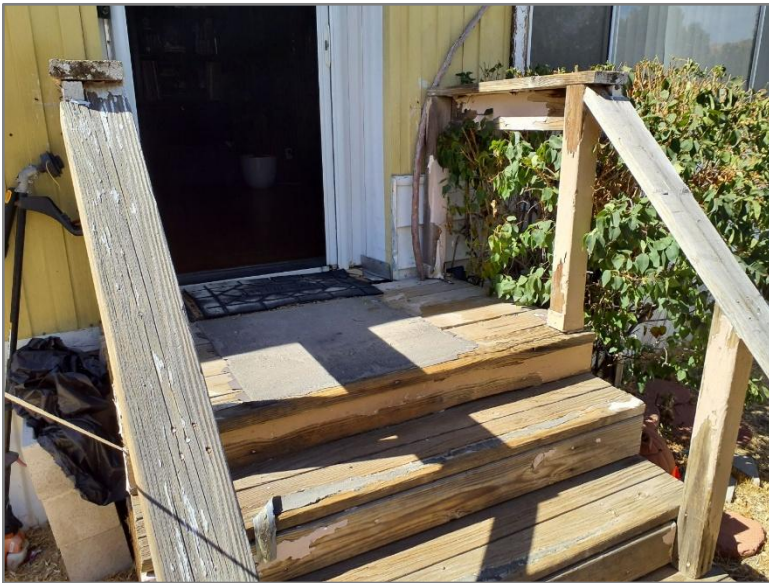
General-12

→ The railings at the front steps are loose and should have guardrails for safety.

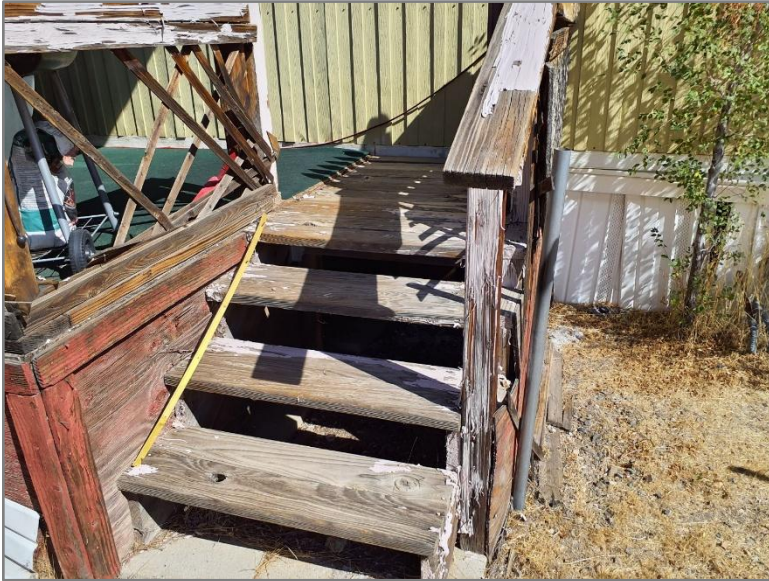
General-13

→ The rear deck is weathered and in need of repairs for safety.

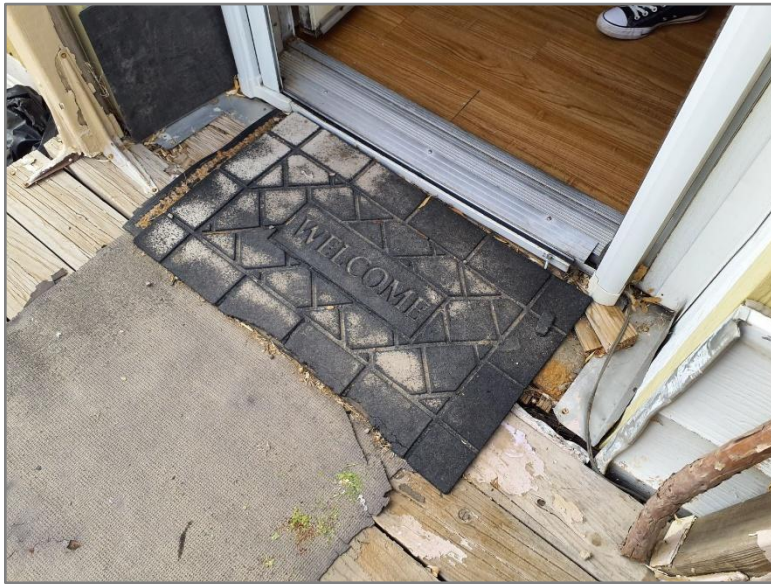
General-18

→ The front steps are rotted and should be replaced.
