## RESIDENTIAL PROPERTY INSPECTION

4732 Lango Dr  
Carson City, NV 89706

09/16/2026

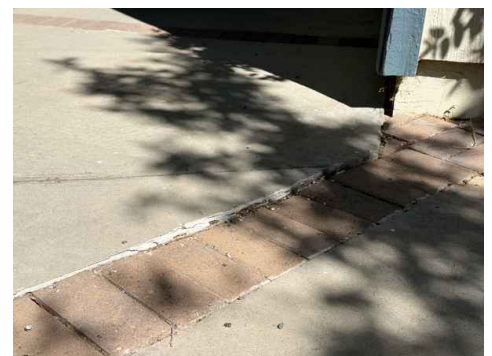
**3.2.1 Driveway and Walkway Condition****TRIP HAZARD(S) PRESENT**

**SFTY** - Cracking, heaving, settlement, movement, deterioration, and/or other defects resulting in trip hazards were present on the referenced surface(s). Repairs are recommended to be conducted to these area(s) as needed for safety by a qualified contractor.

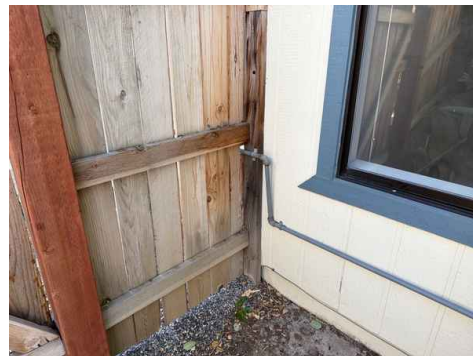
## 3.16.1 Fence

**FENCE POST EARTH TO WOOD**

A fence post attached to the structure was in contact with the soil, which can lead to insect infestation. Recommend either trimming the bottom of the post, leaving a 3" gap, or inserting metal flashing between the post and the siding.

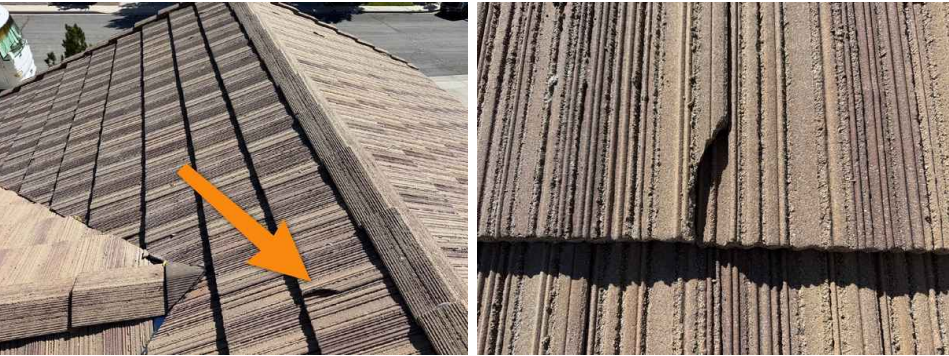
CORNER BREAKS

One or more of the roof tiles had broken corners which appear to be broken beyond the headlap of the below tile (typically ~3"), but they did not expose the underlayment. Minor breaks confined to the lower cover-lock area are common and may not significantly affect water shedding; however, these breaks extended farther upslope, reducing the overlapping tile protection. These known faults should be repaired by a licensed roofing contractor and, at that time, that the roof cover be evaluated for any additional needed repairs.

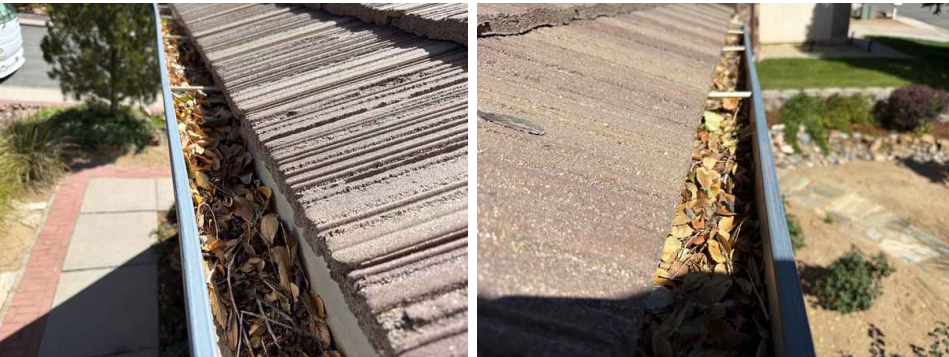
4.9.1 Gutters/Downspouts

GUTTER(S) - HEAVY LEAVES/DEBRIS

A heavy amount of leaves and organic debris was present in the gutters. This can create blockages in the downspouts, allowing water to overflow the gutters. I recommend for a qualified person to clean the gutters as soon as possible.

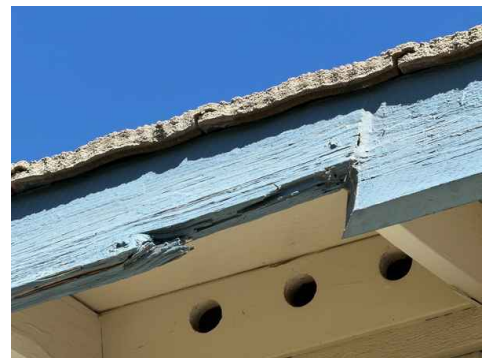
### FASCIA WRAP - DAMAGED

SOUTH

Damaged fascia was present, which is primarily cosmetic, but may present difficulty in installation of gutters. Repairs are recommended, by a qualified person.

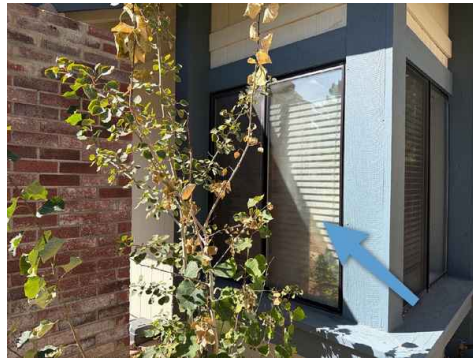
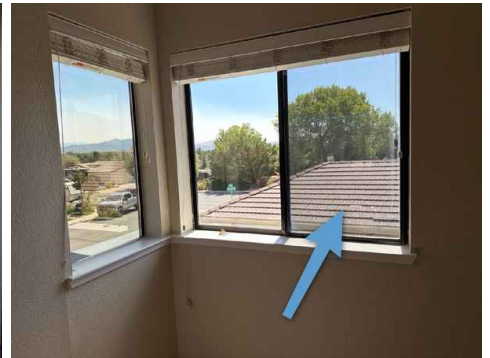
## 5.13.1 Windows

**GLASS - DUAL PANE SEAL FAILURE**

NORTHEAST BEDROOM FRONT, SOUTHEAST BEDROOM RIGHT SIDE

Seal failure was observed or suspected at referenced window(s), typically indicated by condensation or dust between panes, rainbow or shine, or visible separation of the glazing seal. This allows moisture infiltration between the glass layers, reducing insulation effectiveness and potentially leading to interior fogging or water damage over time. As identification of these seal failures is often difficult and inspections are limited to a representative number of accessible windows, additional faulty windows may exist. A window repair or replacement contractor should evaluate all windows in the structure to identify all faults and recommend repair or replacement options.

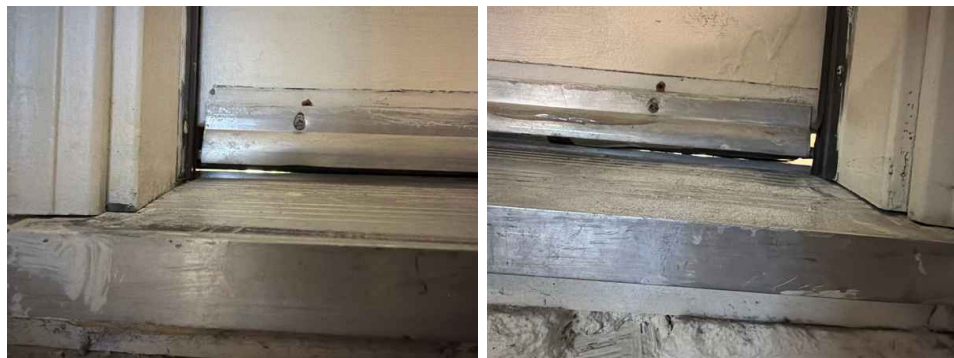
At the door from the garage into the house, there was a gap underneath the door, at the threshold, that could allow carbon monoxide and fumes to enter the living space. Recommend repair by a licensed contractor.

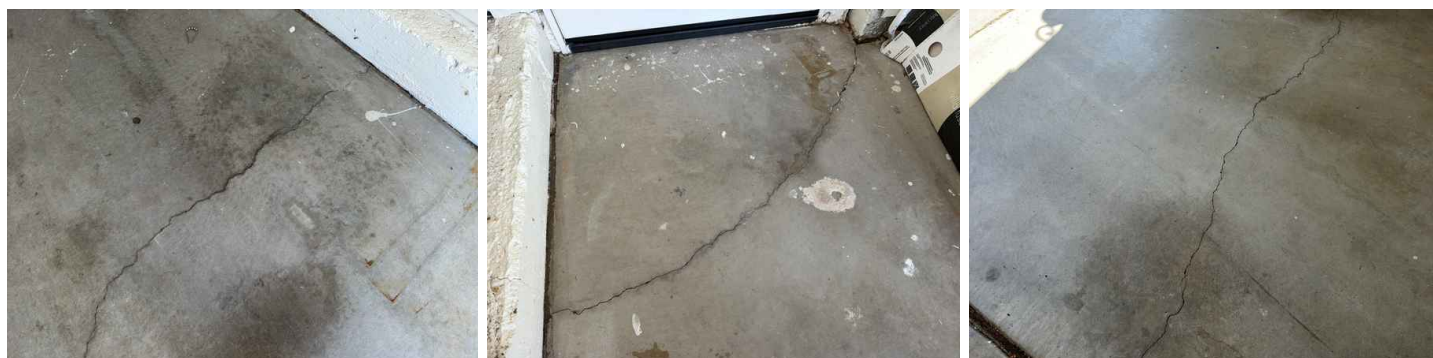
## 6.5.1 Garage Slab

**SLAB - MINOR CRACKS**

The garage slab has several cracks that do not appear to be a safety or structural concern. You may want to have a further evaluation for needed repairs by a licensed contractor.

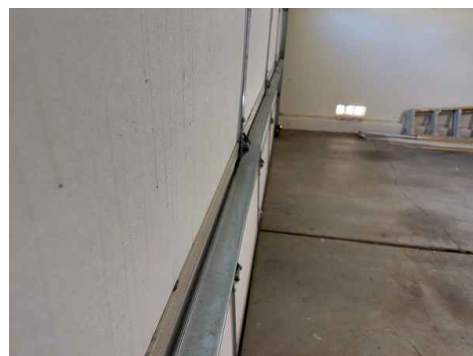
## 6.6.1 Garage Doors

**PANELS - DAMAGE (MINOR)**

Light damage was present to the garage door panel(s), which appears to be the result of pressure against the door from inside, but this damage did not appear to affect the functionality of the door at the time of inspection. If desired, repairs are recommended to be performed, by a garage door contractor.

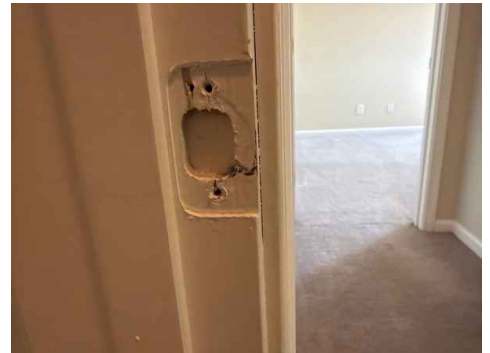
## LINEN CLOSET

A strike plate was missing for the referenced interior door(s). Strike plates act as a receiver for the handle's latch, allowing the door to latch smoothly and securely. Repairs to install a proper strike plate at any areas in need is recommended to be performed by a qualified professional.

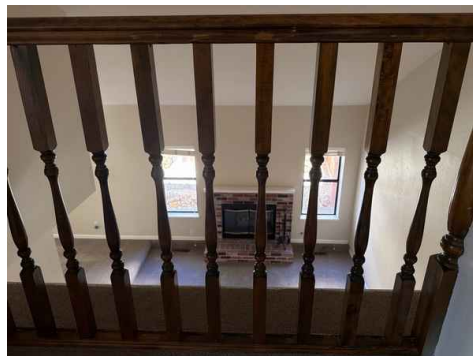
**SFTY** - There was spacing on the guard at the top of the stairs that was greater than 4 inches. Current safety standards require that guards be designed to not allow the passage of a 4-inch sphere through them. Safety upgrades are recommended to be conducted here by a qualified person.

## RAILING

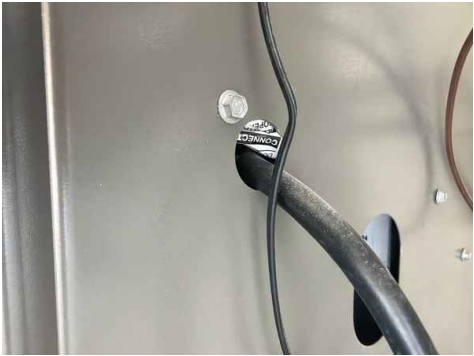
**NO CHAFE/STRAIN RELIEF**

At the furnace cabinet, the control wiring and/or power wiring passes through with no chafe protection, which may result in damage. Recommend a proper grommet be installed.

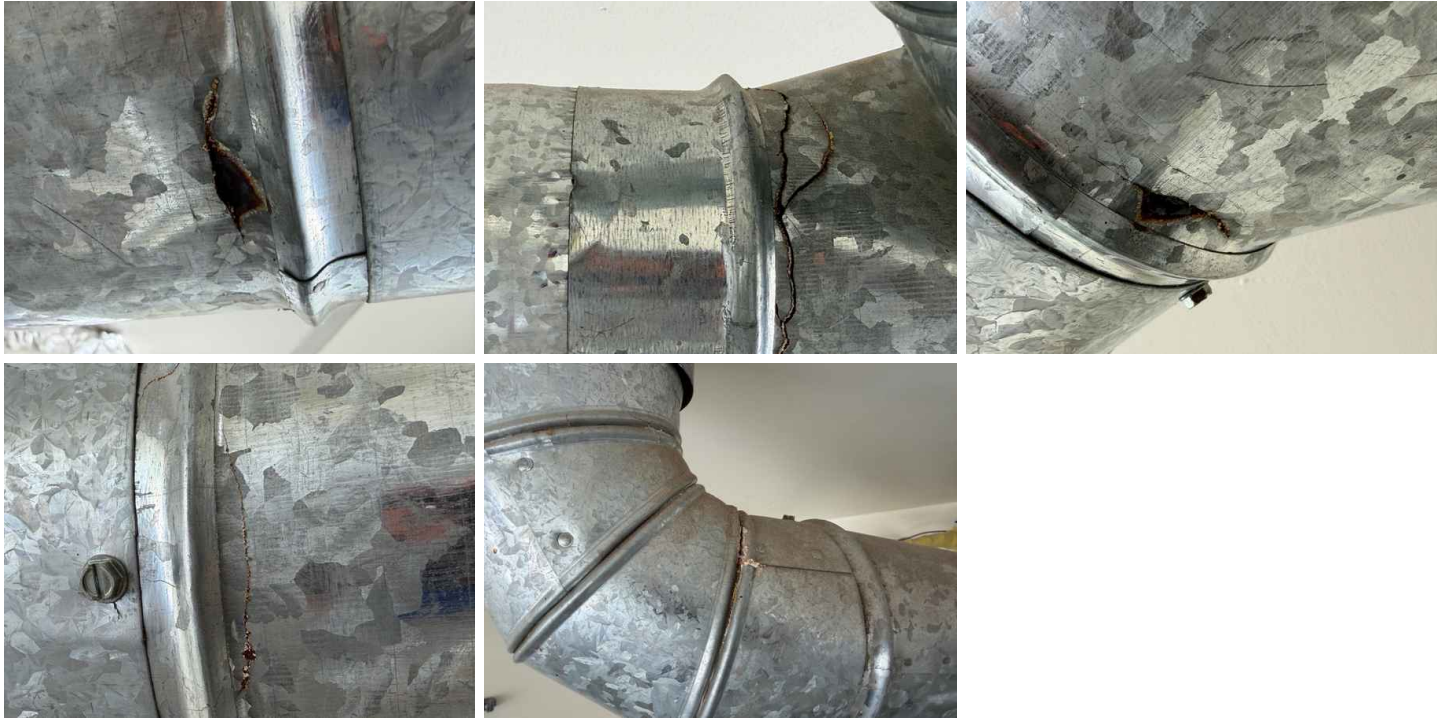
## 14.6.1 Exhaust Gas Venting

**FLUE - RUSTED/CRACKED**

The furnace flue was rusted with openings and cracks and should be serviced by a licensed HVAC contractor.

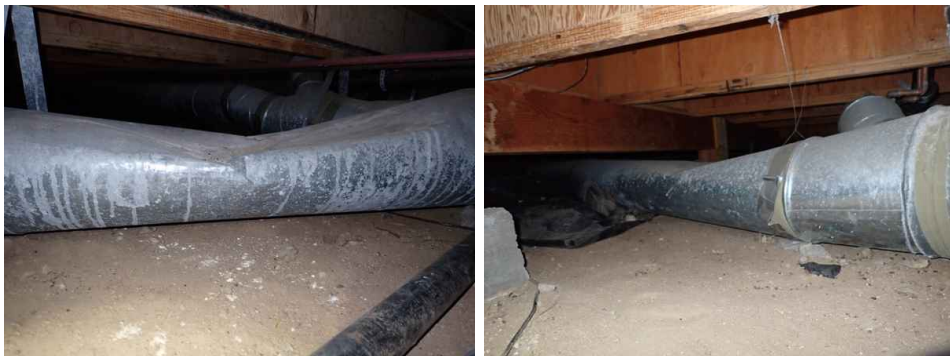
## 14.14.1 Visible Ductwork

**DUCTWORK - KINKED OR DENTED**

Duct(s) were present that were kinked and/of compressed. This can affect air delivery to the affected air supply registers. Repairs made to the ductwork is recommended to be performed by an HVAC contractor. Due to the ducting greatly restricting the movement throughout the crawl space, consider replacement of at least some ducts with flexible ducting, which can be moved and more easily maneuvered around.

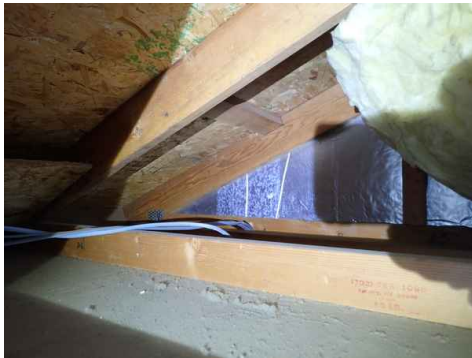
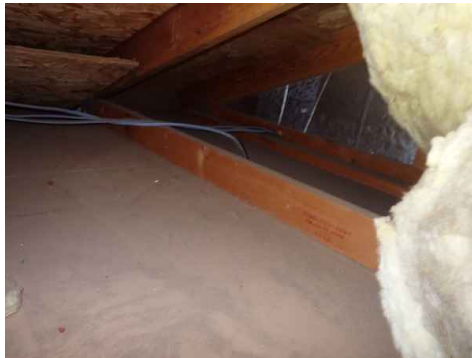
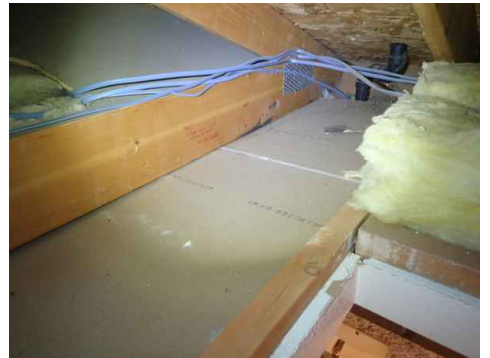
There were areas of disturbed insulation present in the attic which has resulted in less than the recommended depth being present. This affects energy efficiency. The installation of additional insulation or leveling out the current insulation is recommended to be performed by a qualified person.

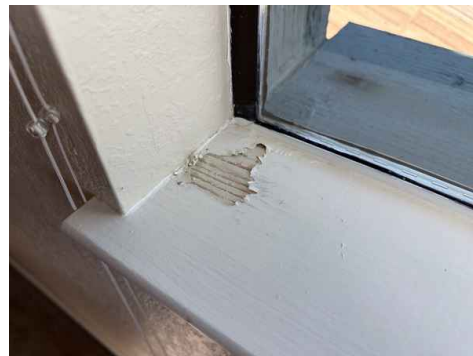
### SOUTHEAST BEDROOM

There is moisture staining at one or more window stool(s) (interior "sills") from prior moisture penetration. While this may be the result of condensation or an object leaking on the wood, the stool should be monitored for moisture during wet weather and condensation conditions.
