## WOOD-DESTROYING PESTS INSPECTION REPORT

N<sup>o</sup> 694916

Property Address: 2987 Del Rio Lane Minden, NV 89423

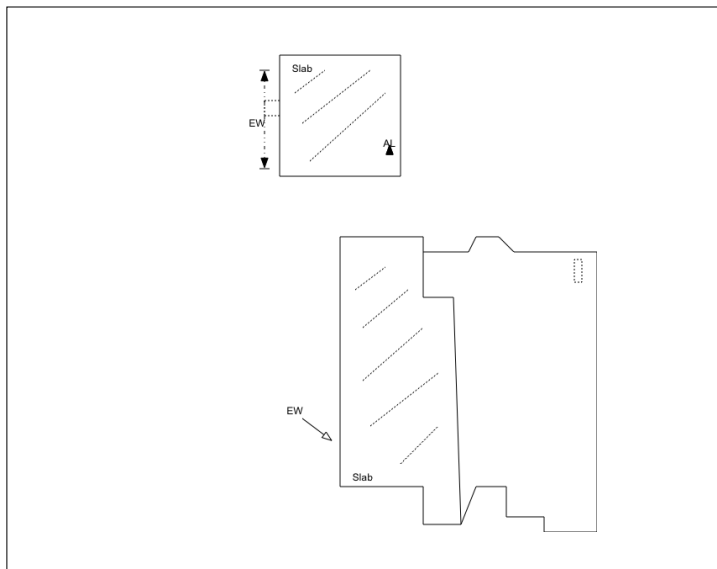
INFESTATION: (See diagram and explanation below.)

At time of inspection found active leak in detached garage sink water supply line. (See picture )

Side of detached garage is Earthwood contact. ( see picture )

Fence is attached to main garage which creates an earth wood contact. (see picture)

AL= actually leak

EW= earthwood contact

**Active Leak** in detached garage sink water supply line is scheduled to be repaired, made inoperable, on 9/22/2026. Please see *Exhibit: Seller Repair Itemization* for updates.
