## INSPECTION REPORT

Property Inspection Address: **17930 Clear Lake Ct, Reno, NV 89508**

Inspection Date: **October 5th, 2026**

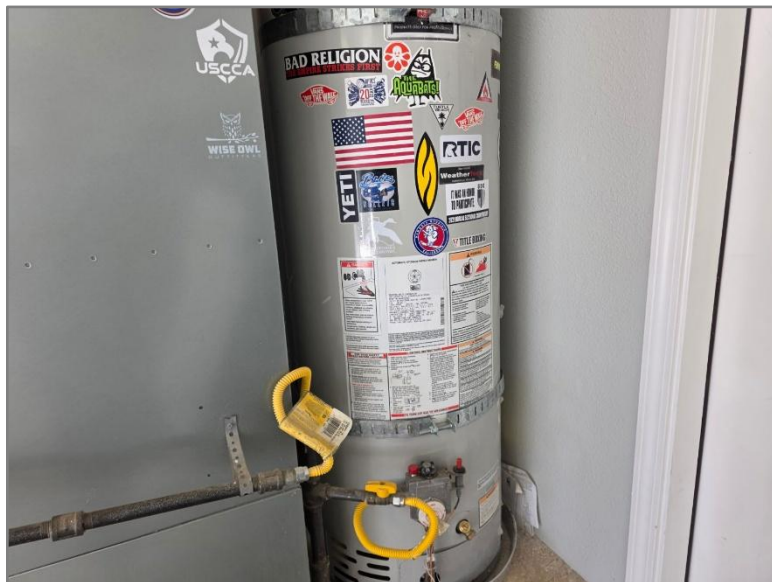
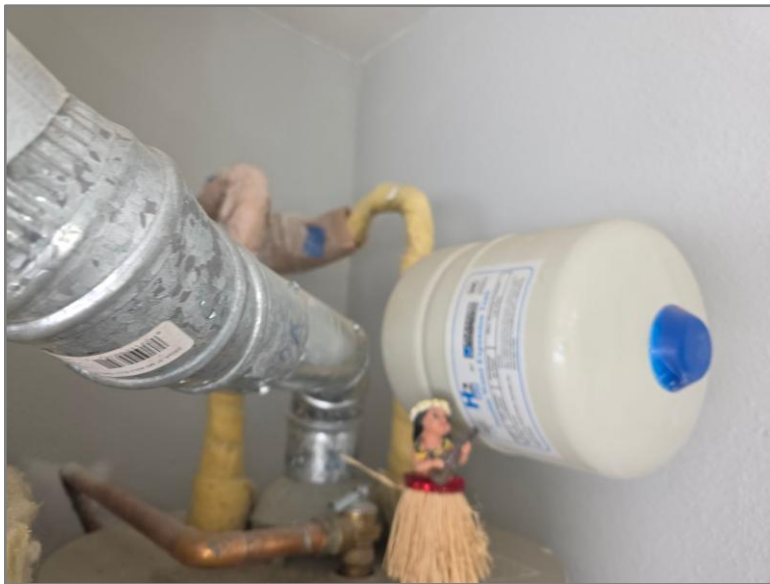
Overall condition: **Poor to Fair**

→ Gas-fired water heater located in the garage. The unit was manufactured in 2005. A well-maintained unit has an estimated service life of around 10 to 15 years; due to the age, the condition is listed as poor to fair. And additionally, recommend strapping the thermal expansion tank to relieve stress on the supporting pipes.

→ Gas-fired water heater located in the garage. The unit was manufactured in 2005. A well maintained unit has an estimated service life of around 10 to 15 years, due to the age the condition is listed as poor to fair. And additionally, recommend strapping the thermal expansion tank to relieve stress on the supporting pipes.

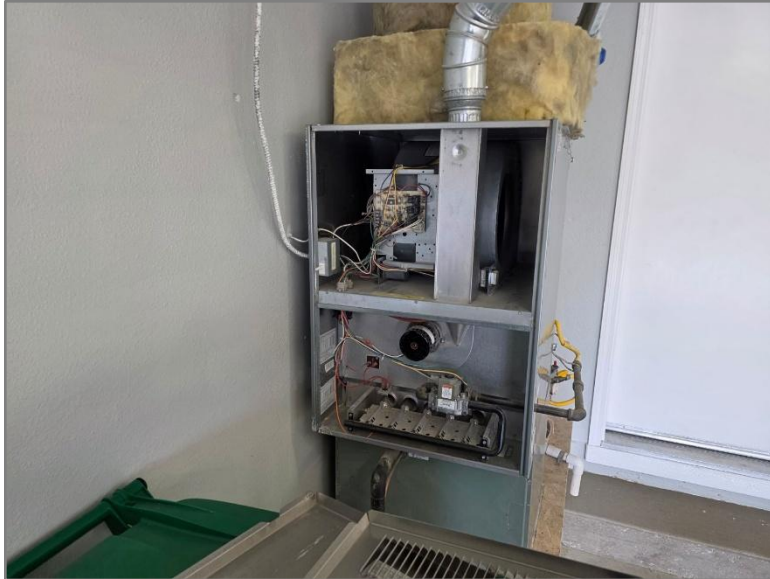
Heating-1

→ Gas-fired furnace located in the garage. The unit was manufactured in 2004. due to the age of the unit. Recommend further evaluation by a licensed contractor.

→ Gas-fired furnace located in the garage. The unit was manufactured in 2004. due to the age of the unit. Recommend further evaluation by a licensed contractor.

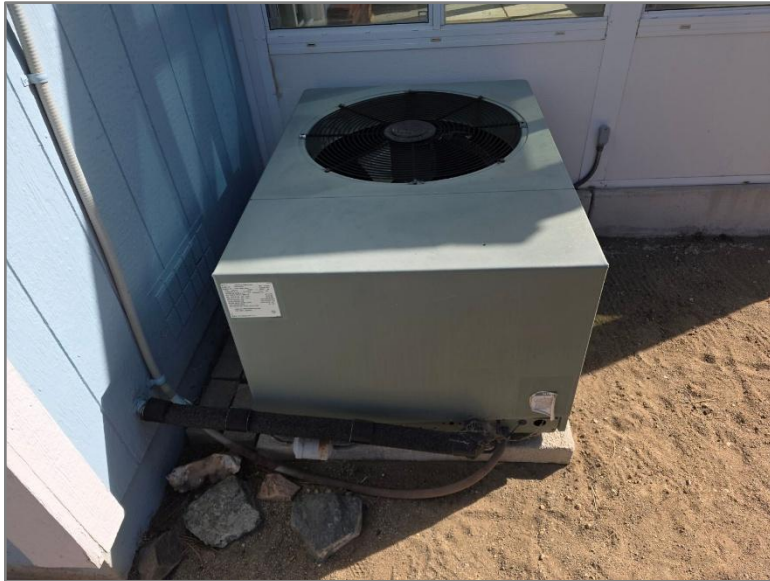
→ Air conditioning unit located on the south side. The unit was manufactured in 2005 due to the age. Recommend further evaluation by a licensed contractor.

→ Air conditioning unit located on the south side. The unit was manufactured in 2005 due to the age. Recommend further evaluation by a licensed contractor.

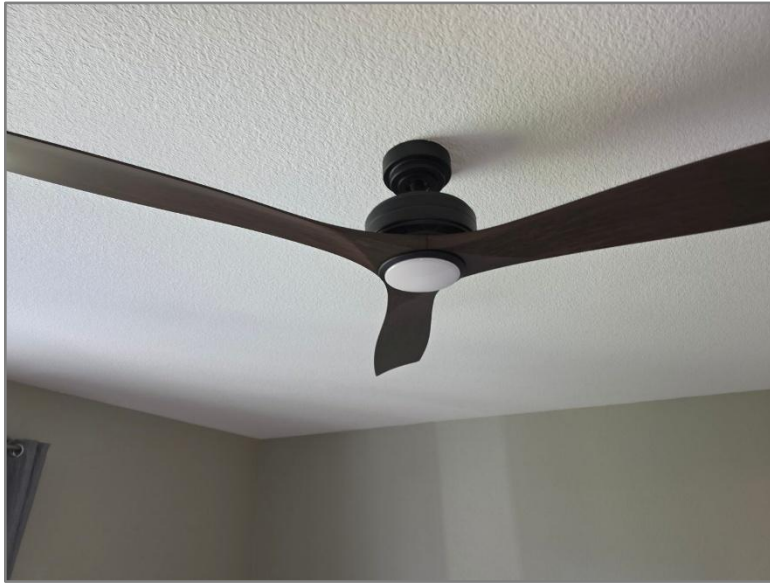
Electrical-1

→ The master of bedroom ceiling fan light is out. Recommend installing a new bulb and evaluating further.

\*\*\*\*The light turns on-it requires a remote control which is in the bedroom.- Listing Agent

→ The master of bedroom ceiling fan light is out. Recommend installing a new bulb and evaluating further.

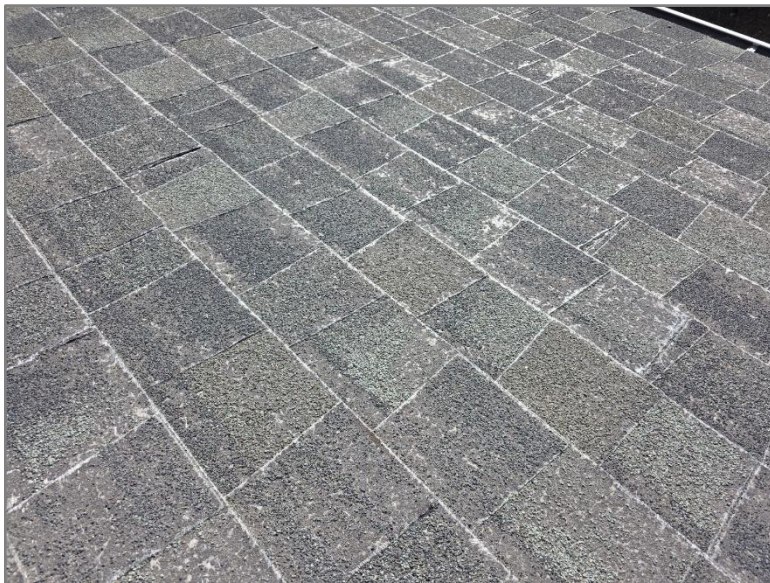
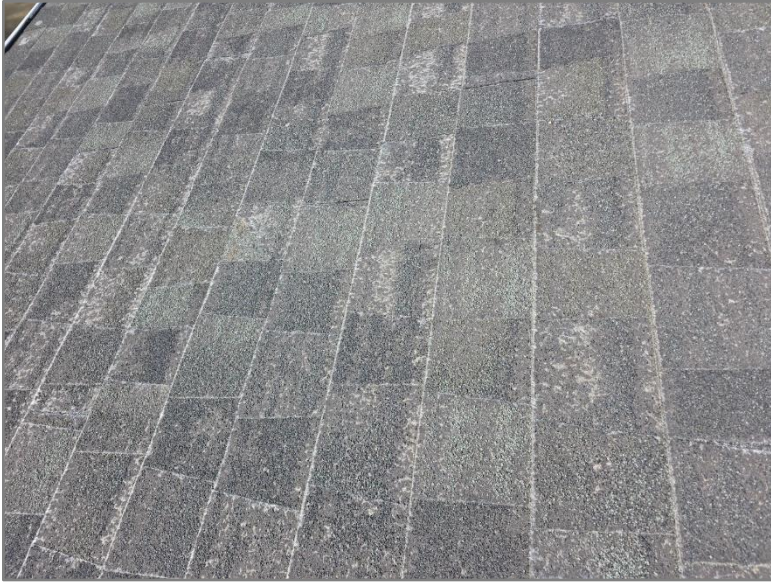
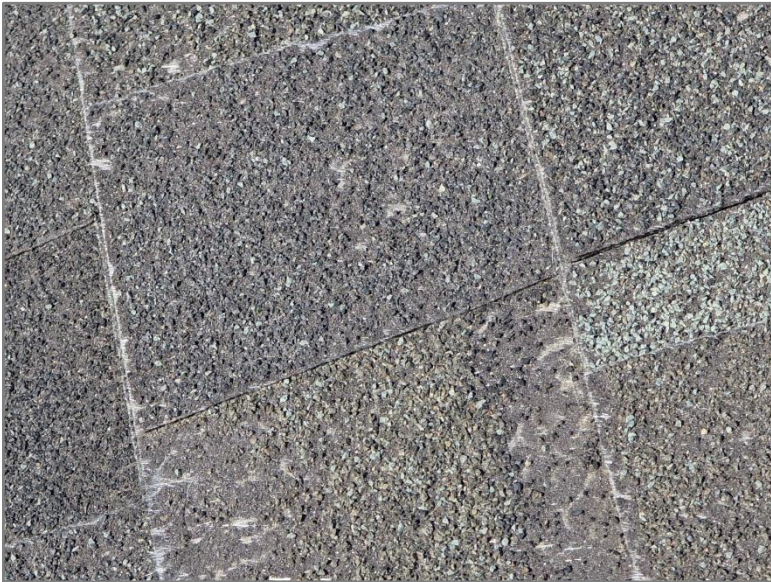
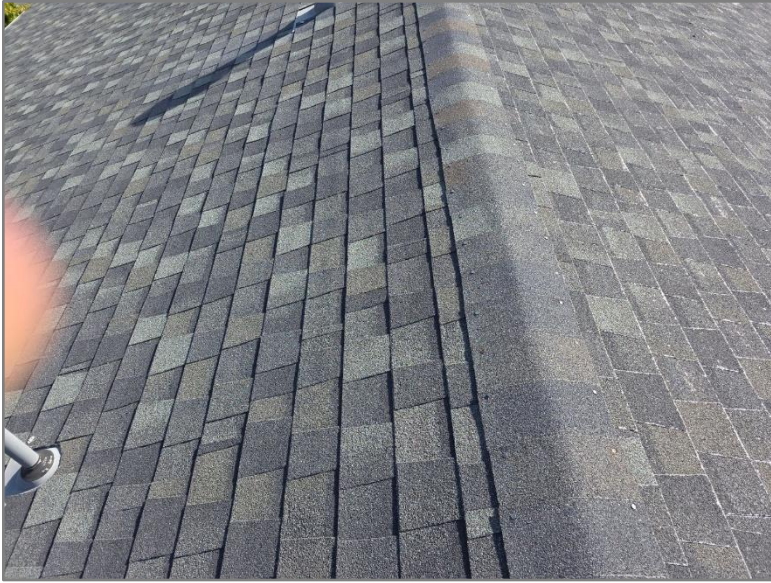
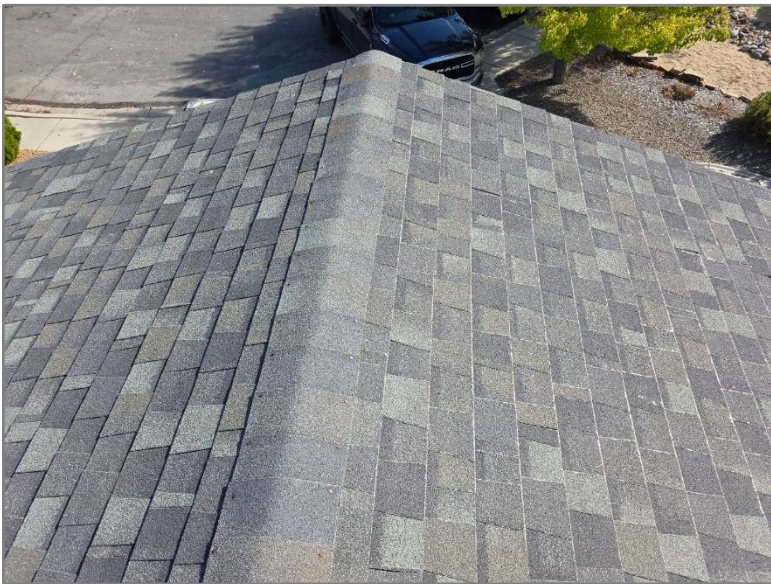
Overall condition: **Fair**

→ The roof appears to be in fair condition but is showing signs of being close to the overall life expectancy. For a more detailed evaluation, contact a licensed roofer.

→ The roof appears to be in fair condition but is showing signs of being close to the overall life expectancy.

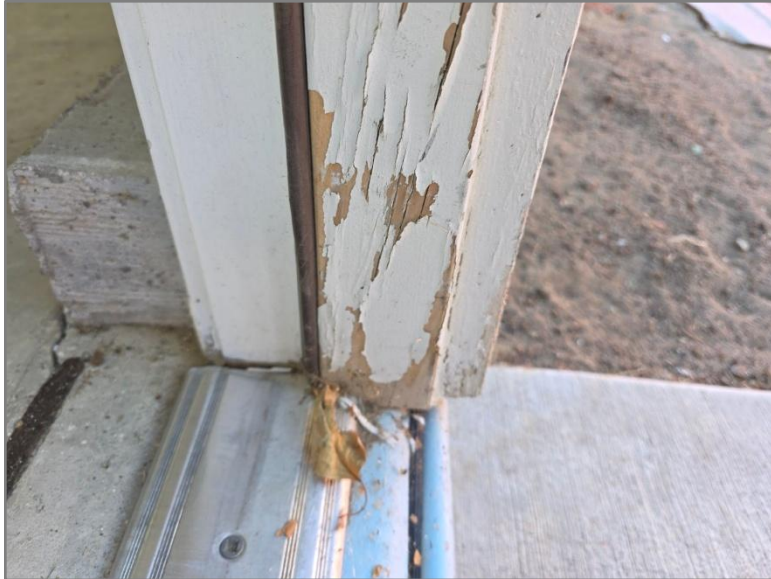
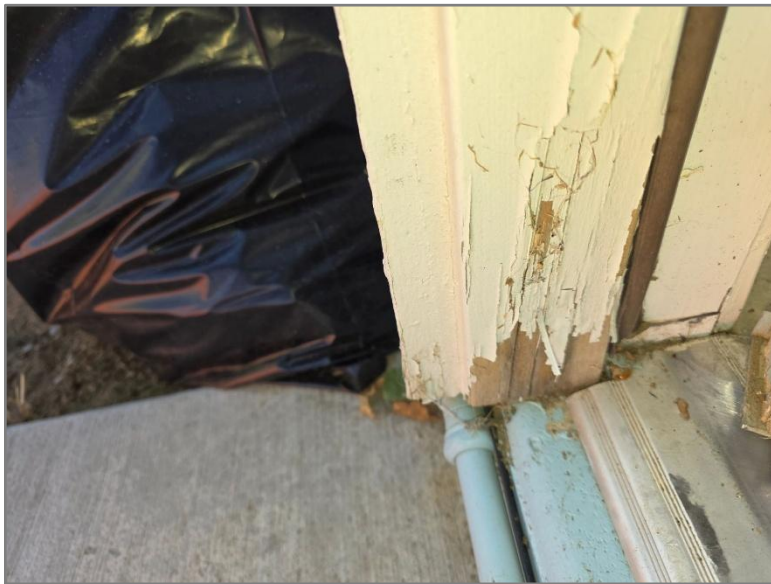
→ Peeling paint observed on the garage exterior man door, recommend sealing.

→ Peeling paint observed on the garage exterior man door, recommend sealing.

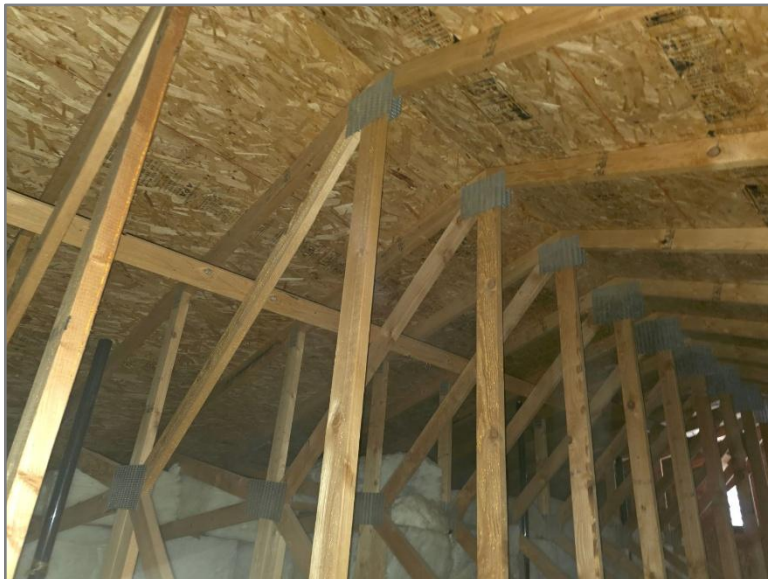
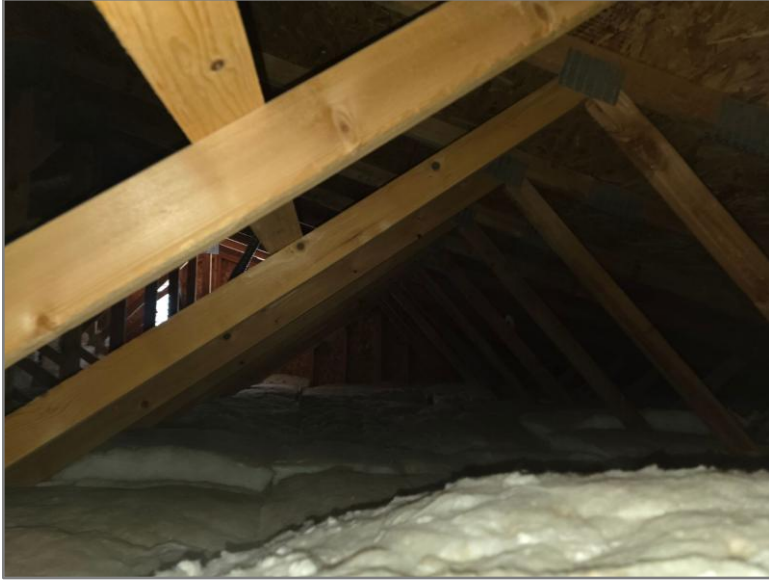
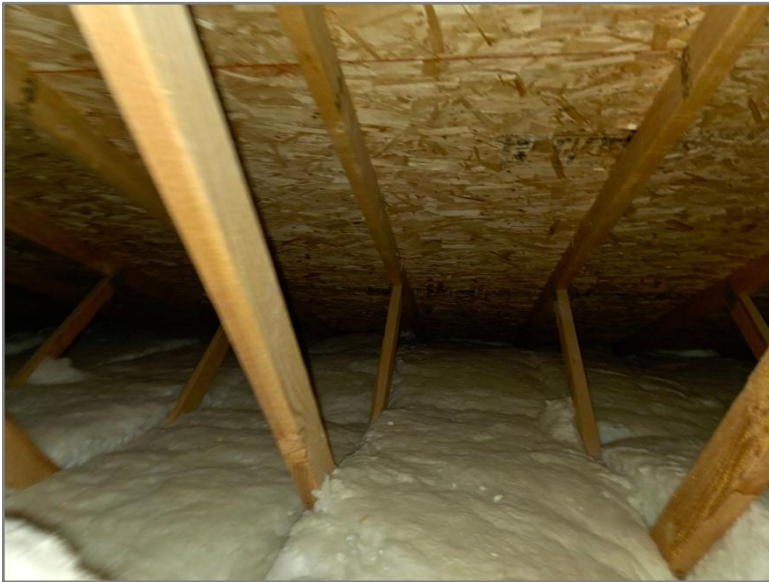
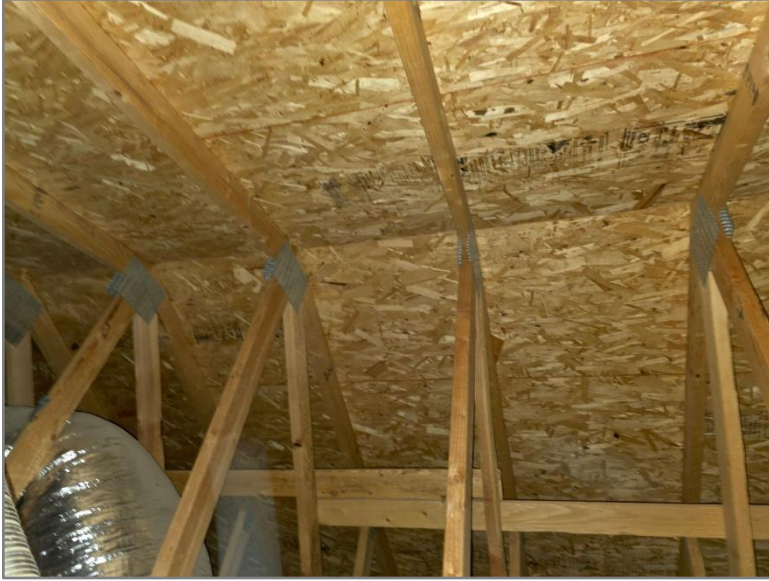
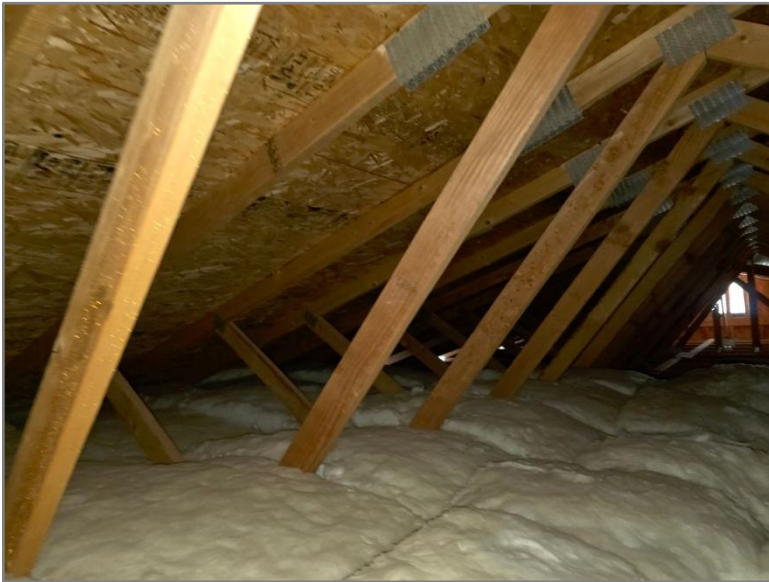
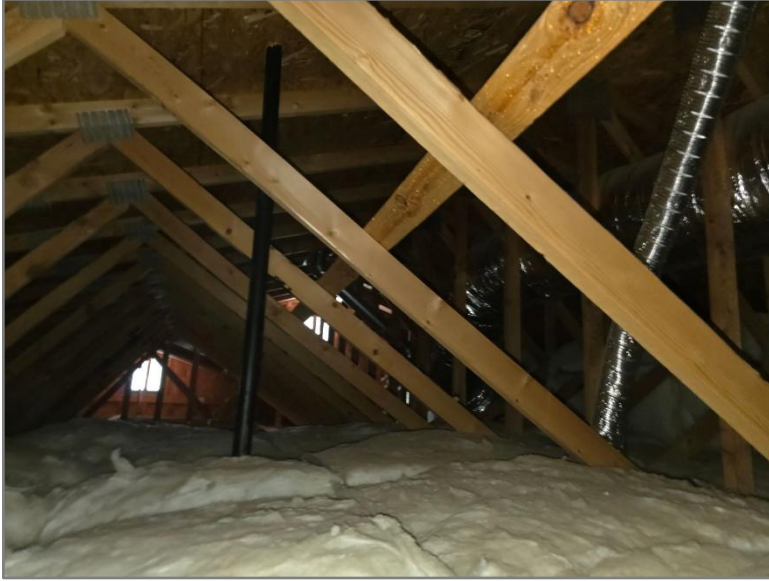
Attic space ventilation condition: **Good**

→ [Attic space photos.](#)

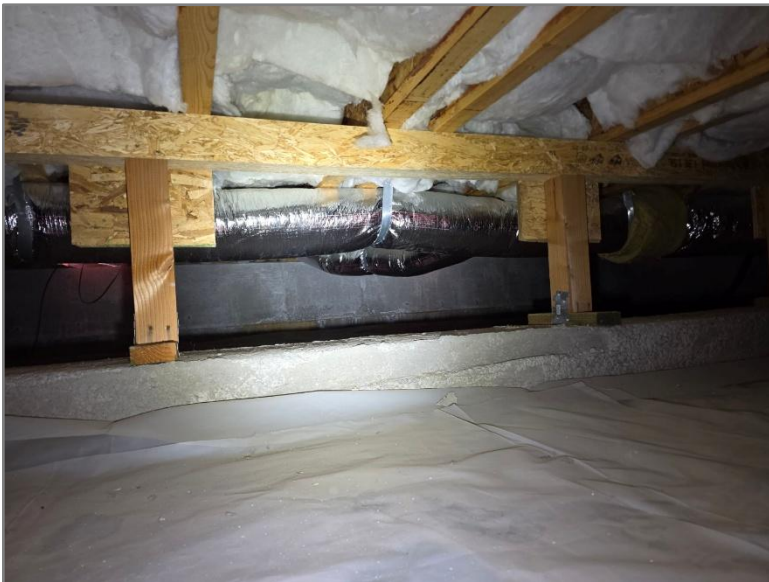
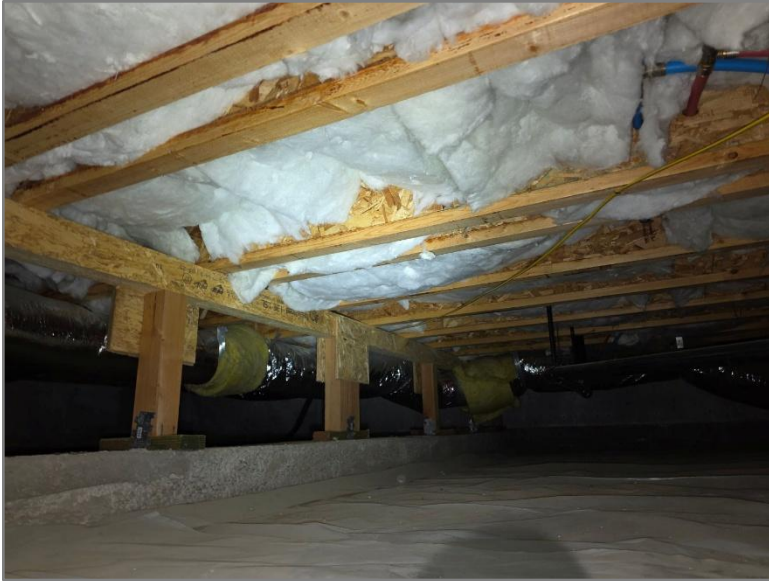
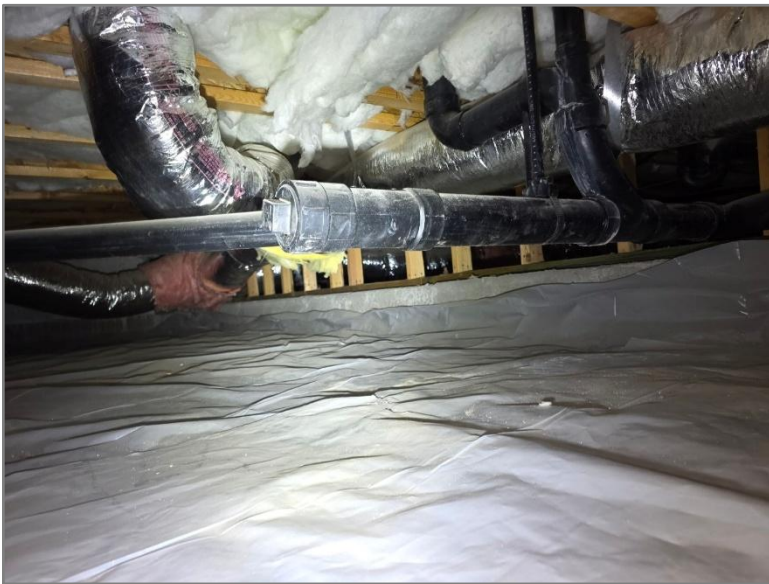
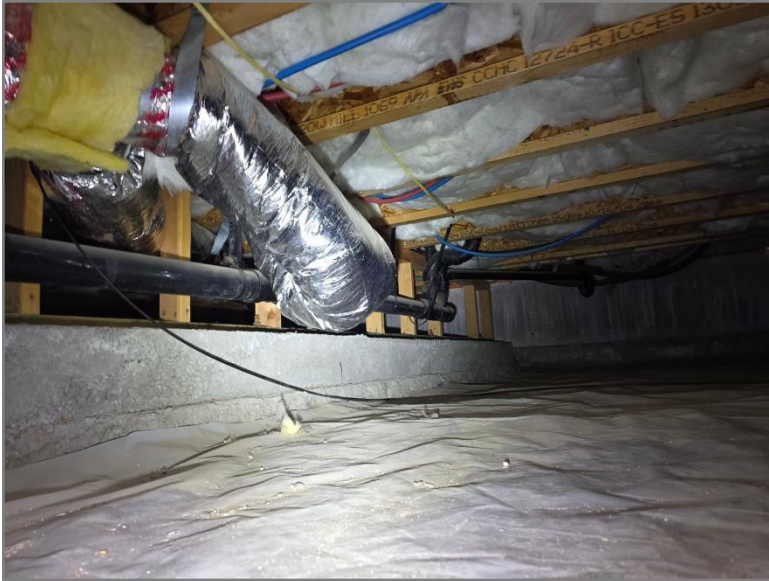
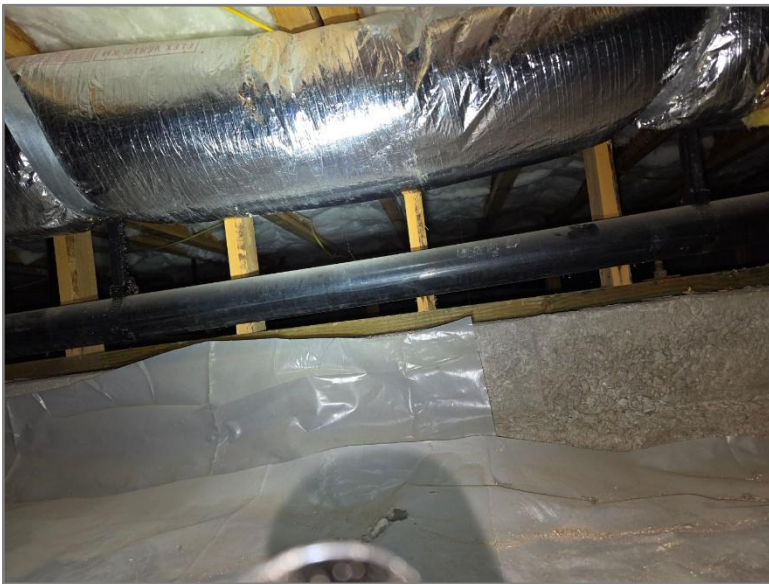
Crawl space ventilation condition: **Good**

→ Crawl space photos
