## SUMMARY

700 Hunter Pl, Reno, NV 89519

Matthew Herron  
Certified Residential and Commercial  
Inspector

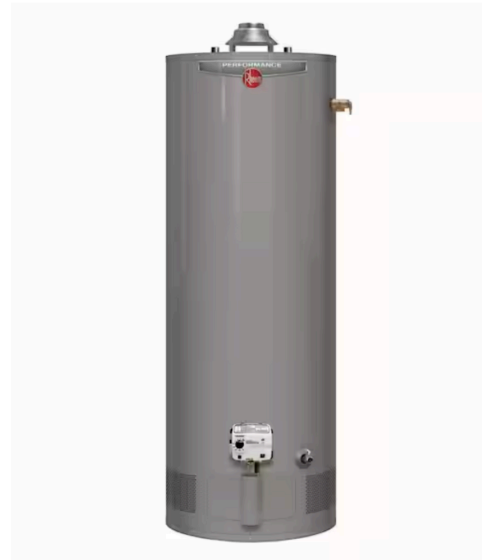
### RECOMMEND PROFESSIONALLY SERVICE WATER HEATER

I recommend a qualified professional service your water heater and that they do so on a yearly basis or as the manufacturer deems necessary. The water heater builds up sediment in the water which is collected in the tank. This can make your water heater inefficient as sediment builds and can possibly damage your water heater/hot water lines if not properly maintained frequently. I recommend a professional servicing/cleaning on your water heater by a qualified professional.

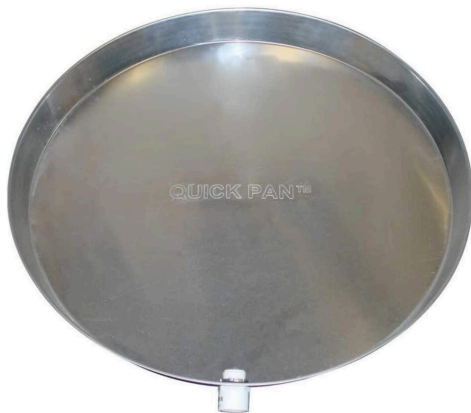
### NO DRIP PAN

No drip pan was present at time of inspection. I recommend a qualified professional evaluate and repair as needed.

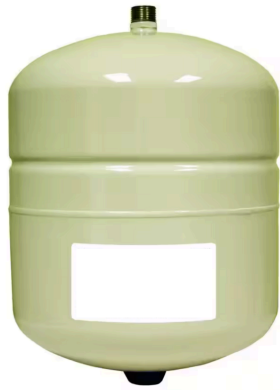
**NO EXPANSION TANK**

Water heater does not have an expansion tank at time of inspection. I recommend a qualified professional evaluate and repair as needed. Expansion tanks intentionally are empty awaiting water that may need to be relieved from the pipes due to extra stress/pressure.

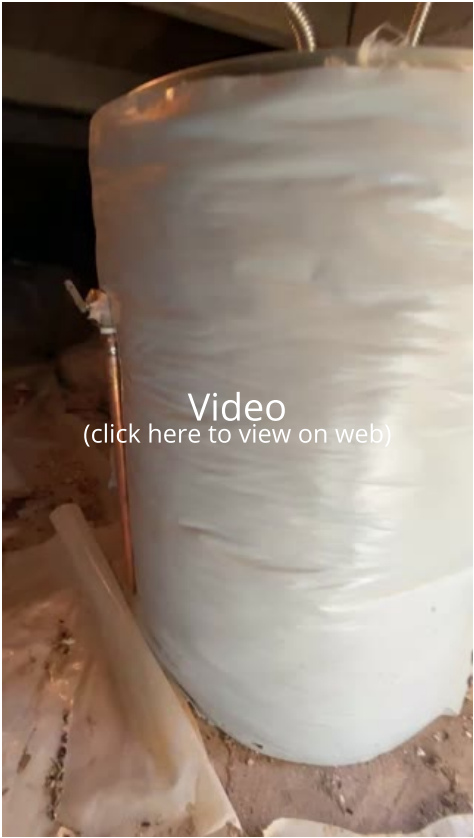
Water heater is showing signs of wear and tear and is nearing the end of its service life. I recommend a qualified professional evaluate and repair as needed.

Recommendation  
Contact a qualified professional.

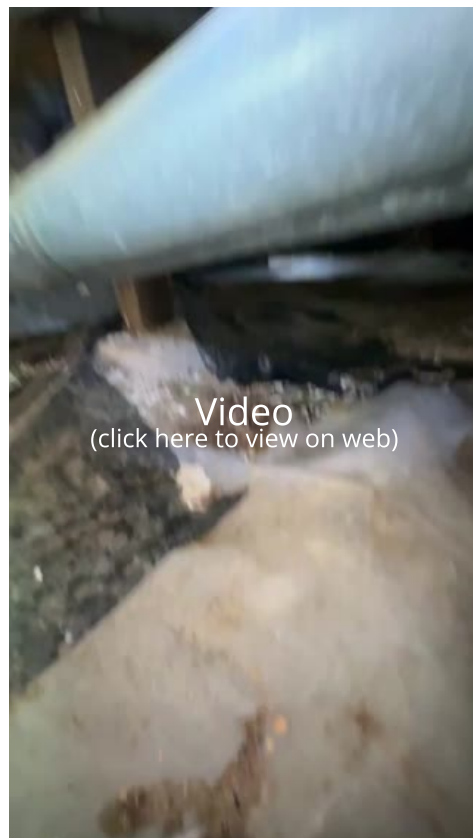
## 5.6.1 Drain, Waste, &amp; Vent Systems

**LEAKING PLUMBING**

A drain, waste and/or vent pipe showed signs of a leak at time of inspection. I recommend a qualified professional evaluate and repair as needed.

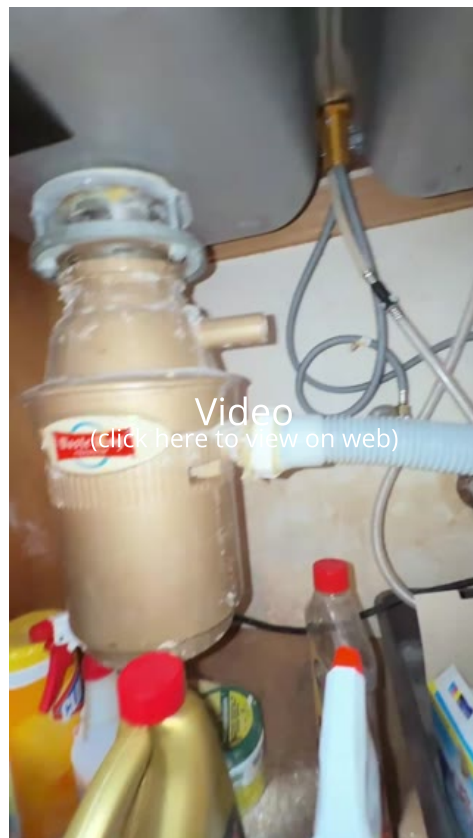
## 5.6.5 Drain, Waste, &amp; Vent Systems

**IMPROPER CONNECTION**

An improper connection was observed at a drain, waste or vent pipe at time of inspection. I recommend a qualified professional evaluate and repair as needed.

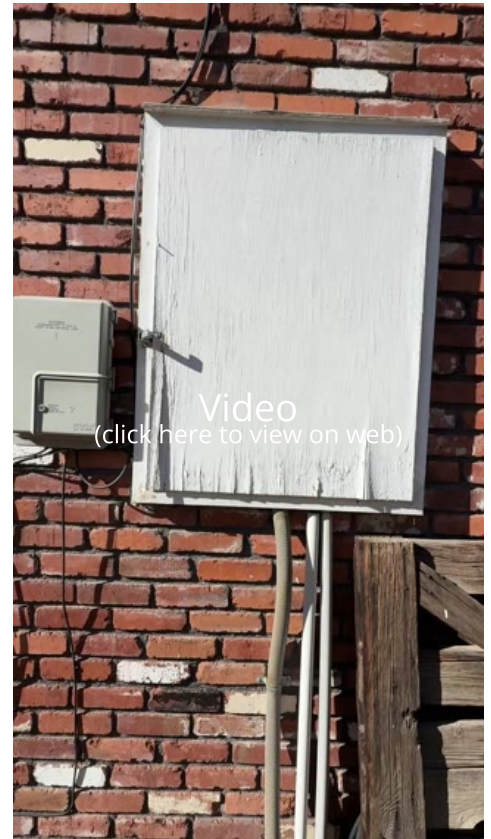
### 6.1.1 Main & Subpanels, Service & Grounding, Main Overcurrent Device

Access to electrical panel is insufficient at time of inspection. I recommend a qualified professional evaluate and repair as needed. There needs to be adequate access for doors to open up and allow room to use the electrical panel safely. Also, the electrical panel should not be hiding behind any other blockings such as doors, shelves or plants.

Contact a qualified professional.

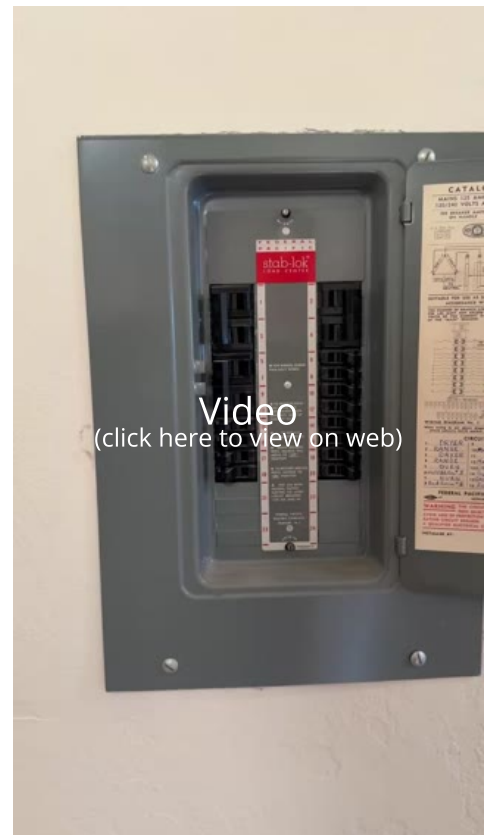
### 6.1.2 Main & Subpanels, Service & Grounding, Main Overcurrent Device

A Zinsco or Federal Pacific Electrical Panel was found at time of inspection. These electrical panels have had a long history of proving time and time again to be defective. Testing by the Consumer Product Safety Commission has shown these breakers to have an unacceptably high rate of failure, which creates a safety hazard. Testing has proven that virtually every panel installed in the United States contains defective breakers. If a breaker fails to trip when it should, the wires in the home that are supposed to be protected can start on fire. I recommend a qualified professional evaluate and repair as needed.

Contact a qualified professional.

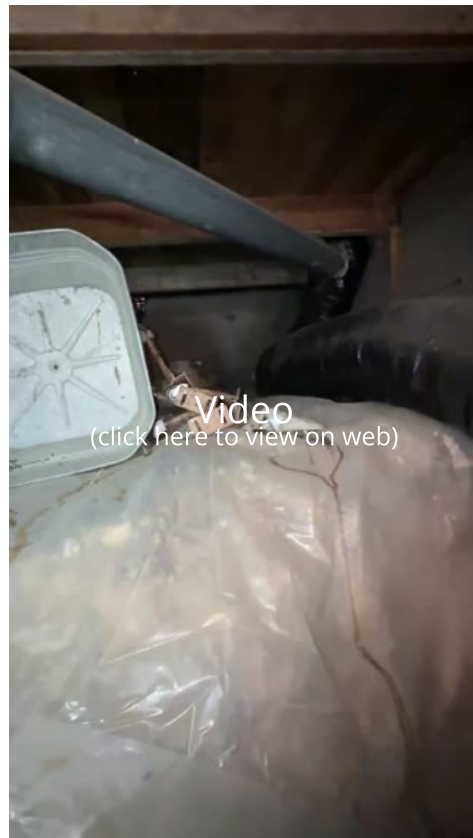
**IMPROPER DUCTWORK**

In one or more locations there appears to be improper ductwork at time of inspection. I recommend a qualified professional evaluate and repair as needed.

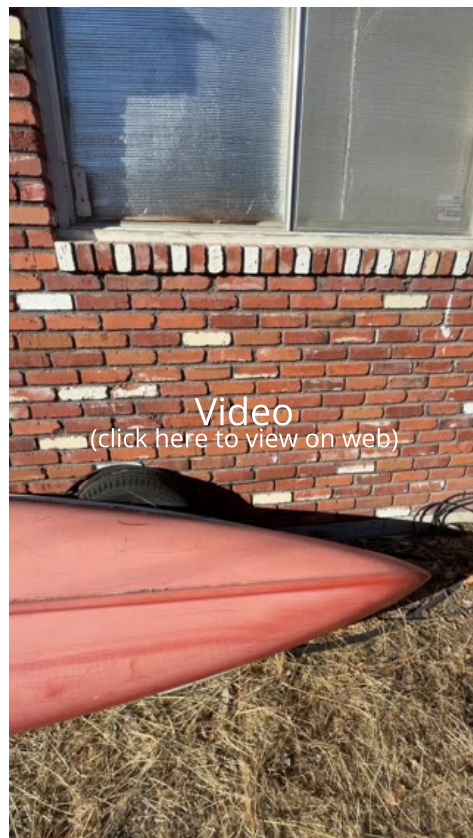
In one or more locations, masonry repointing was needed. I recommend a qualified professional evaluate and repair as needed.

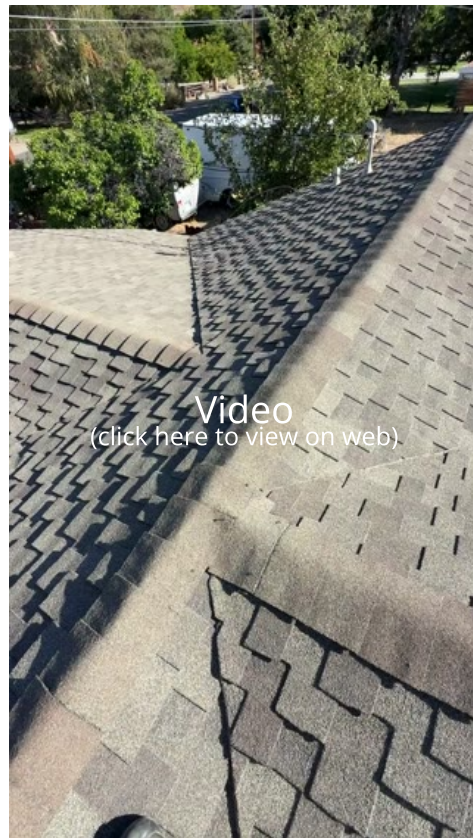
## 10.1.4 Coverings

**EXPOSED FASTENERS**

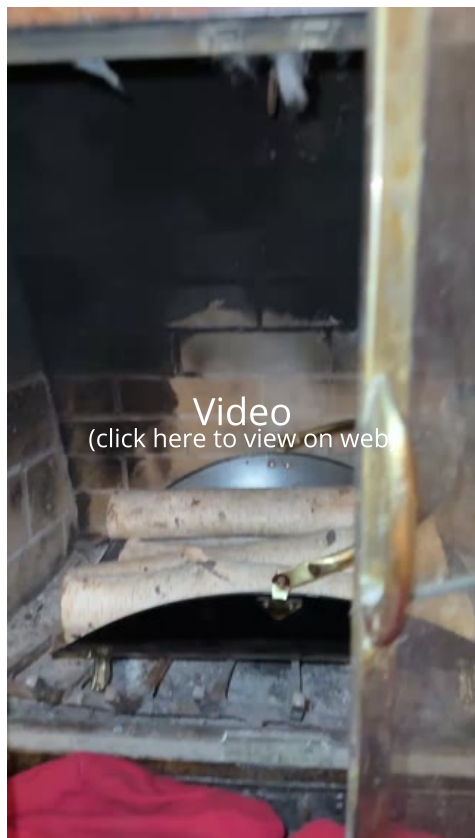
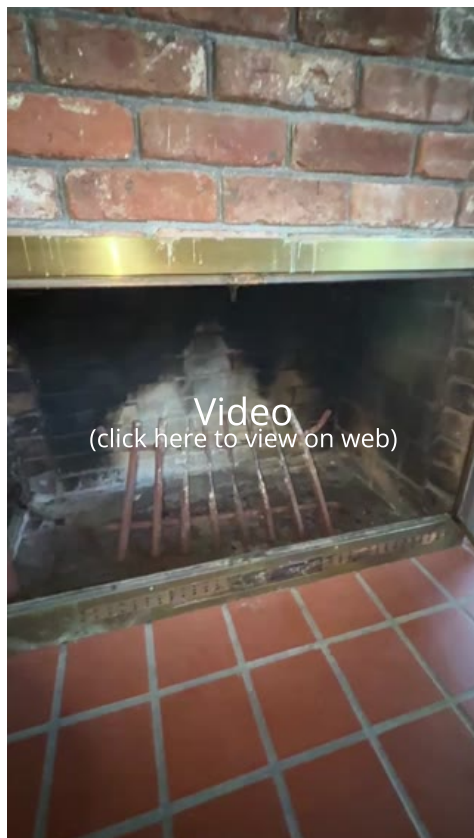
## 12.4.1 Cleanout Doors &amp; Frames

**CREOSOTE BUILDUP**

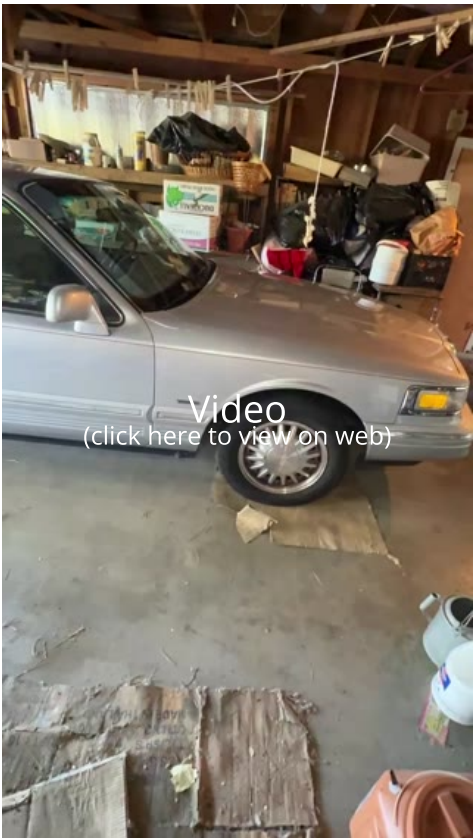
In one or more locations in the garage, there were signs of mice at time of inspection. I recommend they qualified professional evaluate and repair as needed.

Recommendation  
Contact a qualified professional.

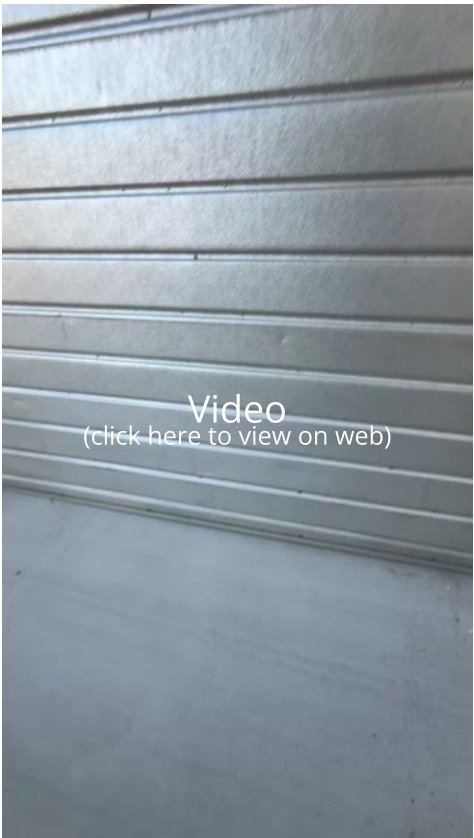
Garage door exterior seal was missing at time of inspection. I recommend a qualified professional evaluate and repair as needed.

Recommendation  
Contact a qualified professional.
