Prepared For:  
Jessica Lovett

4115 Ramsey Circle  
Carson City, NV, 89706

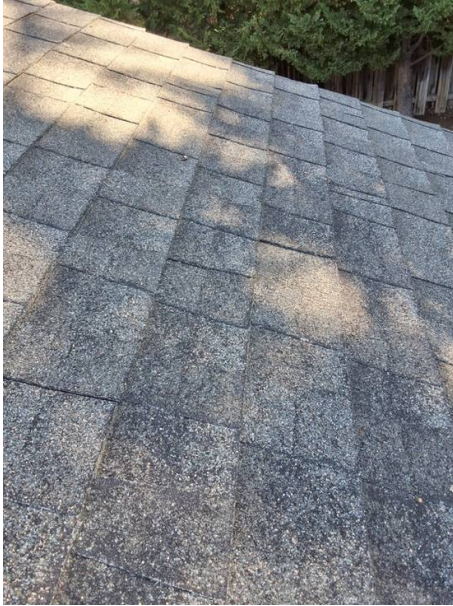
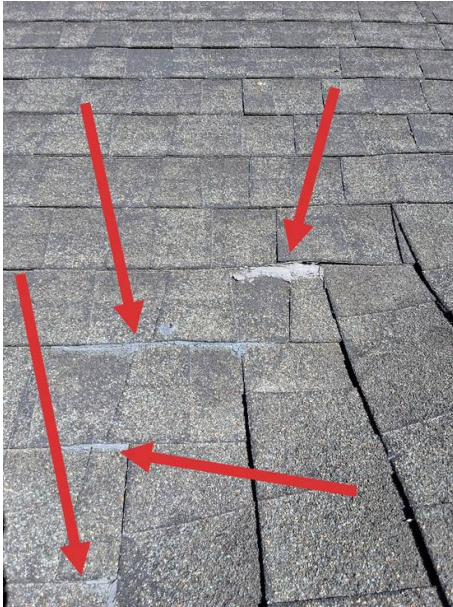
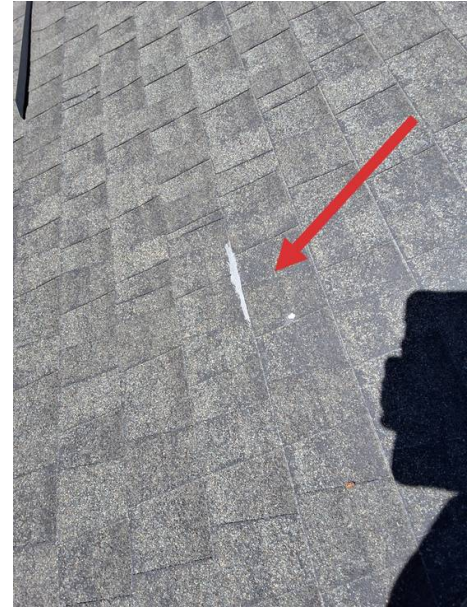
Remaining service life cannot be determined by visual inspection. Recommend budgeting for future replacement and monitoring for further deterioration or leakage.

Due to the limitations of a visual inspection, the adequacy and condition of concealed materials could not be determined. Recommend monitoring and evaluation by a qualified roofing contractor as needed.

South face of roof

East face of roof

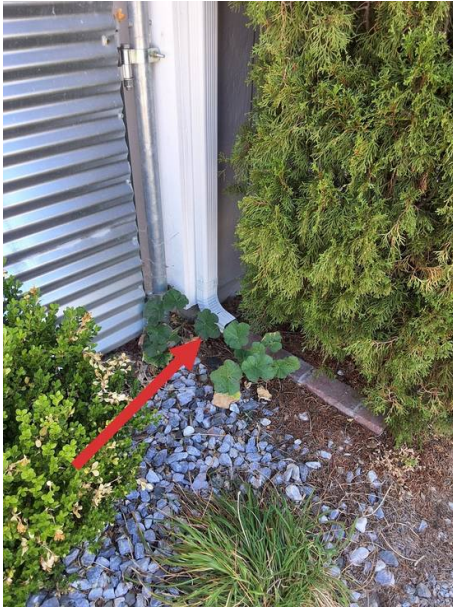
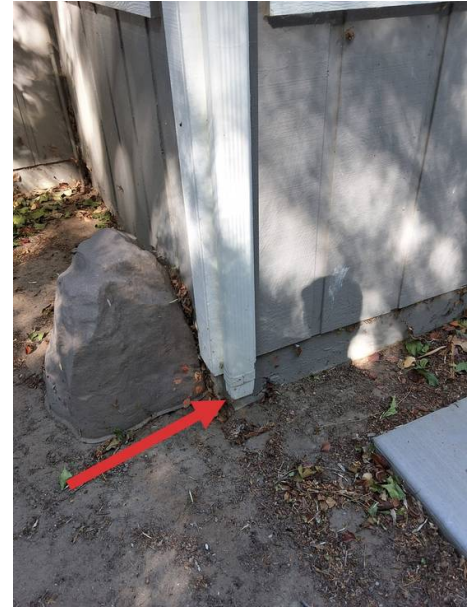
Some gutter downspouts discharge too close to the foundation. Recommend extending the downspouts to discharge farther away from the home to help direct water away from the foundation.

Downspout in front of home

Downspout at rear of home

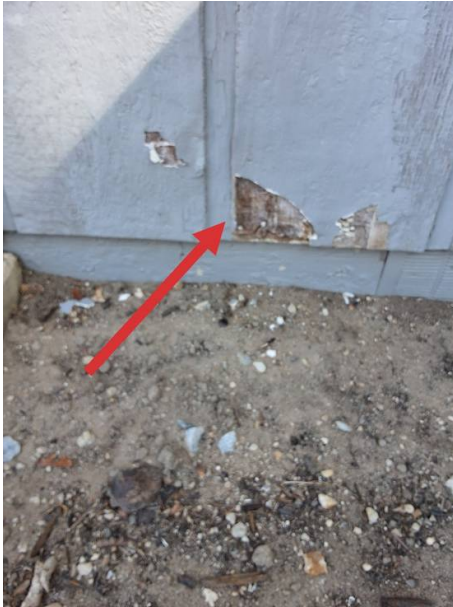
Surface damage noted

Side of garage, front of home.

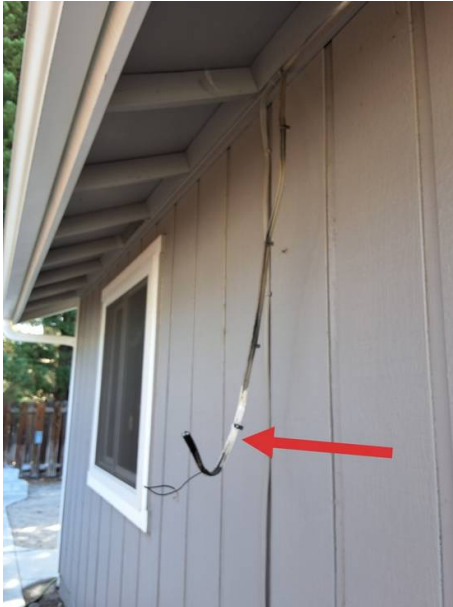
An exposed cable TV line was observed. The line was not evaluated for function or condition. Recommend securing and/or protecting the exposed cable as needed.

TV cable line at north of home

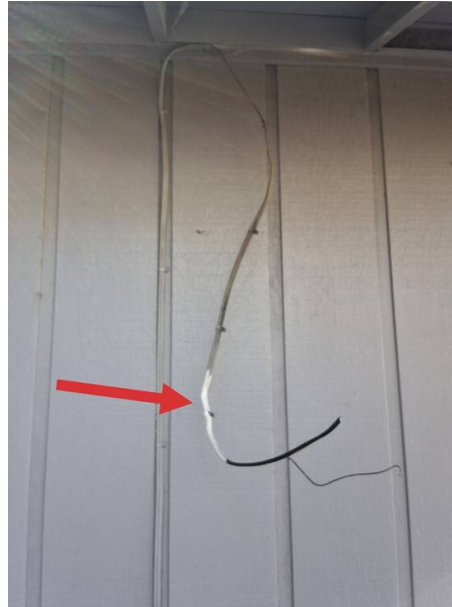
TV cablr line at north of home

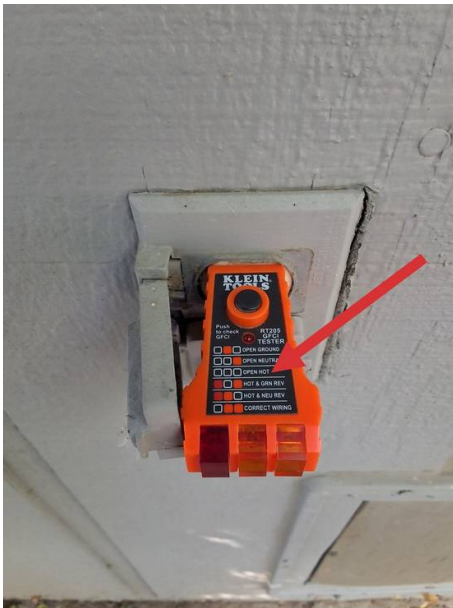
An electrical outlet did not operate when tested. The cause was not determined during the inspection. Recommend evaluation and repair by a qualified electrician.

Outlet located outside, on rear of garage

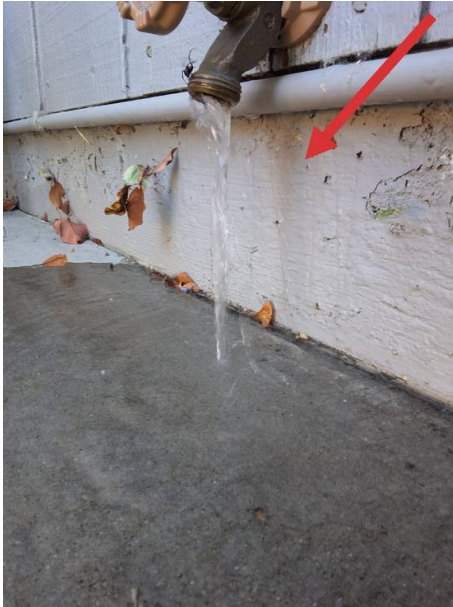
The hose bib was observed leaking when operated, with water appearing to discharge from behind the adjacent siding. The source and extent of the leak could not be determined during the inspection. Recommend evaluation and repair by a qualified plumbing professional.

Hose bib at north side of home

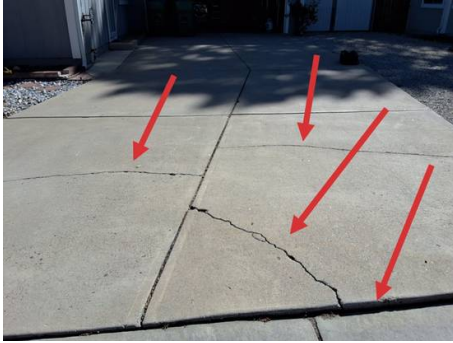
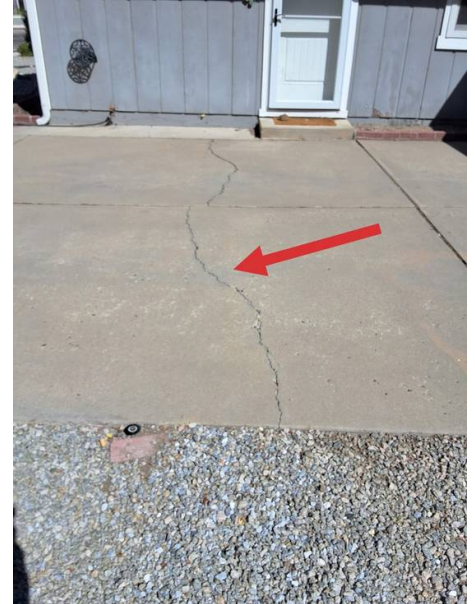
Cracking and localized settlement were observed at the concrete driveway. The cause of any underlying conditions can not be determined during the inspection. Recommend monitoring and repair as needed.

Front driveway

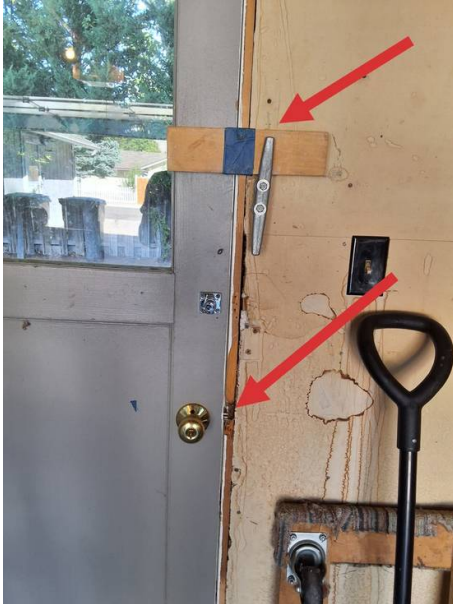
A door knob was not functioning properly at the time of inspection. Recommend evaluation and repair or replacement as needed.

Man door at rear of garage

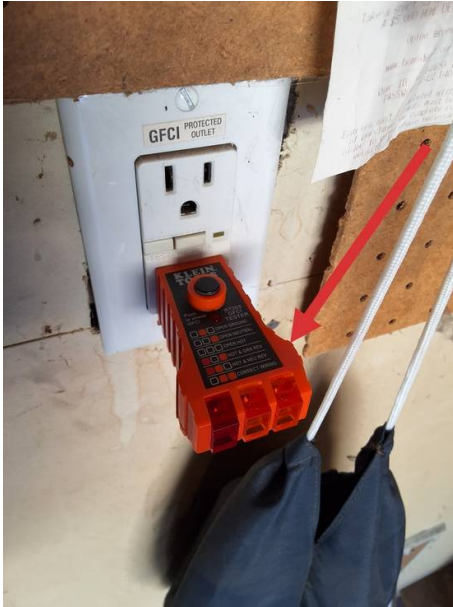
An electrical outlet did not operate when tested. The cause was not determined during the inspection. Recommend evaluation and repair by a qualified electrician.

Garage outlet on South wall

Non-GFCI circuit used near water source

Non-GFCI outlet behind washer/dryer in garage

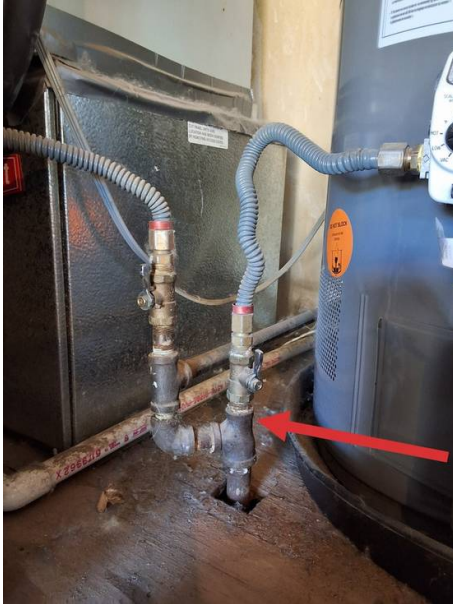
No sediment trap was observed on the gas supply line to the water heater. Recommend evaluation and correction by a qualified plumbing or gas professional

Gas supply line to water heater

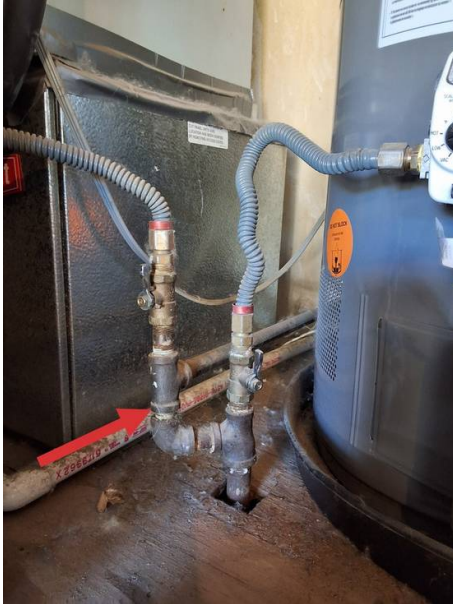
No sediment trap was observed on the gas supply line to the forced air unit. Recommend evaluation and correction by a qualified plumbing or gas professional.

Gas supply line to forced air unit

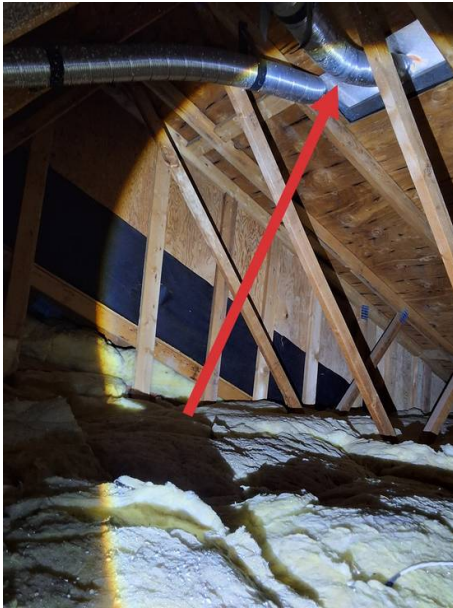
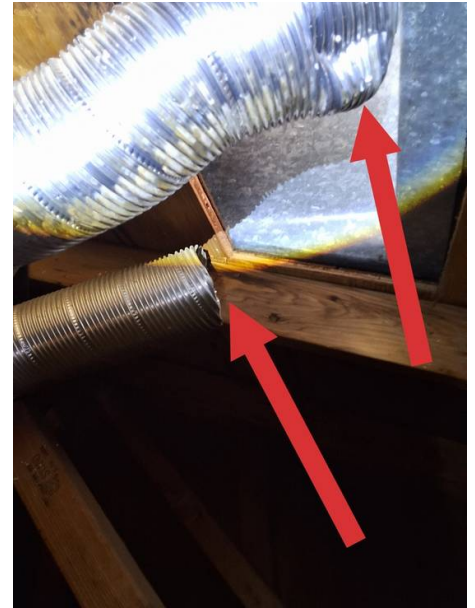
The bathroom exhaust vent was observed terminating in the attic and directed toward a roof vent, with noticeable rusting observed at the vent cover. Recommend correcting the vent termination and evaluating the affected area for moisture-related damage.

Bathroom vents terminating in attic

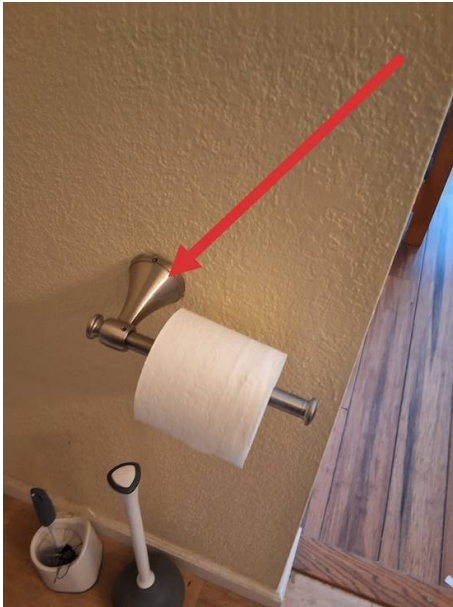
The toilet paper holder was loose at the time of inspection. Recommend securing the holder and repairing the mounting as needed.

Master bathroom

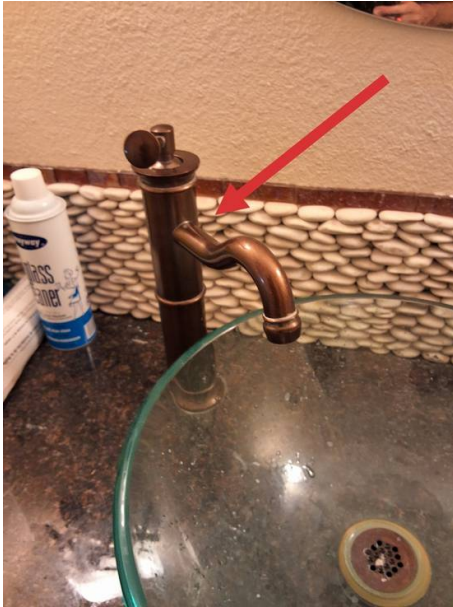
The bathroom sink faucet was loose at the time of inspection. Recommend securing the faucet and verifying proper operation as needed.

Loose faucet at hallway bathroom.

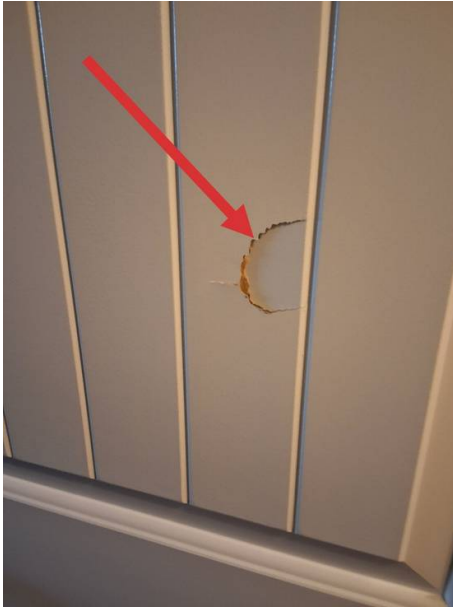
Damage was observed to the door face. Recommend repair or replacement as needed.

Hallway bedroom door

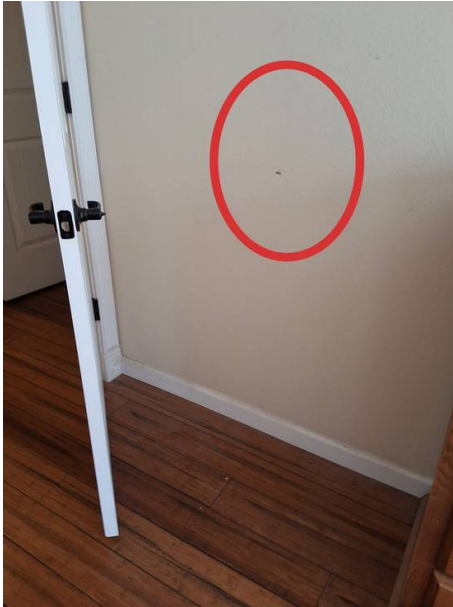
Door stops were not observed at the interior doors inspected. Recommend installation as needed to help prevent damage to doors and adjacent surfaces.

Wall damage due to non-present door stop in master bedroom

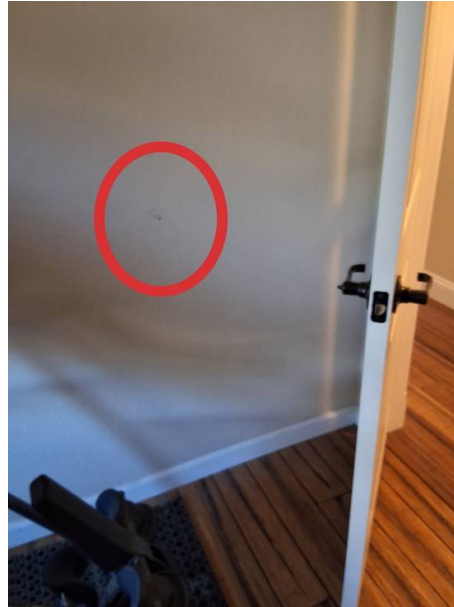
Wall damage due to non-present door stop in hallway bedroom

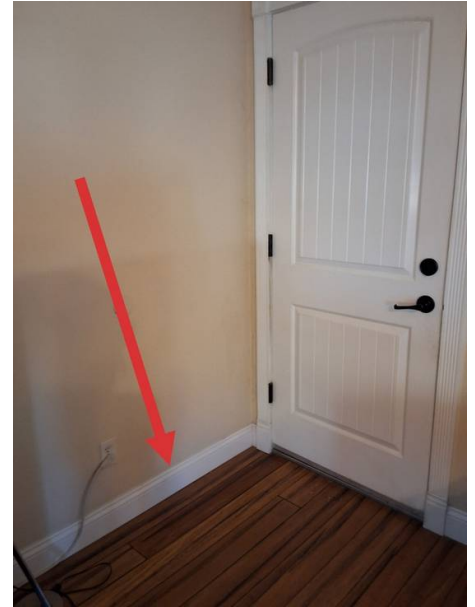
Missing door stop at garage man door

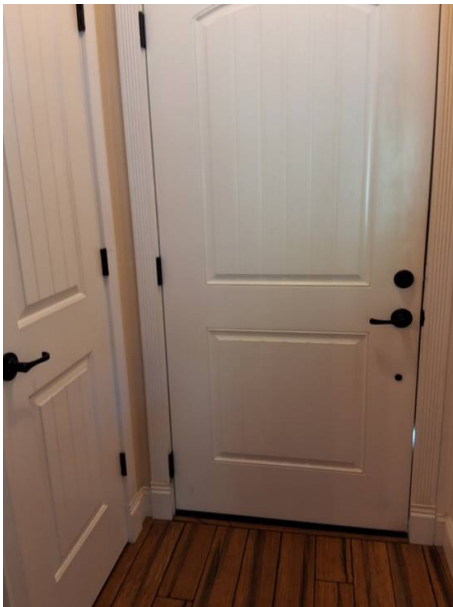
Missing door stops at entry and closet doors

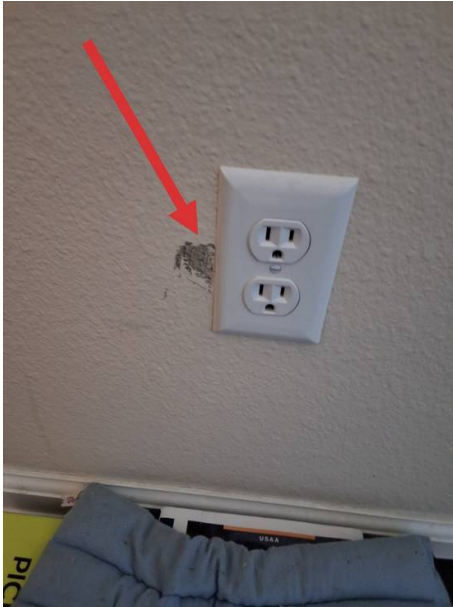
An area of drywall was observed to be damaged or improperly finished. Recommend repair as needed to restore the affected area.

Hallway bedroom

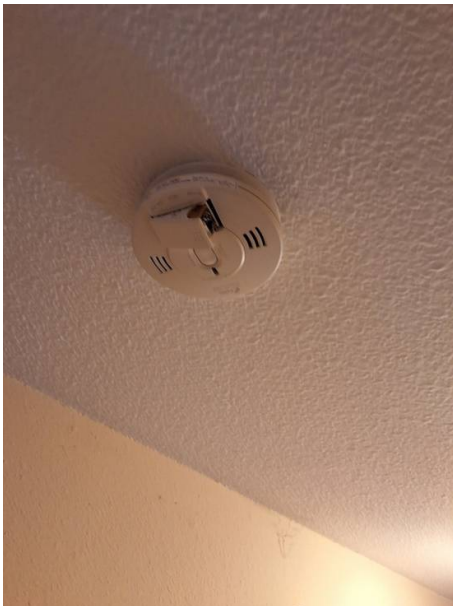
Proper battery installation and operation could not be verified. Recommend checking, servicing, and testing the detector as needed.

Smoke / Monoxide detector in hallway

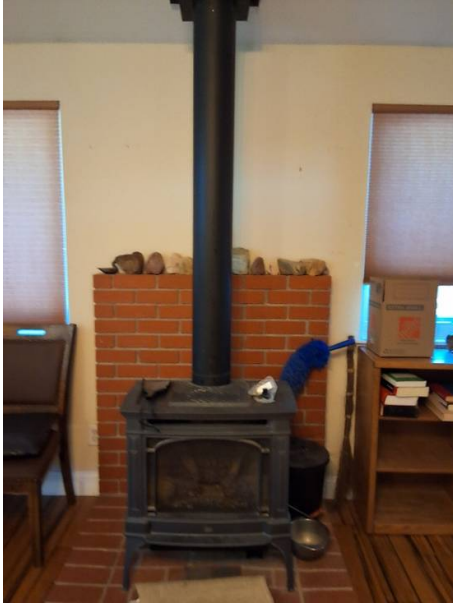
The gas supply to the fireplace was turned off at the time of inspection; therefore, the fireplace could not be tested. Recommend verifying proper operation after the gas supply is restored.

Gas fireplace in living room

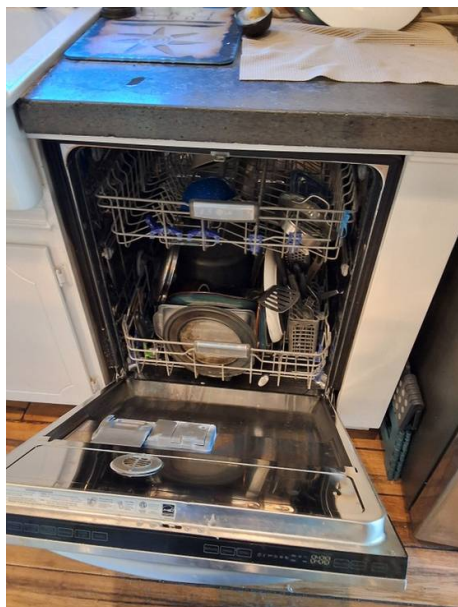
The dishwasher was full of dishes at the time of inspection and could not be operated. Proper operation was not verified. Recommend testing the dishwasher when accessible.

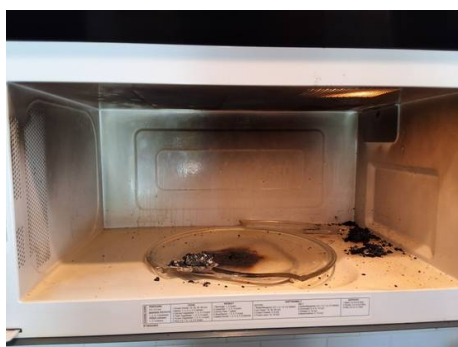
Microwave did not function at time of inspection. Recommend replacement.

Inside of microwave. Kitchen

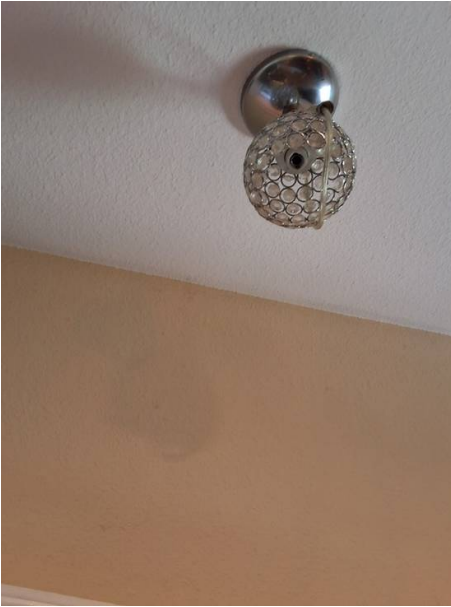
The light fixture over kitchen sink did not operate when tested. The cause was not determined during the inspection. Recommend evaluation and repair by a qualified electrician.

Light fixture over kitchen sink

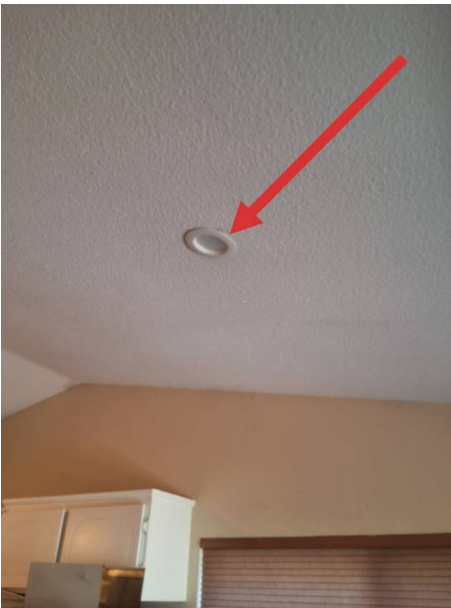
The dining room light fixture did not operate when tested. The cause was not determined during the inspection. Recommend evaluation and repair by a qualified electrician.

Light fixture in dinning area

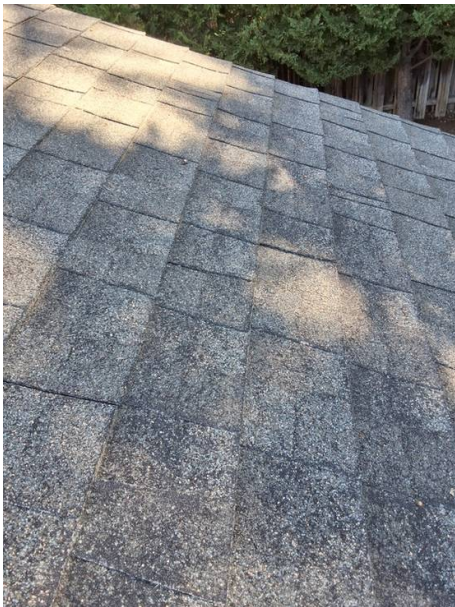
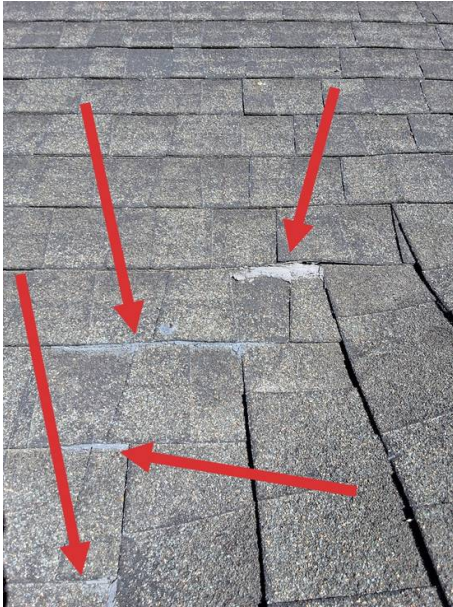
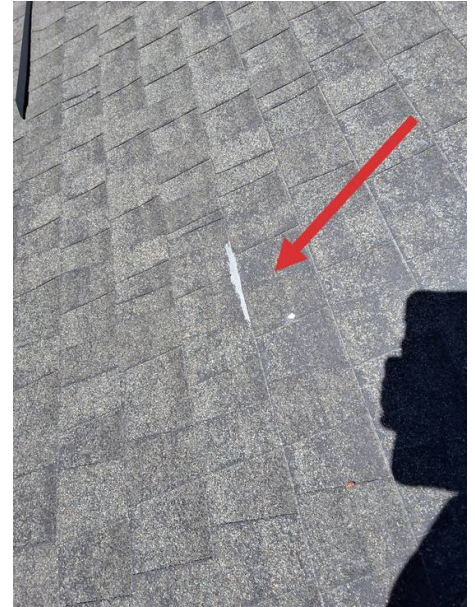
Remaining service life cannot be determined by visual inspection. Recommend budgeting for future replacement and monitoring for further deterioration or leakage.

Due to the limitations of a visual inspection, the adequacy and condition of concealed materials could not be determined. Recommend monitoring and evaluation by a qualified roofing contractor as needed.

South face of roof

East face of roof

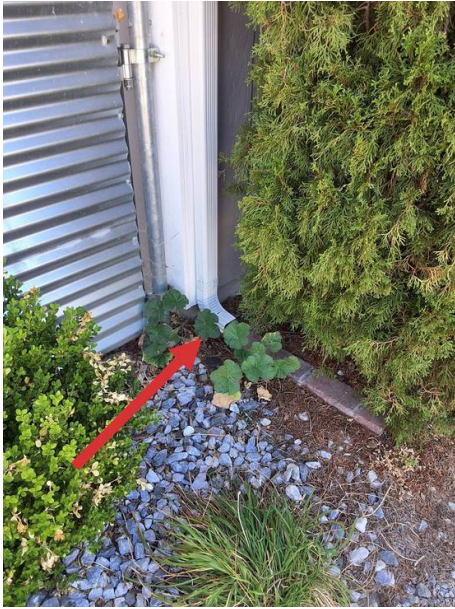
Some gutter downspouts discharge too close to the foundation. Recommend extending the downspouts to discharge farther away from the home to help direct water away from the foundation.

Downspot in front of home

Downspout at rear of home

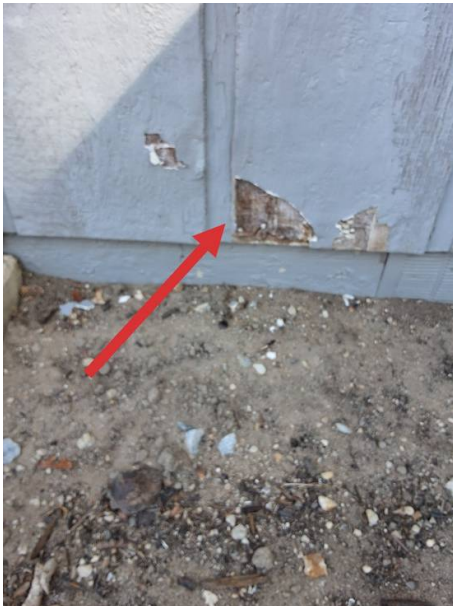
Surface damage noted

Side of garage, front of home.

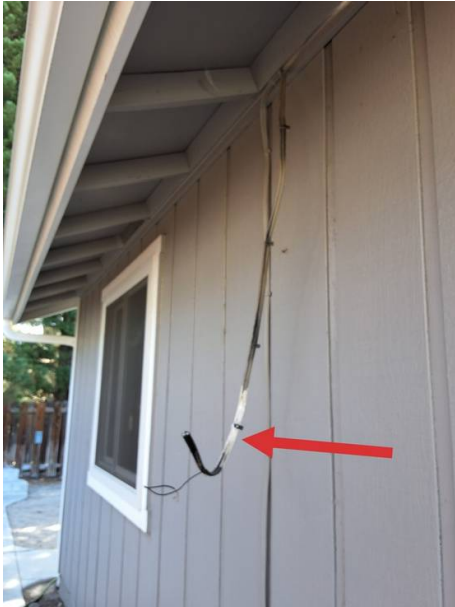
An exposed cable TV line was observed. The line was not evaluated for function or condition. Recommend securing and/or protecting the exposed cable as needed.

TV cable line at north of home

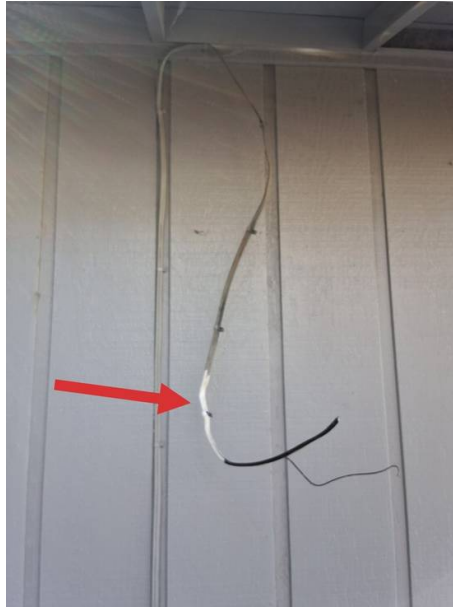
TV cablr line at north of home

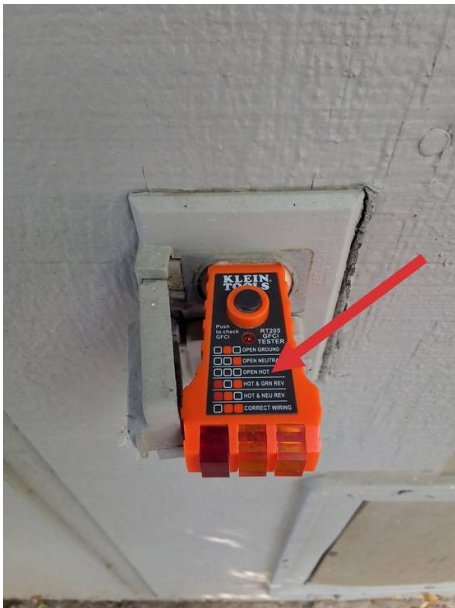
An electrical outlet did not operate when tested. The cause was not determined during the inspection. Recommend evaluation and repair by a qualified electrician.

Outlet located outside, on rear of garage

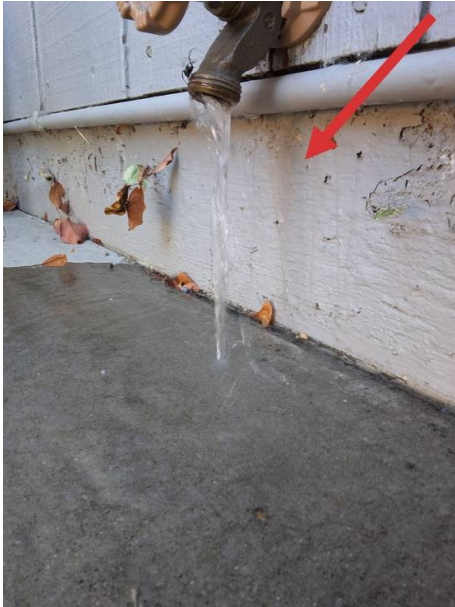
The hose bib was observed leaking when operated, with water appearing to discharge from behind the adjacent siding. The source and extent of the leak could not be determined during the inspection. Recommend evaluation and repair by a qualified plumbing professional.

Hose bib at north side of home

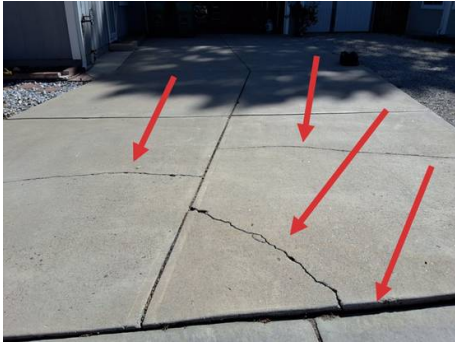
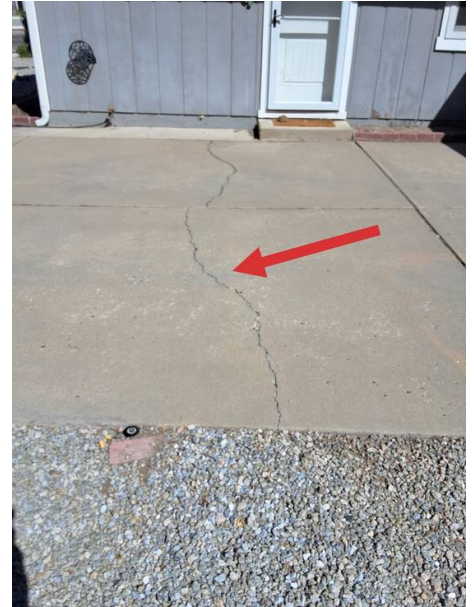
Cracking and localized settlement were observed at the concrete driveway. The cause of any underlying conditions can not be determined during the inspection. Recommend monitoring and repair as needed.

Front driveway

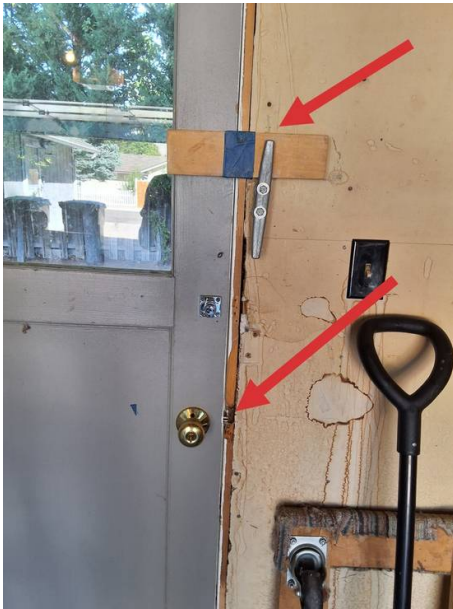
A door knob was not functioning properly at the time of inspection. Recommend evaluation and repair or replacement as needed.

Man door at rear of garage

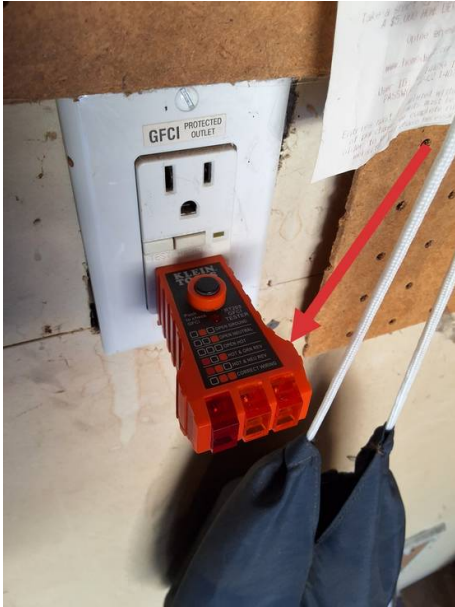
An electrical outlet did not operate when tested. The cause was not determined during the inspection. Recommend evaluation and repair by a qualified electrician.

Garage outlet on South wall

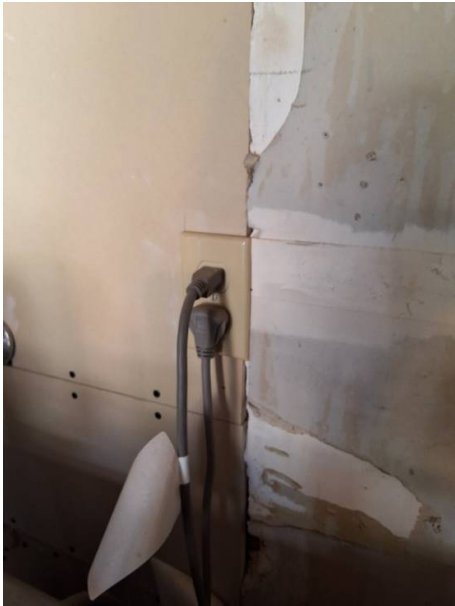
Non-GFCI circuit used near water source

Non-GFCI outlet behind washer/dryer in garage

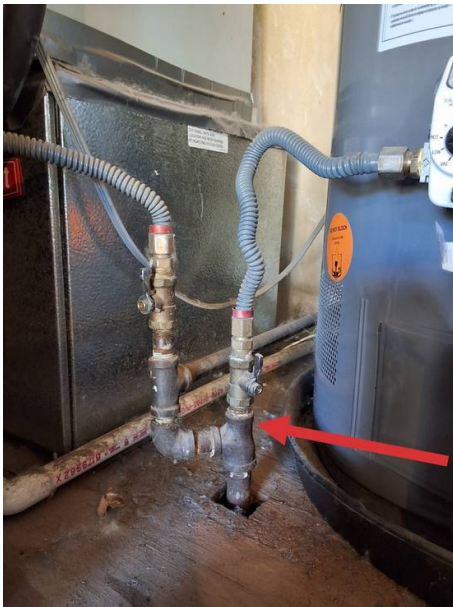
No sediment trap was observed on the gas supply line to the water heater. Recommend evaluation and correction by a qualified plumbing or gas professional

Gas supply line to water heater

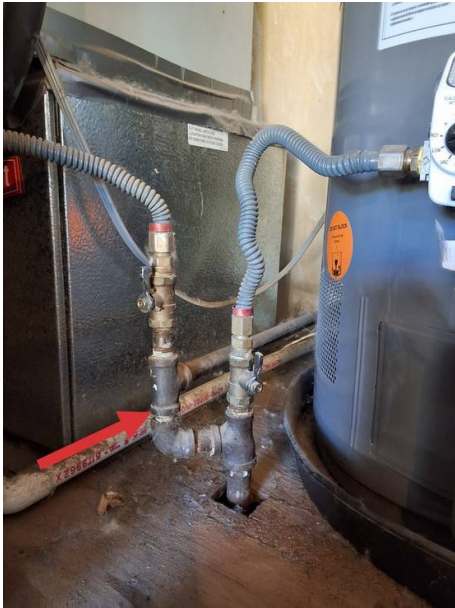
No sediment trap was observed on the gas supply line to the forced air unit. Recommend evaluation and correction by a qualified plumbing or gas professional.

Gas supply line to forced air unit

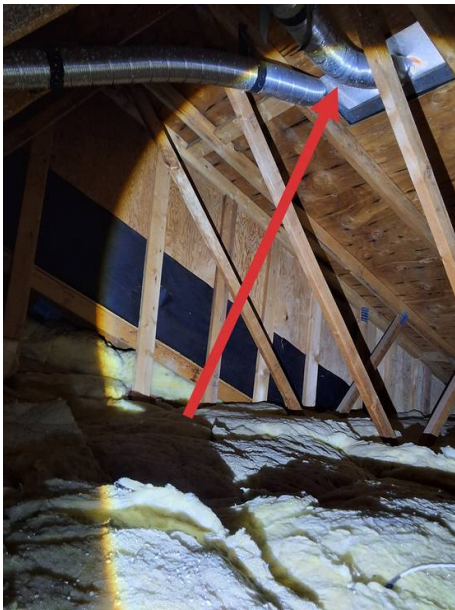
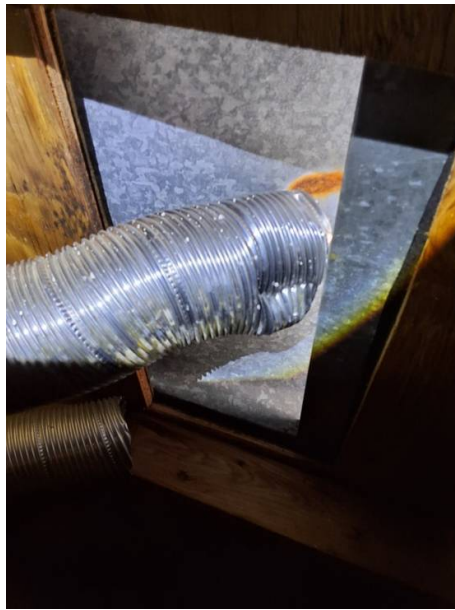
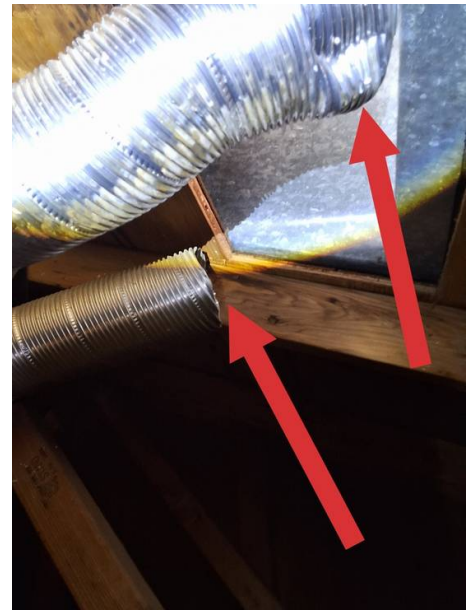
The bathroom exhaust vent was observed terminating in the attic and directed toward a roof vent, with noticeable rusting observed at the vent cover. Recommend correcting the vent termination and evaluating the affected area for moisture-related damage.

Bathroom vents terminatating in attic

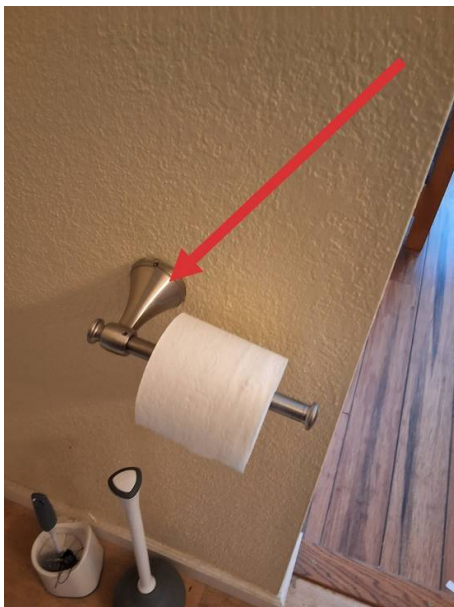
The toilet paper holder was loose at the time of inspection. Recommend securing the holder and repairing the mounting as needed.

Master bathroom

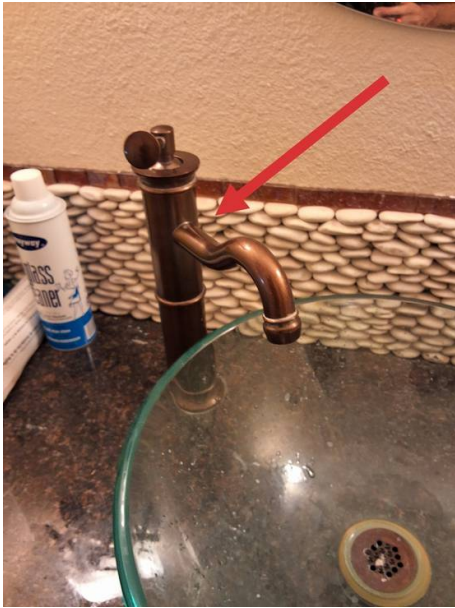
The bathroom sink faucet was loose at the time of inspection. Recommend securing the faucet and verifying proper

operation as needed.

Loose faucet at hallway bathroom.

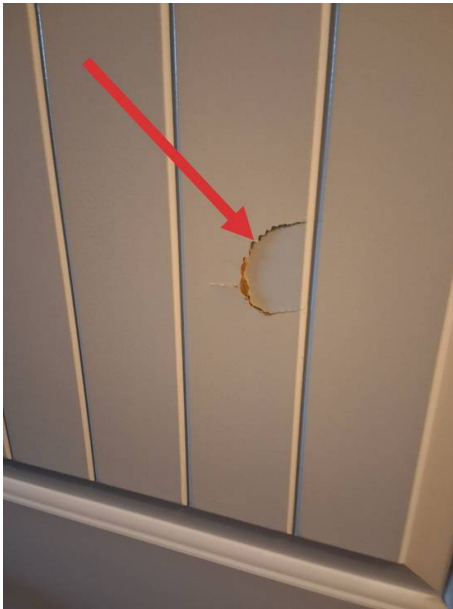
Damage was observed to the door face. Recommend repair or replacement as needed.

Hallway bedroom door

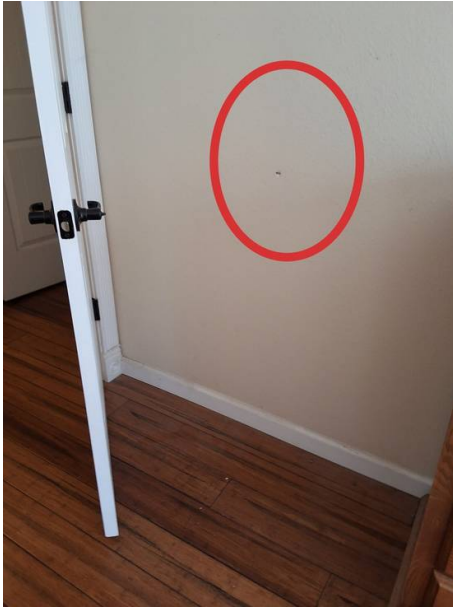
Door stops were not observed at the interior doors inspected. Recommend installation as needed to help prevent damage to doors and adjacent surfaces.

Wall damage due to non-present door stop in master bedroom

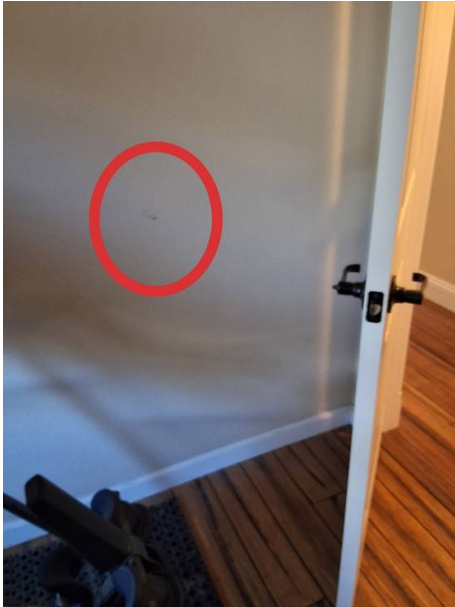
Wall damage due to non-present door stop in hallway bedroom

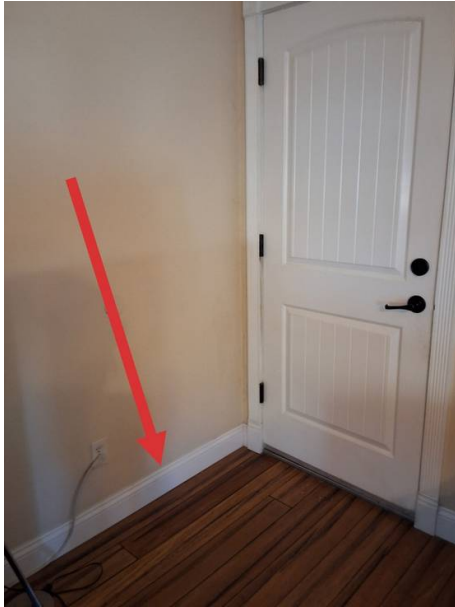
Missing door stop at garage man door

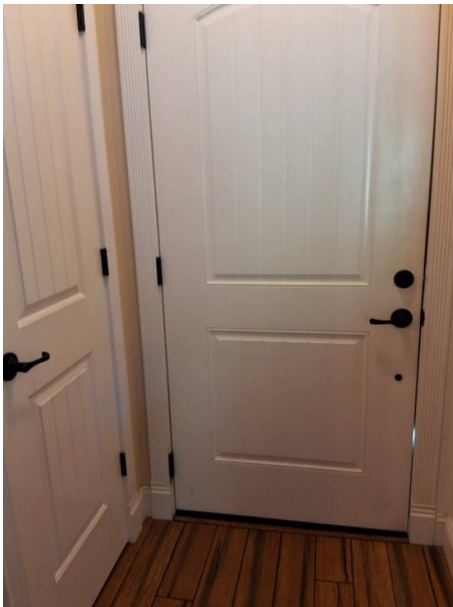
Missing door stops at entry and closet doors

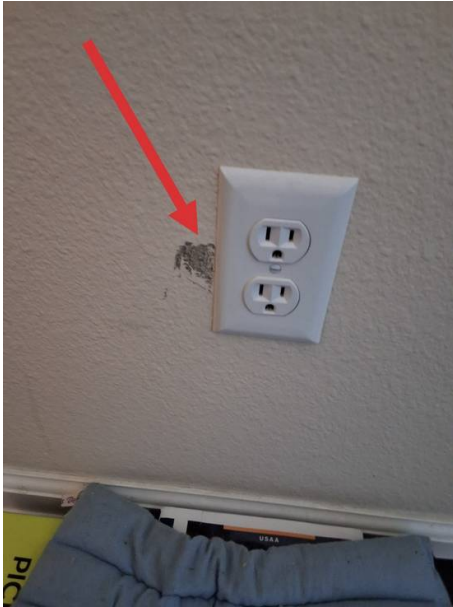
An area of drywall was observed to be damaged or improperly finished. Recommend repair as needed to restore the affected area.

Hallway bedroom

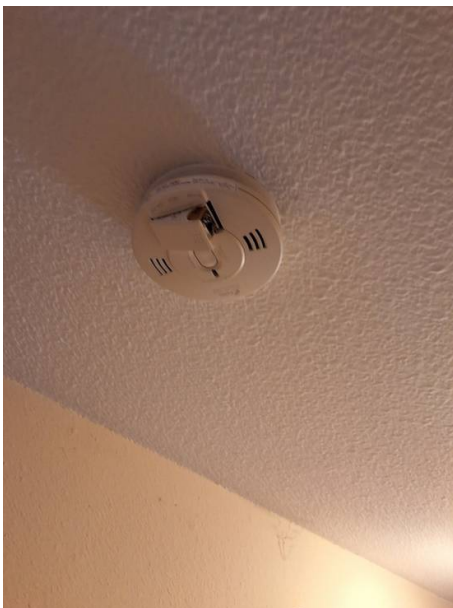
Proper battery installation and operation could not be verified. Recommend checking, servicing, and testing the detector as needed.

Smoke / Monoxide detector in hallway

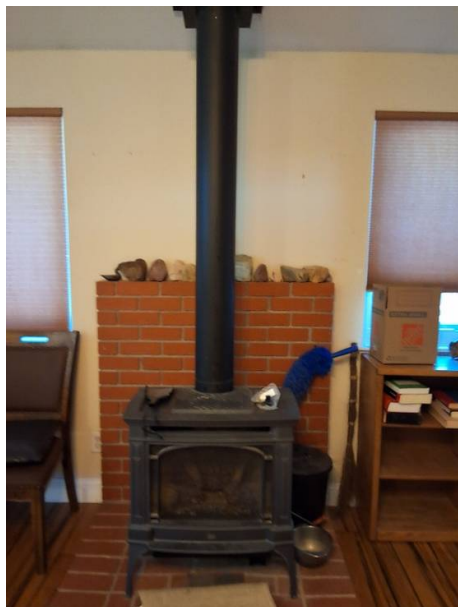
The gas supply to the fireplace was turned off at the time of inspection; therefore, the fireplace could not be tested. Recommend verifying proper operation after the gas supply is restored.

Gas fireplace in living room

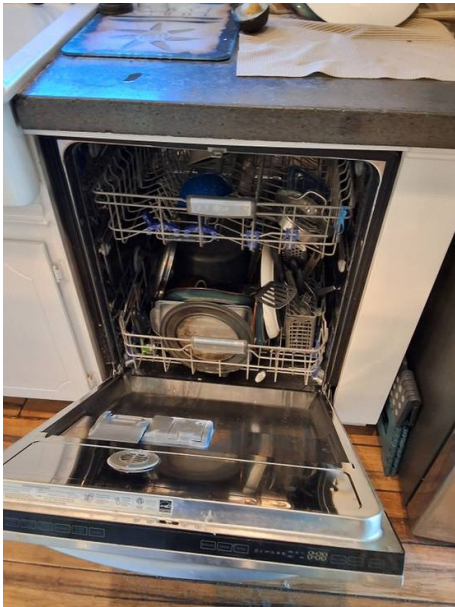
The dishwasher was full of dishes at the time of inspection and could not be operated. Proper operation was not verified. Recommend testing the dishwasher when accessible.

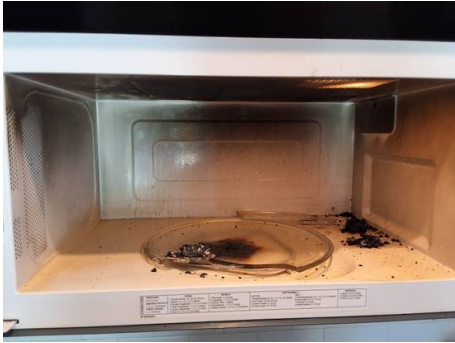
Microwave did not function at time of inspection. Recomend replacement.

Inside of microwave. Kitchen

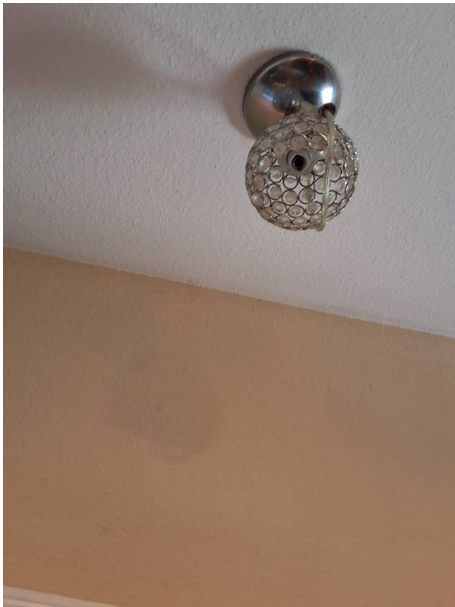
The light fixture over kitchen sink did not operate when tested. The cause was not determined during the inspection. Recommend evaluation and repair by a qualified electrician.

Light fixture over kitchen sink

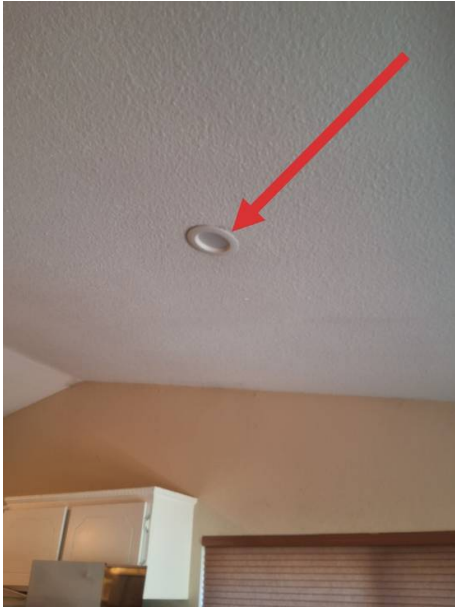
The dining room light fixture did not operate when tested. The cause was not determined during the inspection. Recommend evaluation and repair by a qualified electrician.

Light fixture in dinning area
