SEPTIC INSPECTION

Inspection Date: ***March 23, 2026***

Inspector's Name: ***Skyler C.***
Inspection Address: ***3000 Fischer Pl., Fallon, NV***
Inspection Requested By: ***Huckleberry Corp.***

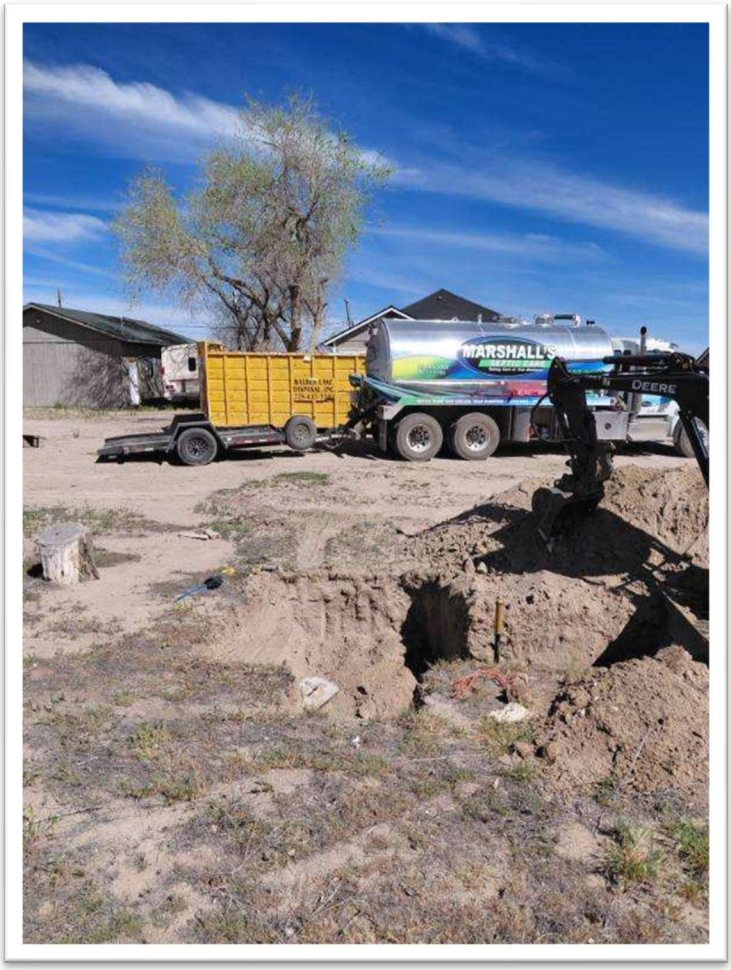
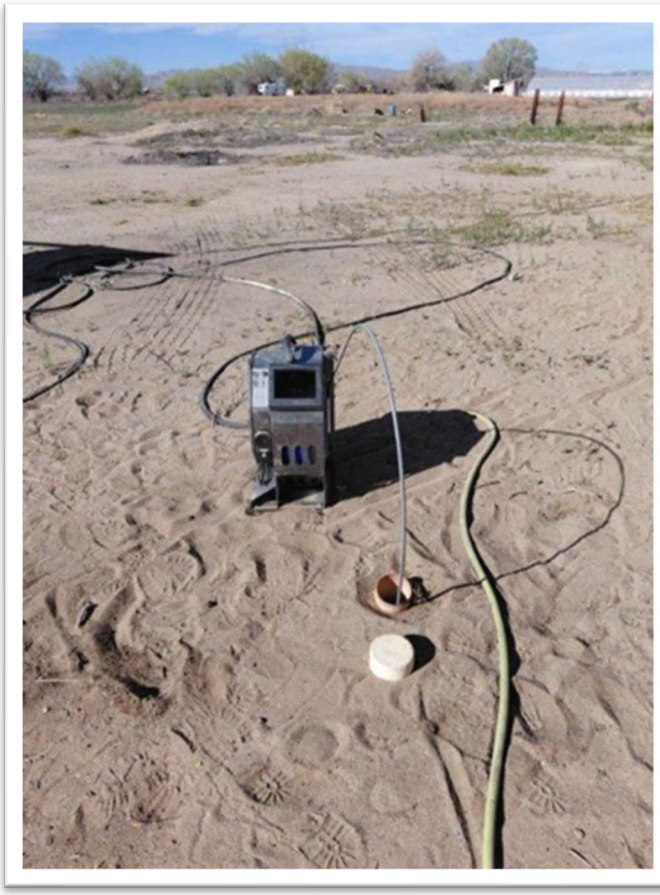
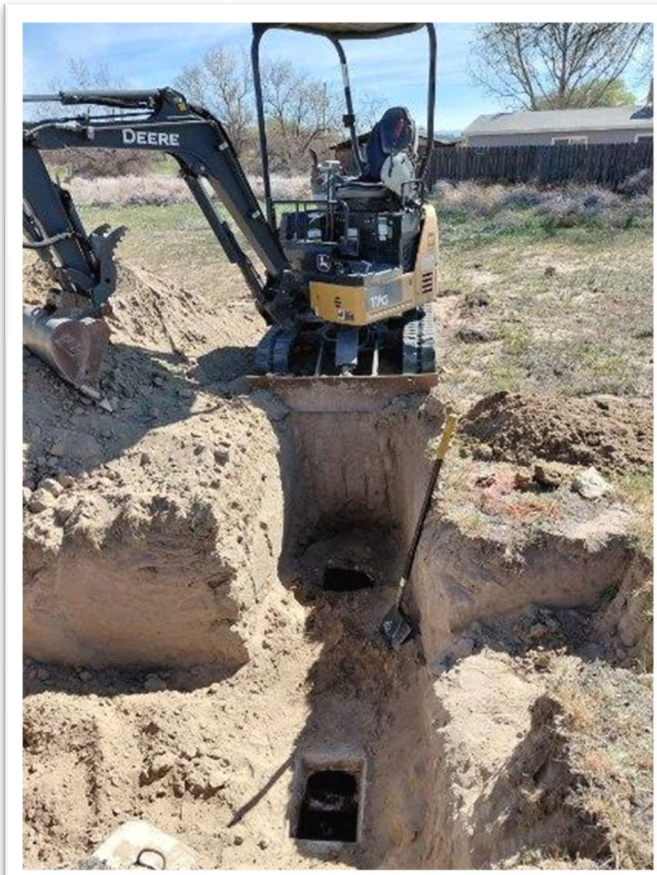
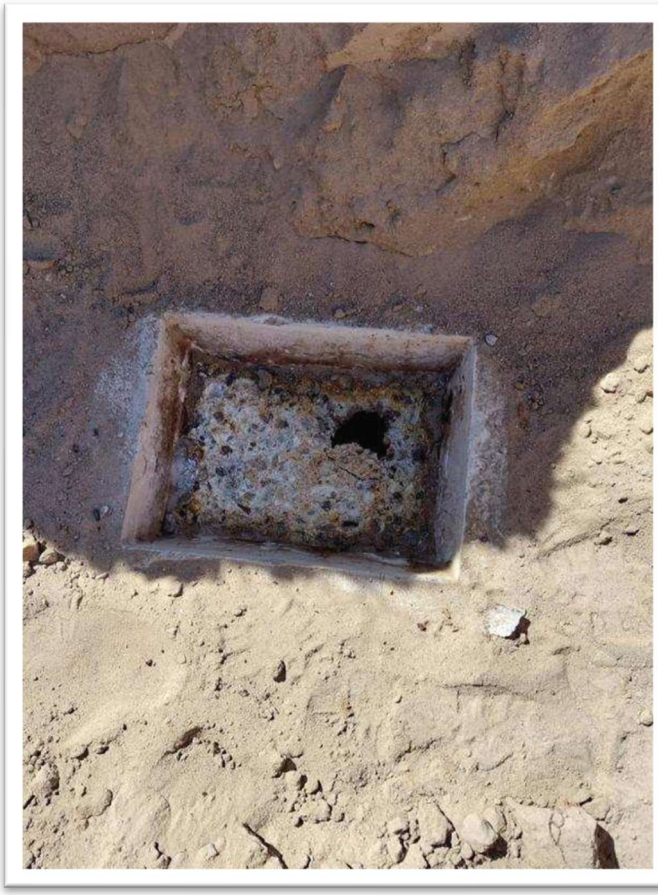
Septic Tank – The tank is in overall good condition with minor deterioration on the outlet side.
