RESIDENTIAL PROPERTY INSPECTION

6085 Quail Meadows Ct
Reno, NV 89519

Ginny Recanzone & Julie Langston
10/20/2026

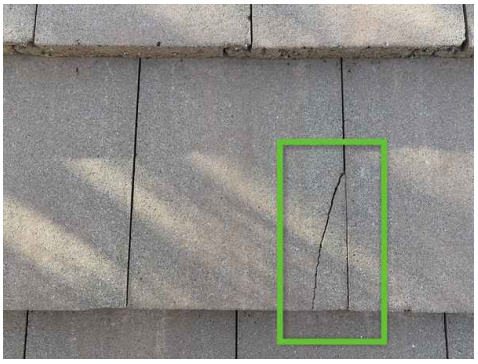
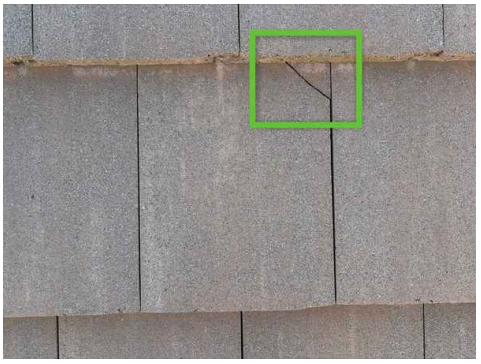
CRACKED TILES

One or more cracked roof tiles were observed, but they do not expose the underlayment. Recommend that these known faults be repaired by a licensed roofing contractor and, at that time, that the roof cover be evaluated for any additional needed repairs.

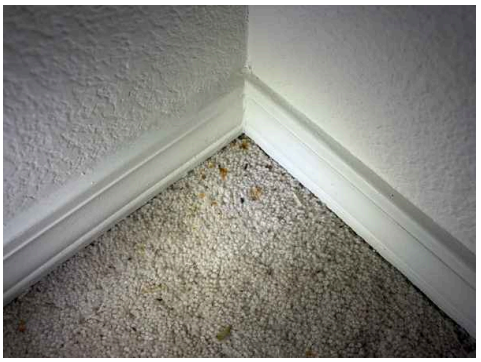
HALLWAY CLOSET, EAST BEDROOM CLOSET, MASTER BEDROOM

Evidence of rodent activity was identified at the referenced area(s) of the interior. Recommend a pest control company evaluate and treat as needed.

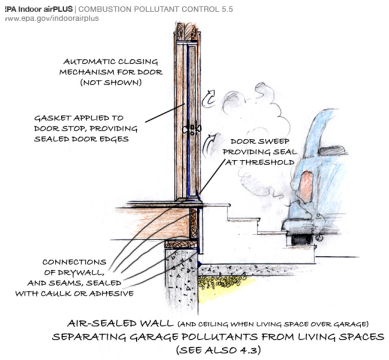
Garage Separation Door

SFTY - Current building standards for homes require "garage to living space separation". This separation helps to slow a garage-oriented fire and to help prevent carbon monoxide gases and other garage fumes from entering living areas. This is achieved by the installation of a fire-rated door between the garage and living areas, with proper weatherstripping, to prevent fumes leaking in. The walls and the ceiling (if living areas are overhead) require the installation of appropriate drywall or other materials to slow fire spread. No protrusions should be present on the area's walls and/or ceiling unless properly sealed with an approved fire-rated foam or sealant. The house should not be at a lower pressure than the garage (to prevent fumes from being drawn inside), which can result from exhaust fans, fireplaces/stoves, dryers and natural draft heating units and water heaters. **These items are recommended to be upgraded for safety if not present,** and a qualified contractor can be consulted for more information.

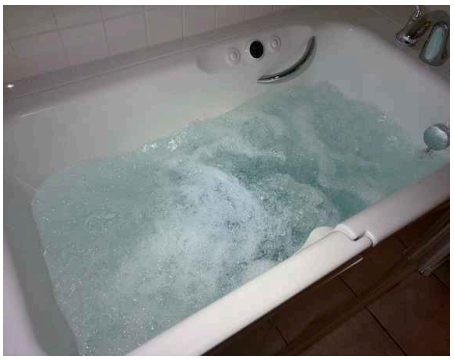
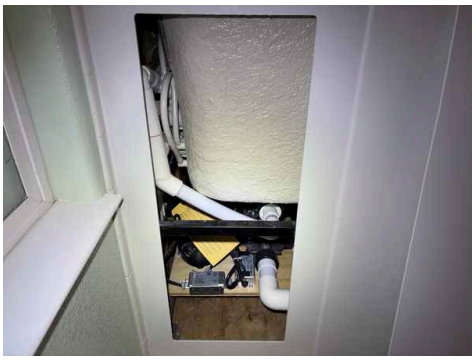
LMT - The walk-in tub was inspected by sealing the door and running water from the fixture to fill the tub. Leaks were inspected for as well as running the motor. The tub was then drained, checking for proper drainage. Heating and additional functions are not tested, and a plumbing contractor should be consulted as desired for more information on additional functions of walk-in tubs.

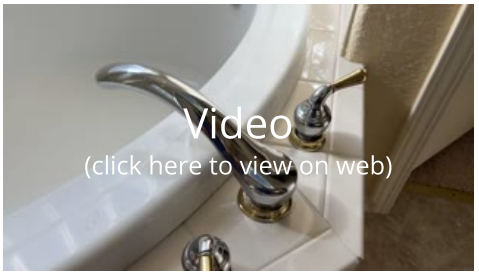
MASTER BATHROOM

The referenced bathtub spout was loose and should be secured and sealed against the surround surface by a qualified person.

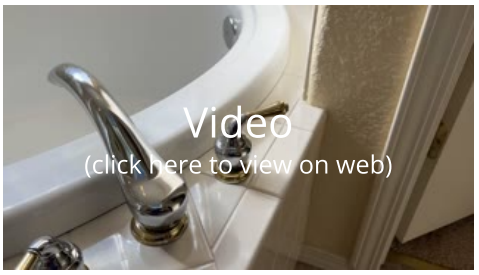
MASTER BATHROOM HOT SUPPLY HANDLE

The faucet valve handle was loose and not functional at the referenced bathtub. Recommend further evaluation and securement of the handle is recommended to be performed by a qualified person.

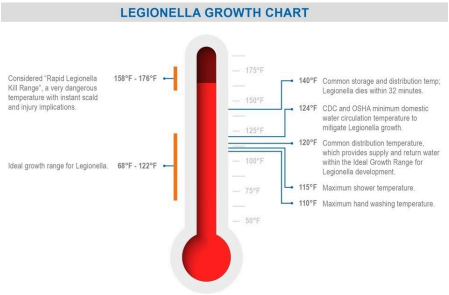
The maximum recommended water temperature produced at faucets in the home is 120 degrees due to the possibility of scalding at temperatures above this. But to prevent the formation of Legionellae bacteria in the water heater, tank temperatures are recommended to be kept between 135-140 degrees.

A tempering valve can allow for this combination, keeping water at faucets in the home to safe levels while keeping tank temperatures high enough to kill harmful bacteria.

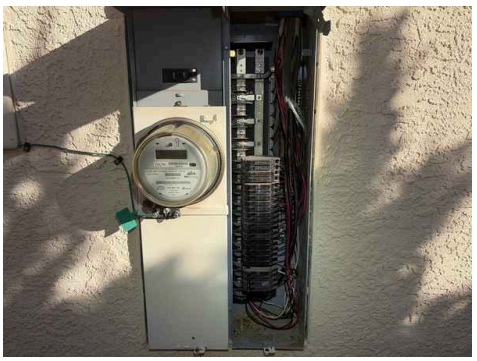
South Side of Structure

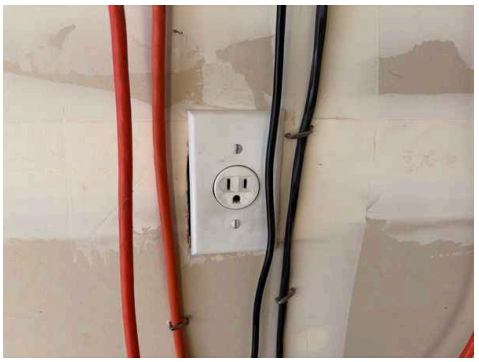
GARAGE SOUTH WALL

There were receptacle(s) present in the referenced area(s) that were not functional at the time of inspection. These may be associated with a "tripped" GFCI receptacle or an unfound switch, if so the tripped receptacle or switch was not found. Repairs or replacement as needed for proper operation is recommended to be performed by a licensed electrician.

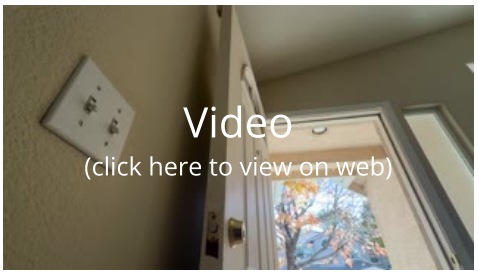
ENTRY

The referenced exterior light(s) were not functioning properly at the time of inspection. This could be as simple as a bad bulb. This could also be more extensive and represent a deficiency with the fixture, wiring, and/or switch. Repairs are recommended to be performed as needed for proper operation by a licensed electrician.

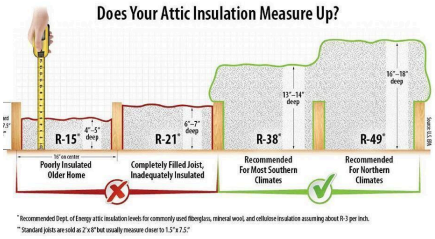
The insulation was inspected to determine the approximate depth and type. Current energy star standards recommend between 10-17 inches of insulation (dependent upon type) to achieve an R-38 rating. Depending on when the structure was constructed, anywhere from 6 - 14 inches may be present. No reportable deficiencies were observed with the insulation unless otherwise noted in this report.

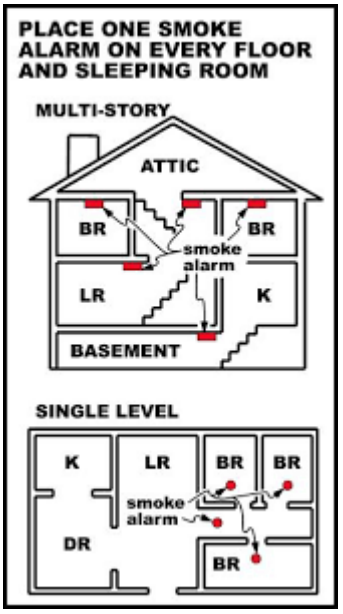
Smoke alarms are recommended to be installed in each sleeping room, outside of sleeping room(s), and one per level including habitable attics and basements. **I recommend replacing the batteries and testing the smoke alarms before spending your first night in the home.** Several other recommendations relating to smoke alarms and fire safety are recommended by the NFPA, and can be found here:

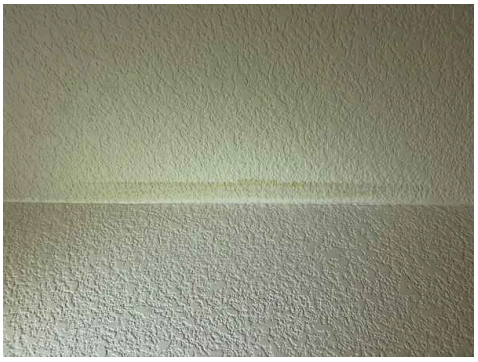
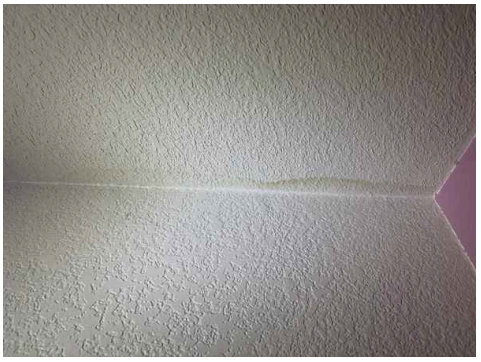
EAST BEDROOM CEILING & NORTH BEDROOM CEILING

Moisture stain(s) were present on the ceilings in the referenced areas. Although the area(s) were not damp at the time of inspection, hidden defects may exist and moisture stains should be viewed as active leaks until proven otherwise. I recommend inquiring with the sellers about the stains as they may have knowledge of why the stain is present, and what repairs were carried out to address it. If they are unsure of the stains, a roofing contractor is recommended to evaluate and make repairs as needed. Painting and/or repairs as needed to the area(s) of the staining is recommended to be conducted by a qualified person.

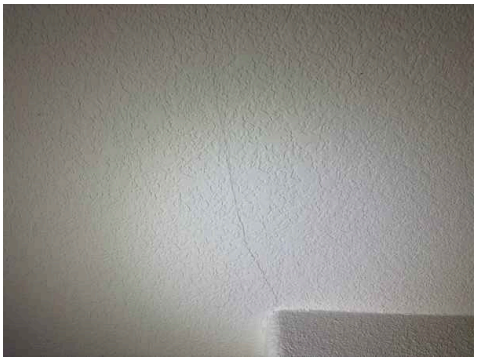
LIVING ROOM CEILING & NORTH BEDROOM CEILING

LMT - There was cracking present on the referenced wall(s) and/or ceiling(s), and no attributable conditions were observed with visible portions of the floor structure or foundation in these area(s) at the time of inspection. I can only report on the visible conditions of these items as they existed at the time of inspection, as I do not know how long they have been in this condition, or if any further movement could occur. I recommend consulting with the seller(s) as to any information regarding the indications of settlement or movement. If concern still exists, the evaluation and guidance of a licensed contractor or engineer is recommended. *****Please read the Indications of Movement/Settlement Limitations at the top of this section of the report.***
