## SELLER'S REAL PROPERTY DISCLOSURE FORM

Property Address: 8605 Eaglesnest Rd Sparks NV 89436

## Sparks, Nevada 89436

Prepared exclusively for:  
Mike Fredenburg

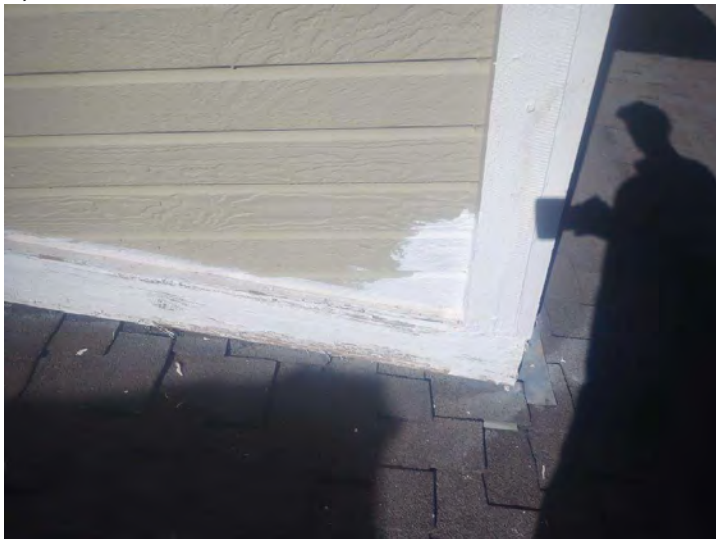
1. ☐☐☐☒☐ Type: Pressed wood/ Composite/Manufactured siding - Painting the exterior in the near future may prevent weathering of the siding. Small gaps and thin or flaking paint noted in spot locations and between panel seams. Ongoing paint repair appears in progress. Material appears otherwise intact.

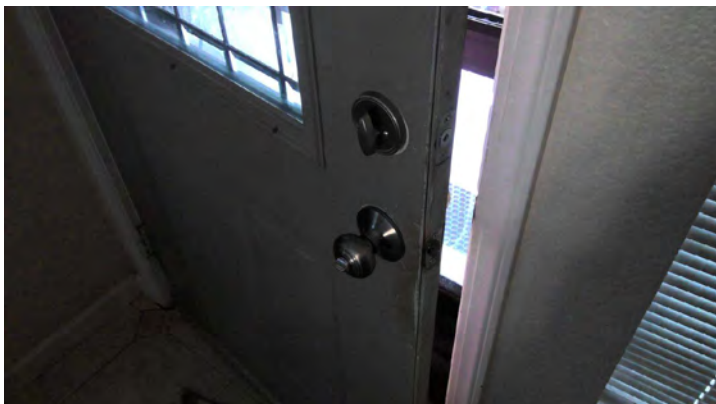
2. ☒ ☐ ☐ ☐ ☐ Trim: Wood
3. ☒ ☐ ☐ ☐ ☐ Fascia: Wood
4. ☒ ☐ ☐ ☐ ☐ Soffits: Plywood with exposed framing
5. ☒ ☐ ☐ ☐ ☐ Door Bell: Hard wired
6. ☐ ☐ ☐ ☒ ☐ Entry Doors: Metal and Wood, Wood with glass - [Adjustment of the entry door striker may improve ease of closure.](#)

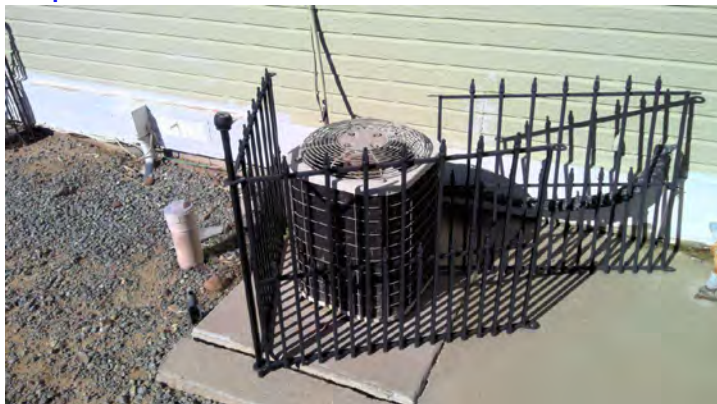
1. ☐ ☐ ☐ ☒ ☐ A/C System Operation: Due to temperatures below 65 degrees the unit was not fully tested. The inspector visually inspected the unit only. Full operation in cold temperatures may result in damage. Further information may be provided by a licensed HVAC tech. **Though the 2000MFD unit appears otherwise operational at the time of inspection, select components may be nearing the end of their expected service lives. The opinion of a qualified HVAC tech is recommended to determine the longevity of the system. R-22 refrigerant may no longer be serviceable.**

**Yearly service of the MFD:2020 unit by a qualified HVAC tech is recommended as part of regular up keep and for additional maintenance recommendations.**

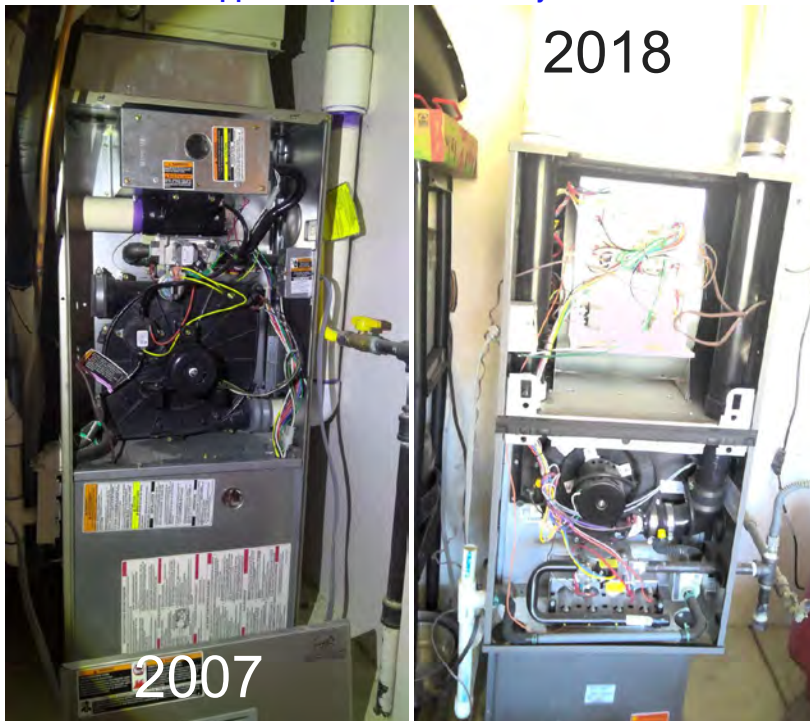
1. Area Served: Whole building Service Record No service records have been provided
2. Fuel Type: Propane gas
3. ☐☐☐☒☐ Heat Exchanger: Visually Restricted - MFD:2007 produced a hum/buzz in standby mode. Clearance between flue and roofing is minimal. Due to no record of cleaning or service within the past 24 months it is recommended the unit be serviced by a licensed HVAC tech as part of regular maintenance. Unit remains functional at the time of inspection.

MFD:2018 unit appears operational. Yearly service is recommended as part of routine up keep.

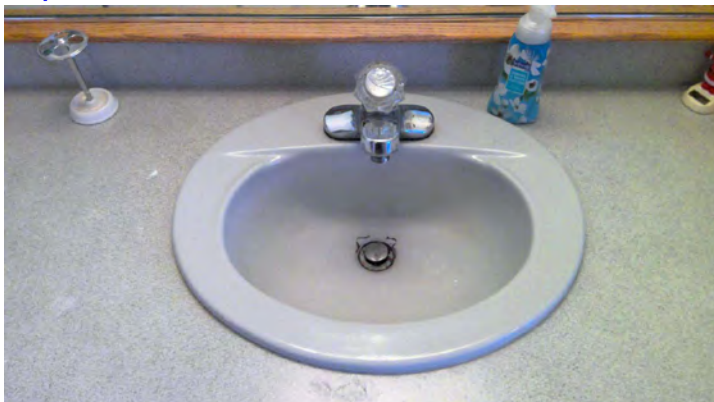
34. ☒ ☐ ☐ ☐ ☐ Windows: Metal Sliding Frame  
35. ☒ ☐ ☐ ☐ ☐ Electrical: 120 VAC GFCI  
36. ☒ ☐ ☐ ☐ ☐ Counter/Cabinet: Laminate and wood  
37. ☐ ☐ ☐ ☒ ☐ Sink/Basin: Pressed/Coated Metal - 2nd floor guest bathroom sink bowl is chipped. Sealing the chip is recommended.

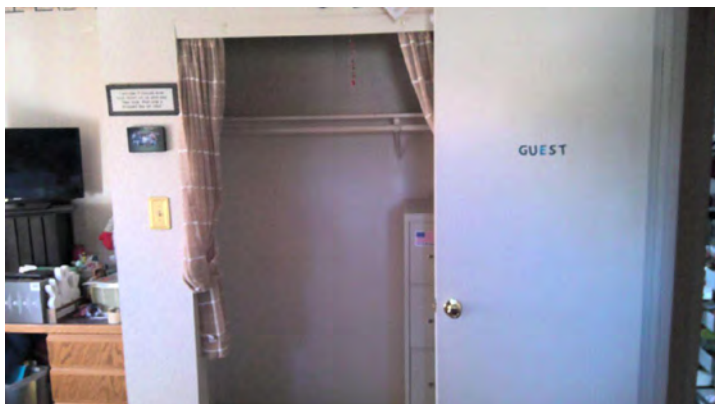
11. ☐ ☐ ☐ ☒ ☐ Closet: Single - **2nd floor left guest bedroom closet doors are missing. Replacement could be considered.**

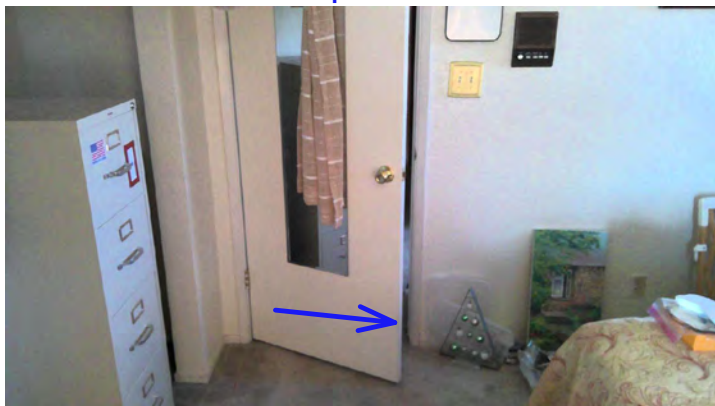
15. ☐ ☐ ☐ ☒ ☐ Doors: Hollow wood - 2nd floor left guest bedroom door strikes the wall. Wall is damaged. Repair and addition of a door stop is recommended.
