EAGLE ROCK INSPECTIONS

## RESIDENTIAL PROPERTY INSPECTION

3293 Belford Rd  
Reno, NV 89509

Dawn Koerner  
07/28/2026

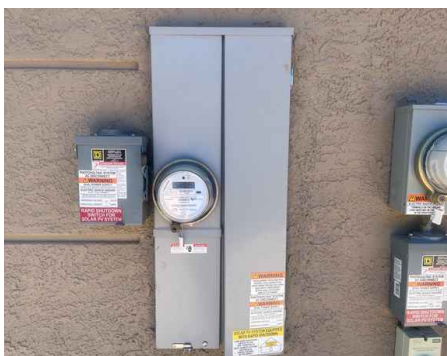
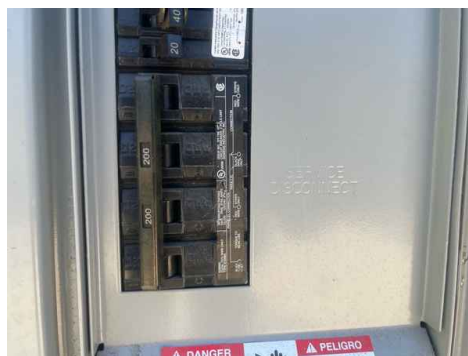
East Side of Structure

The pictured electrical service disconnect will shut off all power to the home in the case of an emergency, or for servicing.

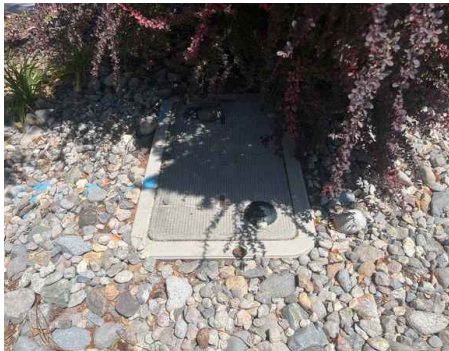
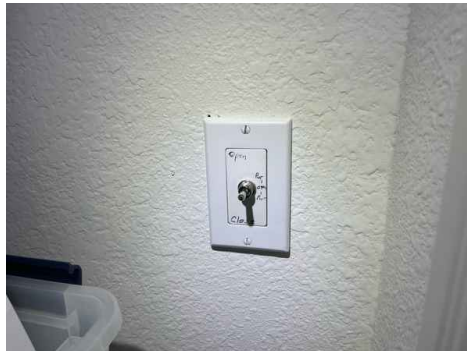
West Corner of Front Yard, Office Closet

The pictured water shutoff valve will shut off the water supply in the home in the case of an emergency, or for servicing.

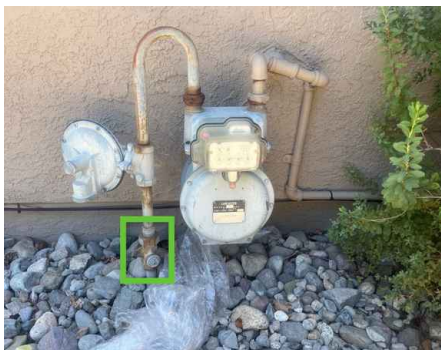
East Side of Structure

The pictured main gas shutoff valve will shut off the gas supply to the home in the case of an emergency, or for servicing.

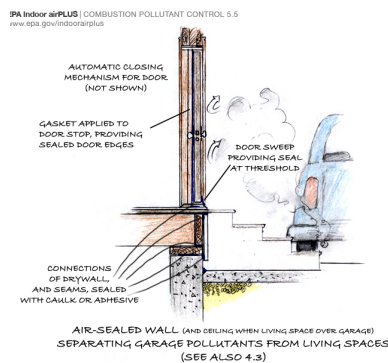
Garage Separation Door

**SFTY** - Current building standards for homes require "garage to living space separation". This separation helps to slow a garage-oriented fire and to help prevent carbon monoxide gases and other garage fumes from entering living areas. This is achieved by the installation of a fire-rated door between the garage and living areas, with proper weatherstripping, to prevent fumes leaking in. The walls and the ceiling (if living areas are overhead) require the installation of appropriate drywall or other materials to slow fire spread. No protrusions should be present on the area's walls and/or ceiling unless properly sealed with an approved fire-rated foam or sealant. The house should not be at a lower pressure than the garage (to prevent fumes from being drawn inside), which can result from exhaust fans, fireplaces/stoves, dryers and natural draft heating units and water heaters. **These items are recommended to be upgraded for safety if not present**, and a qualified contractor can be consulted for more information.

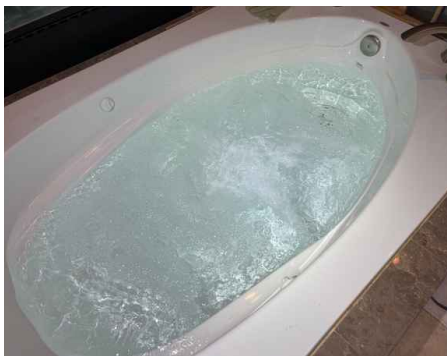
Master Bathroom

The jetted tub was inspected by filling the tub with water to a level above the ports, and then initiating the motor to check that the motor was functional. The tub was then drained to check for leaks and/or damage or cracking in the tub. No significant deficiencies or leaks were observed at visible portions, at the time of inspection, unless otherwise noted in this report.

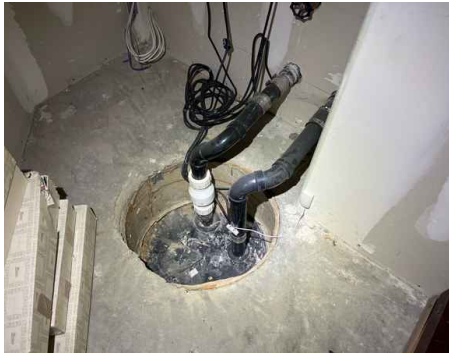
There is a sewage ejector pump installed in the basement. The pump appeared to function properly, but the sealed system was not opened or fully assessed for function or efficiency, which would require a licensed plumber, as would evaluation of pump back flow valves, discharge pipes or other features.

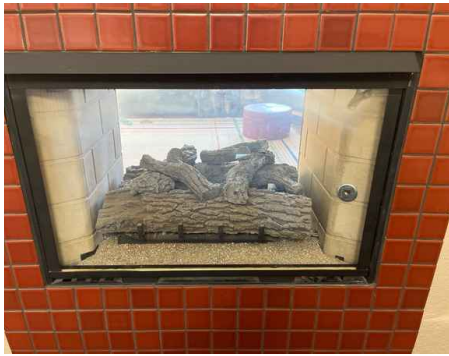
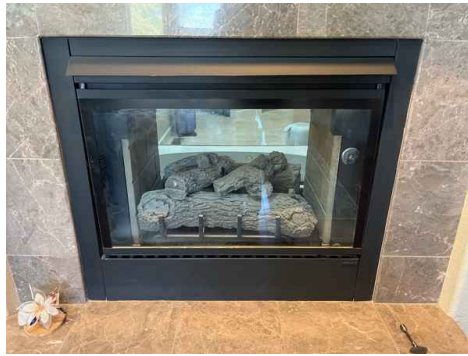
Living Room & Master Bedroom

There was a gas-fired fireplace with a standing pilot flame ignition. Circulation fan was not installed. A fan, to circulate heated air into the room may be possible to be installed.

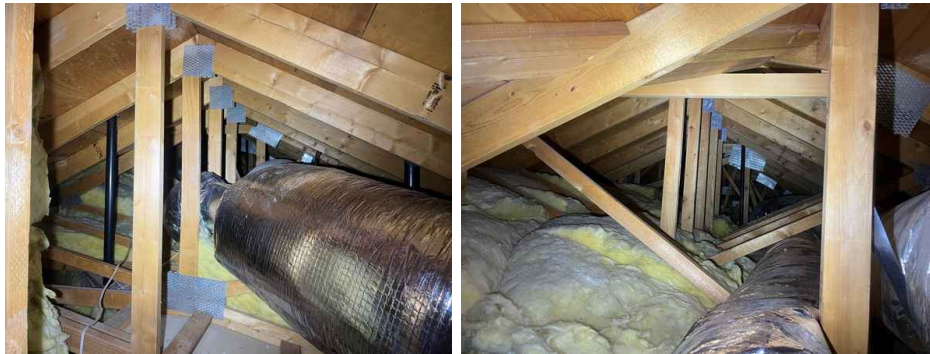
The roof structure was inspected at visible portions looking for any signs of moisture infiltration, damage, or other deficiencies. No reportable conditions or indications of past or present leaks were observed at the time of inspection unless otherwise noted in this report.

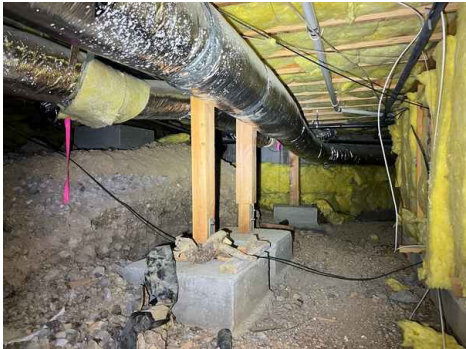
**LMT** - Insulation was present between the floor joists/trusses. This insulation obscured the visual accessibility of the subfloor, as well as most portions of the floor structure (joists, etc.). Portions of the plumbing, wiring, and HVAC ductwork, as applicable, are also typically partially covered. This insulation is not moved or manipulated in any way to observe hidden components. The possibility of hidden defects exists in areas that were not visible.

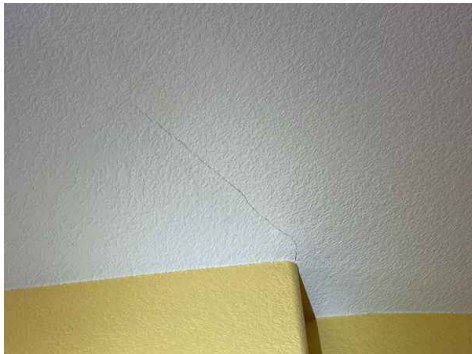
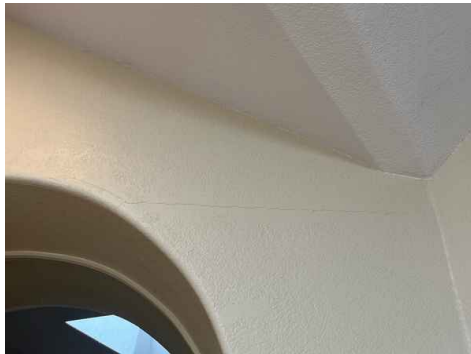
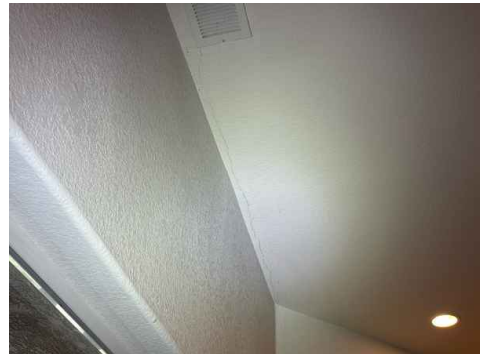
## 20.4.1 Interior Areas - CSM

### MOVEMENT/SETTLEMENT - NO OBSERVABLE CAUSE
