# Inspection Report

2987 Del Rio Ln  
Minden NV 89423

## Clear Choice Home Inspection Services

| <b>Date:</b> 9/7/2026 | <b>Time:</b> 09:00 AM | <b>Report ID:</b> SPA298 |

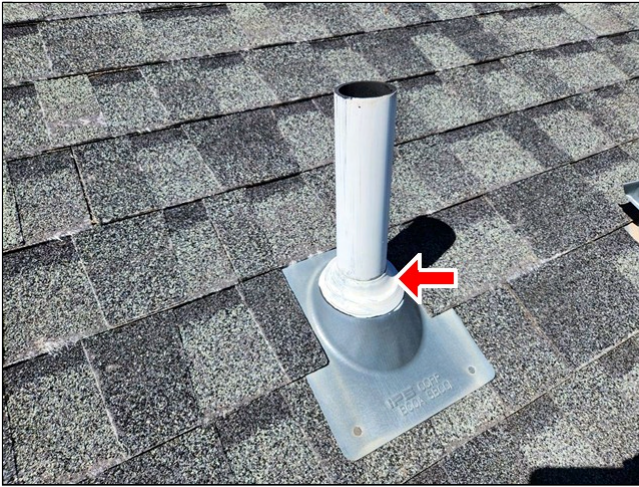
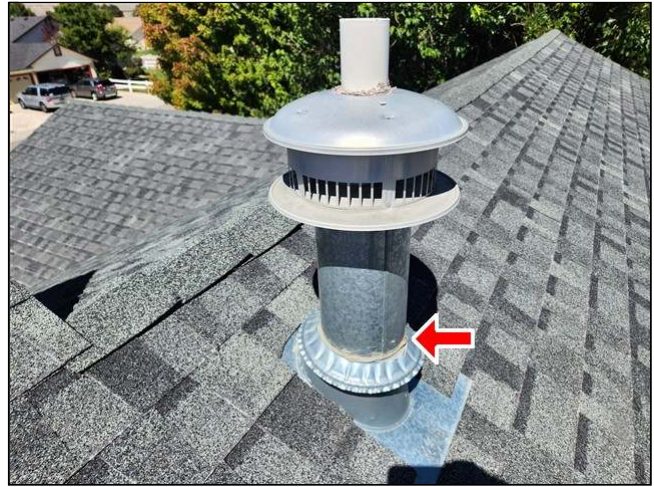
Plumbing and furnace vent pipes are sealed well against flashings to prevent moisture intrusion into attic framing areas.

2.3 Item 1(Picture) Plumbing and furnace vent pipes are sealed well

2.3 Item 2(Picture) Plumbing and furnace vent pipes are sealed well

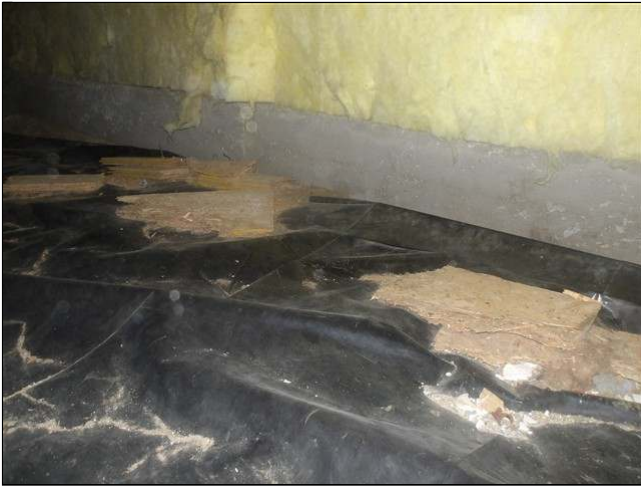
- (3) Construction debris (and/or trash) should be removed from the crawlspace area under the master bathroom.

3.2 Item 1(Picture) Construction debris (and/or trash) should be removed

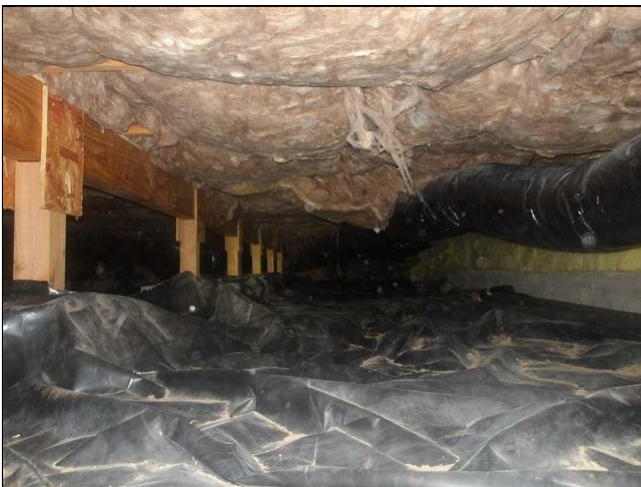
NOTE: Subfloor area is NOT visually accessible for inspection, due to installation of floor insulation between the floor joists. Moisture Vulnerable areas such as adjacent to plumbing drain pipes, and exterior subfloor edges, were viewed by pulling back insulation. No obvious problems noted at time of inspection.

3.6 Item 1(Picture) due to subfloor insulation

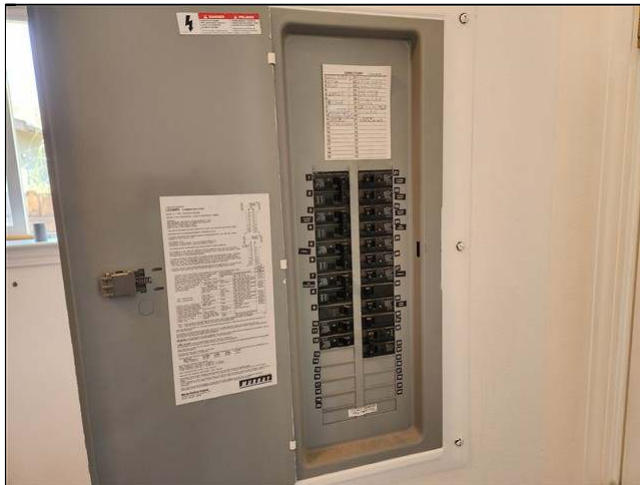
The Main and Distribution Panels are well labeled for circuit identification. "Dead front" cover appears serviceable. No problems noted.

4.1 Item 1(Picture) laundry room panel

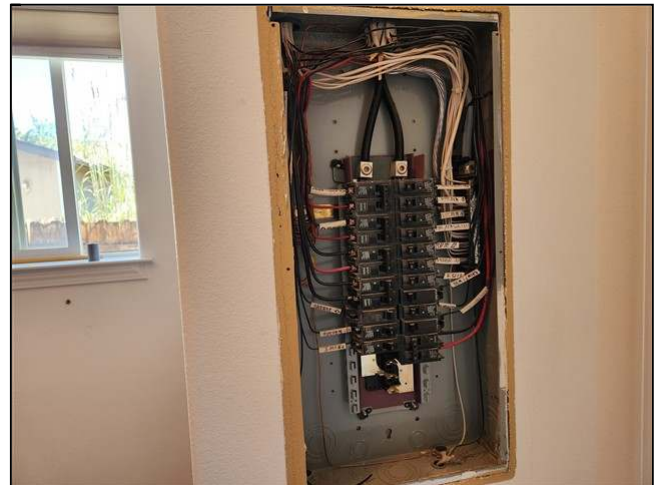
4.1 Item 2(Picture) panel conductors

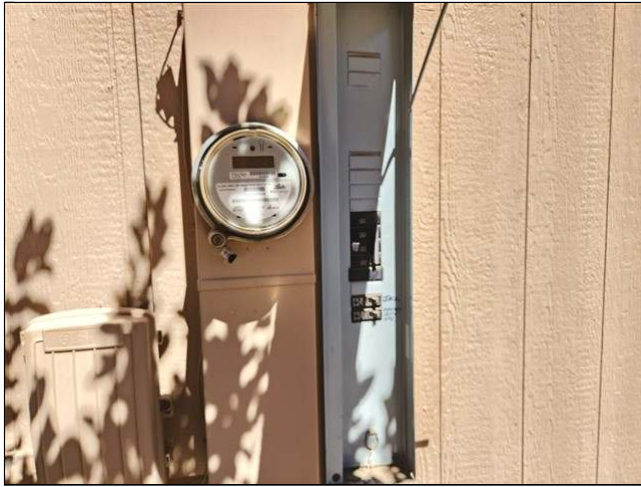
4.1 Item 3(Picture) main electrical panel

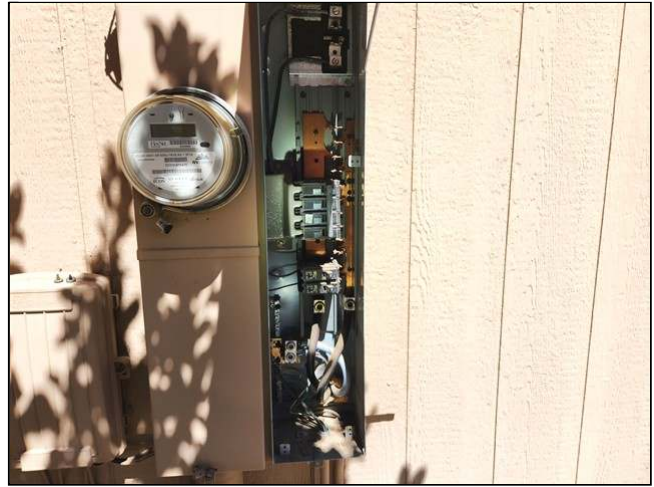
4.1 Item 4(Picture) main panel conductors

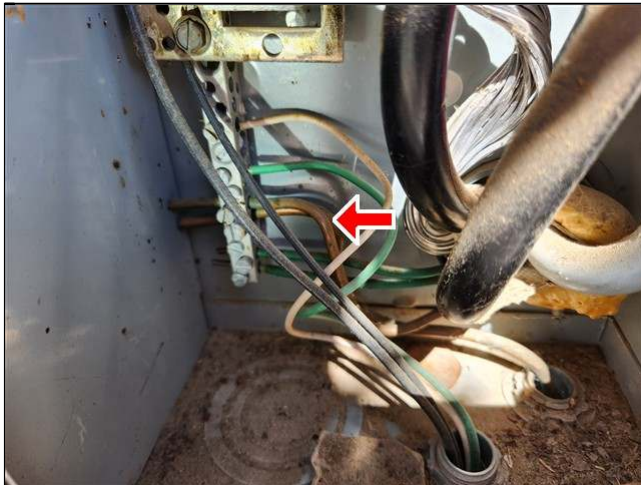
The Grounding system for the Main Service Panel is not visible due to construction materials. However, there is a Grounding wire present in the Panel, which is important for proper grounding (safety) of the home... A ground wire to grounding rod is present.

4.3 Item 1(Picture) grounding wire inside main panel

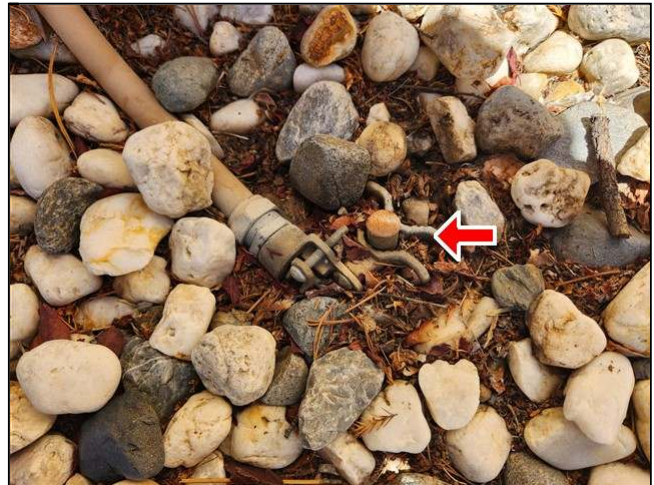
4.3 Item 2(Picture) grounding rod and clamp

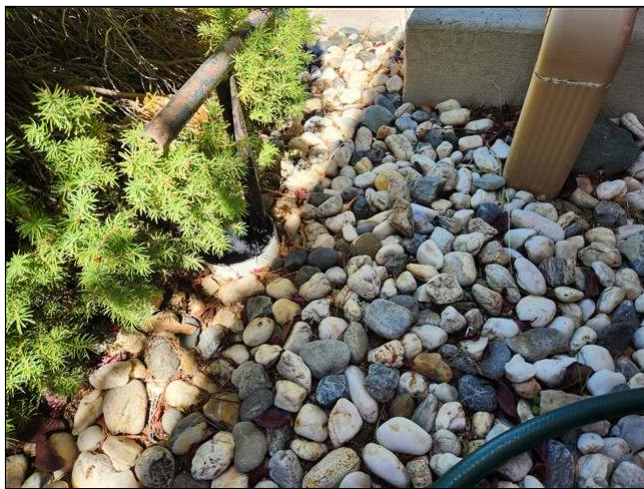
There are a couple main water shut-off locations. With the water meter at front of property (for emergencies), and at front yard to right of entry. Note: Both of these locations will require a water key tool to operate.

5.0 Item 1(Picture) main water shut-off valve location

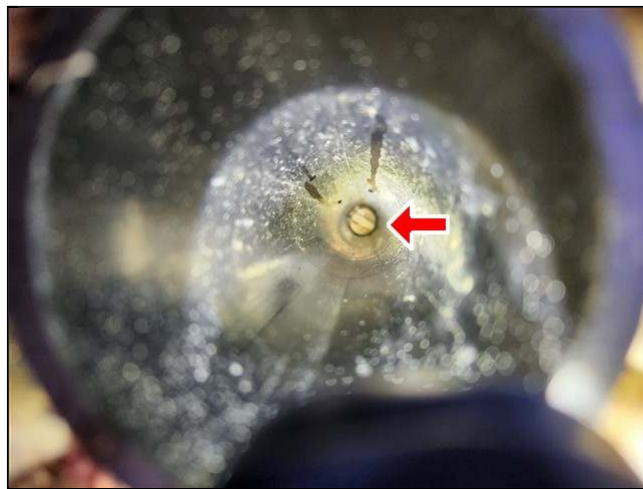
5.0 Item 2(Picture) main water shut-off valve

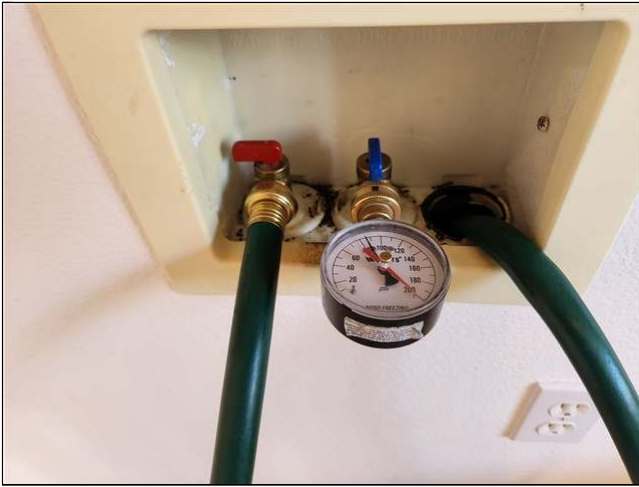
The water pressure was tested at the Laundry room connections, pressure was 85 psi at time of inspection.

5.2 Item 1(Picture) water pressure at laundry connections

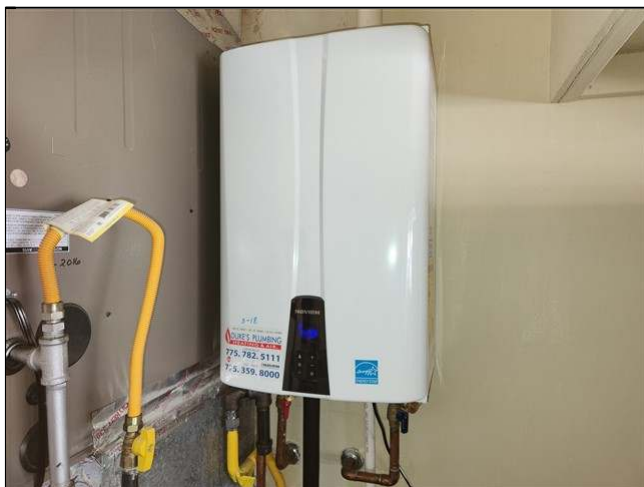
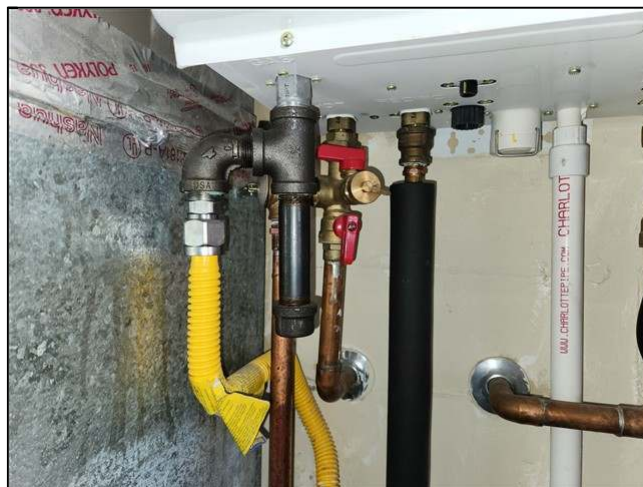
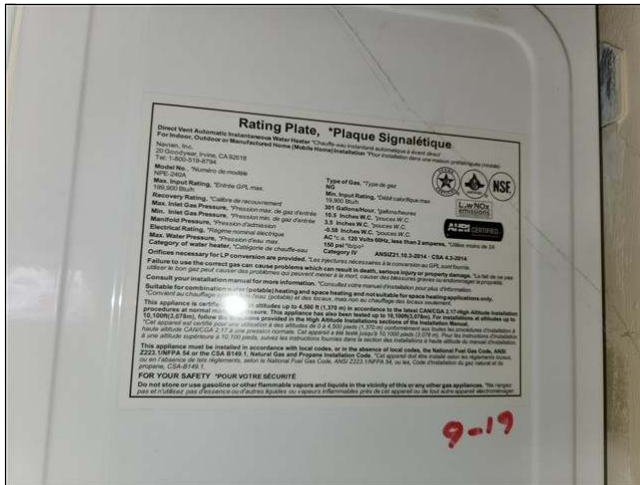
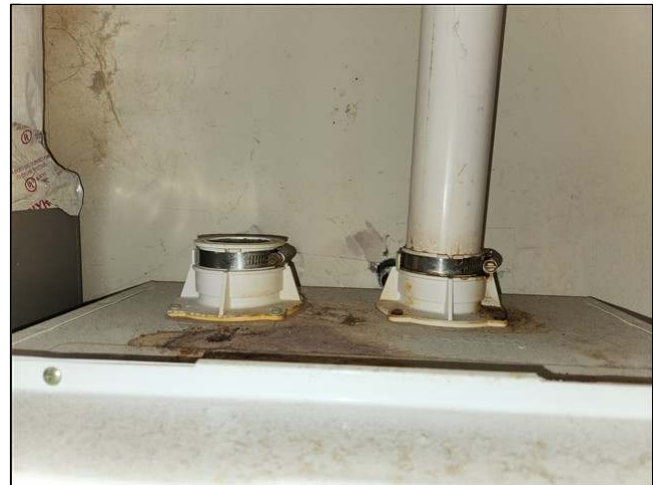
The home uses an on-demand, tankless, gas fired water heater for the whole house hot water supply, located in the garage. Unit operated as intended with no leaks or abnormal noises noted at time of inspection. Water temperature control is located at the front cover housing of the w/h unit. Manufactured in 2018 by Navien.

5.4 Item 1(Picture) on demand water heater

5.4 Item 2(Picture) water heater hookups

5.4 Item 3(Picture) manufacturer's label

5.4 Item 4(Picture) combustion air and exhaust pipes

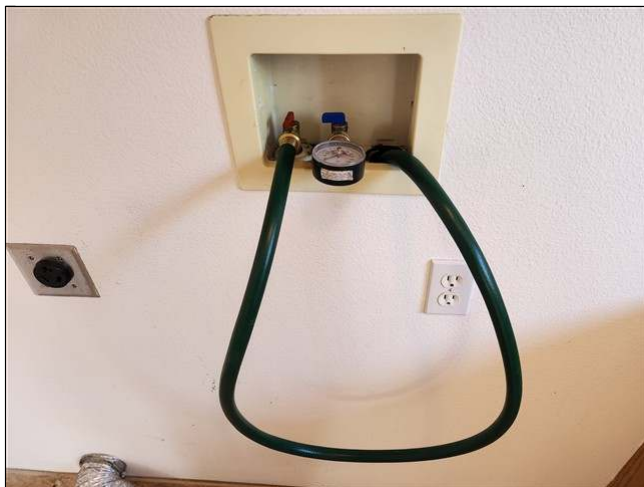
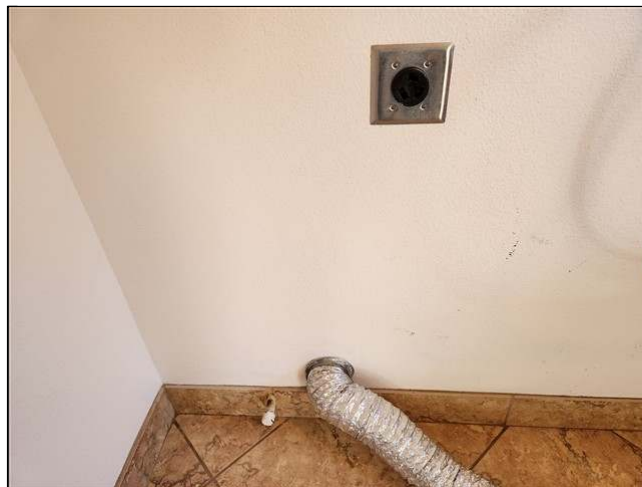
Washer and dryer hook-ups were inspected, with no problems noted. Dryer is electric or gas powered with rigid metal venting installed in the crawlspace. Washer drain is 2" diameter, Hot and Cold hook-ups with no problems noted.

5.6 Item 1(Picture) checking laundry valves and drain

5.6 Item 2(Picture) laundry hookups

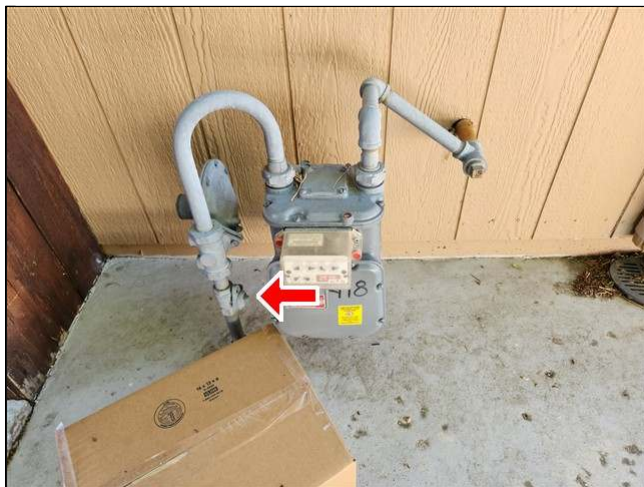
Located at the North side of the house with the gas meter. No problems noted.

5.11 Item 1(Picture) main gas shut-off valve

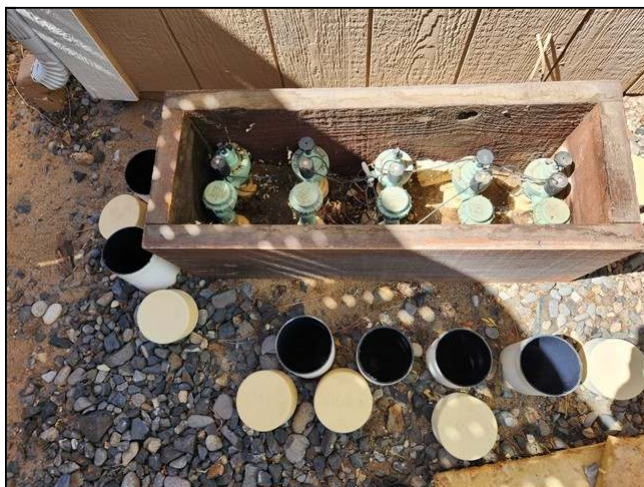
Sprinkler system inspection is beyond the scope of this Home Inspection. Irrigation boxes were opened and inspected for damage and/or major water leaks. No obvious problems noted at time of inspection.

5.13 Item 1(Picture) irrigation box/valves

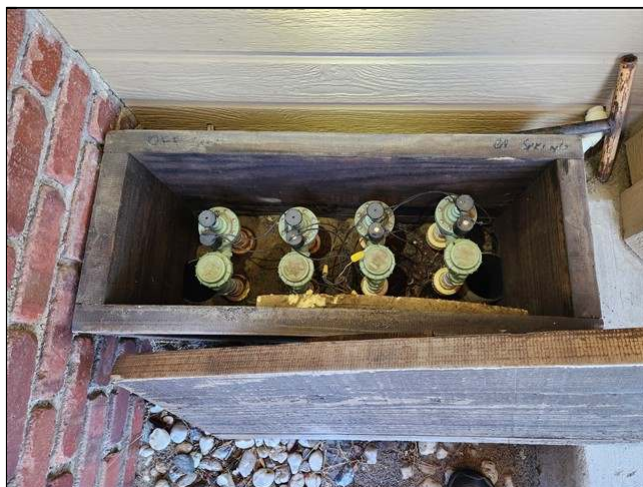
5.13 Item 2(Picture) irrigation box/valves

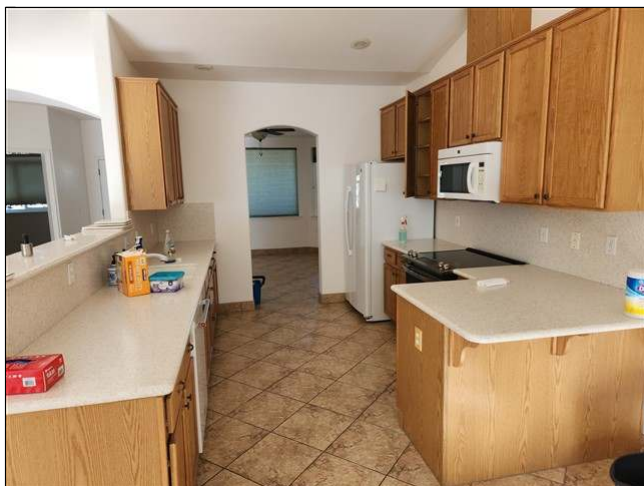
6.0 Item 1(Picture) view of kitchen

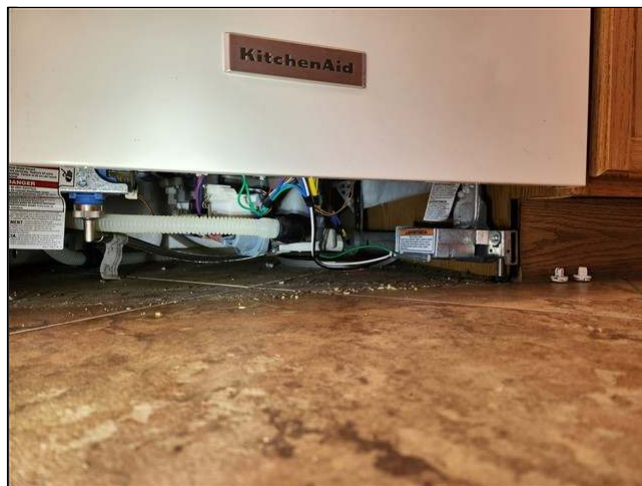
6.0 Item 2(Picture) dishwasher hookups

The Dishwasher was run through a complete cycle, with no leaks or abnormal noises noted. Inspection cover was removed to view the Dishwasher electric/plumbing hook-ups, Door seals and dish racks appear in serviceable condition. Mounted securely to under countertop. Drain hose is routed to a high loop prior to connecting to drain, as required to prevent backflow/siphon of waste into dishwasher.

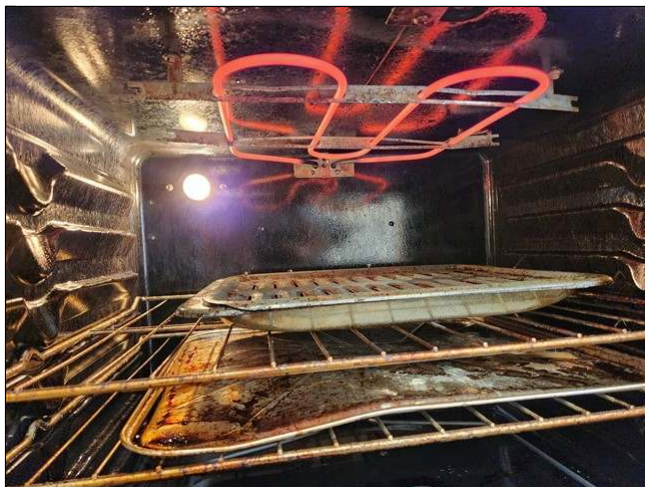
The Electric Range and Oven was inspected at all heating elements and settings. No problems noted at time of inspection.

6.2 Item 1(Picture) range oven broiler element

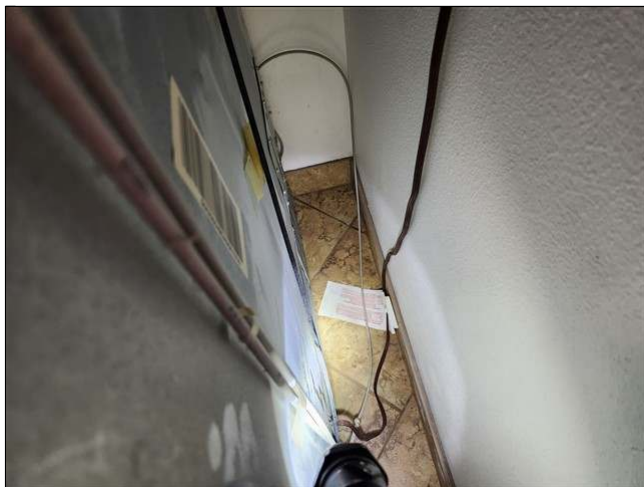
Refrigerator was operating at time of inspection. Door seals appear to be in good condition. The Fridge and Freezer temperatures were 44 and 16 degrees respectively at time of inspection.

6.6 Item 1(Picture) behind refrigerator

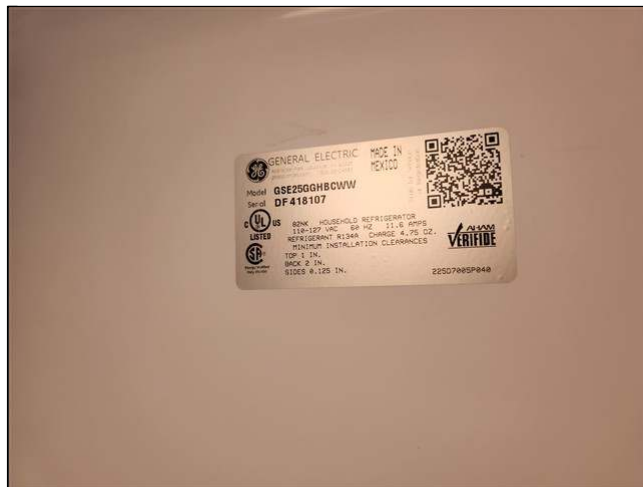
6.6 Item 2(Picture) manufacturer's label

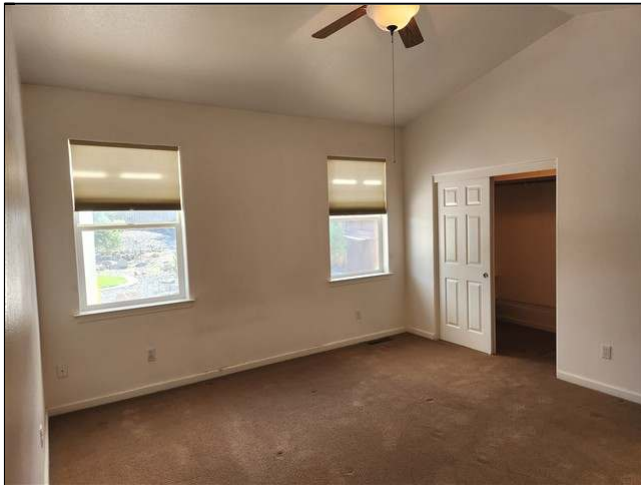
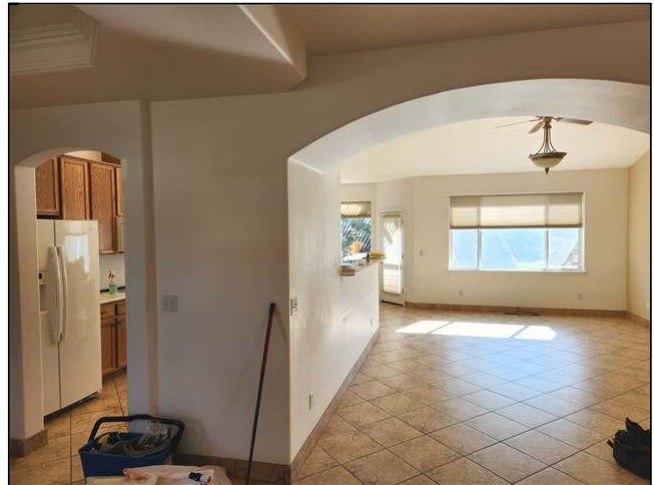
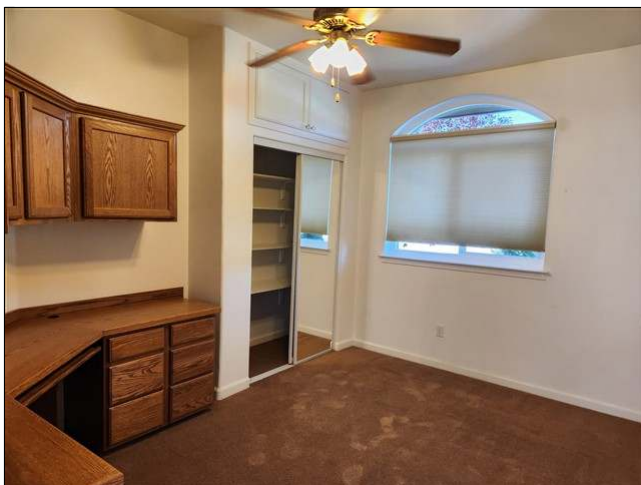
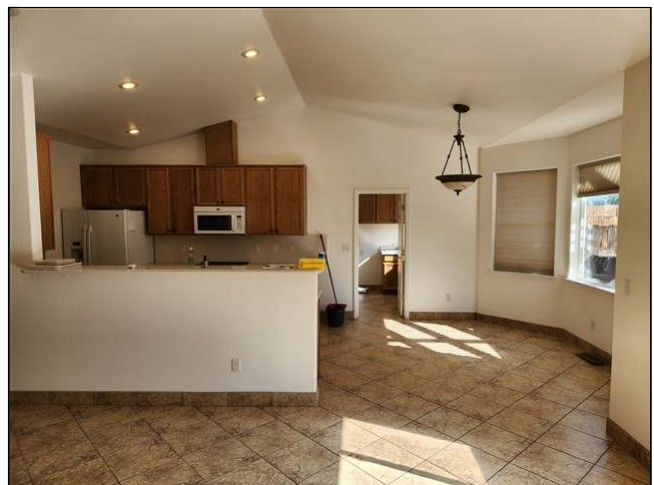
7.0 Item 1(Picture) view of interior

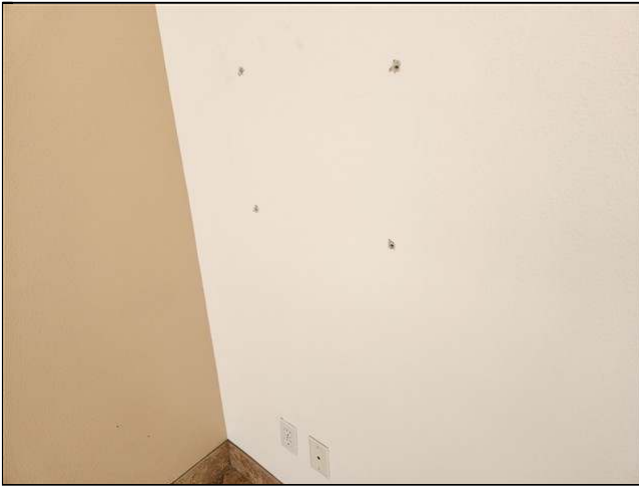
Typical holes through drywall from mounting brackets, etc. we're noted at various locations, and are considered to be cosmetic.

7.2 Item 1(Picture) Typical holes through drywall

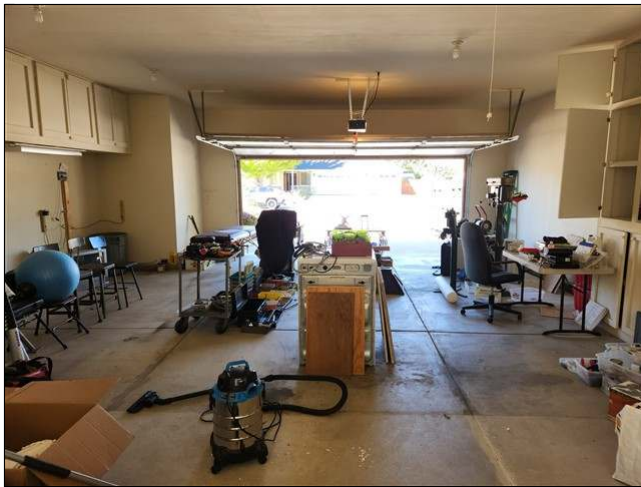
8.0 Item 1(Picture) view of garage

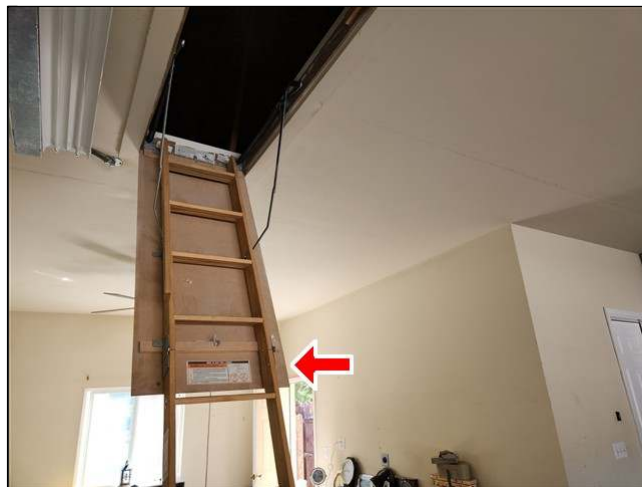
Ceilings finished with drywall, with normal settlement cracks... NOTE: The Attic "Pull down access" cover is 1/4" thick panel board, and needs to afford fire protection from garage to attic space, which is connected to the home's attic space, with a wood framed wall rather than a Fire-separation wall. Recommend repair by a qualified person as needed.

8.2 Item 2(Picture) cover is 1/4" thick panel board

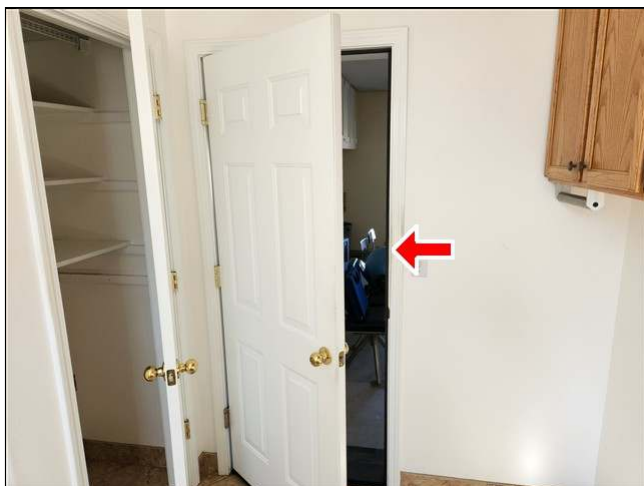
(1) Occupant door is fire rated and weather stripped, and "does not" completely close with self closing hinges to prevent accidental carbon monoxide/fire intrusion to home.

8.8 Item 1(Picture) garage occupant door

(2) Occupant door from Garage to Interior of house, does not completely self-close on it's own momentum. Recommend repair/adjust door to close completely to prevent accidental carbon monoxide or fire intrusion into home.

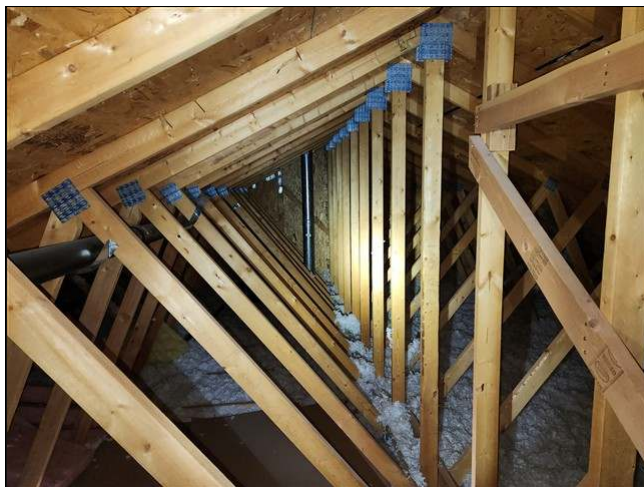
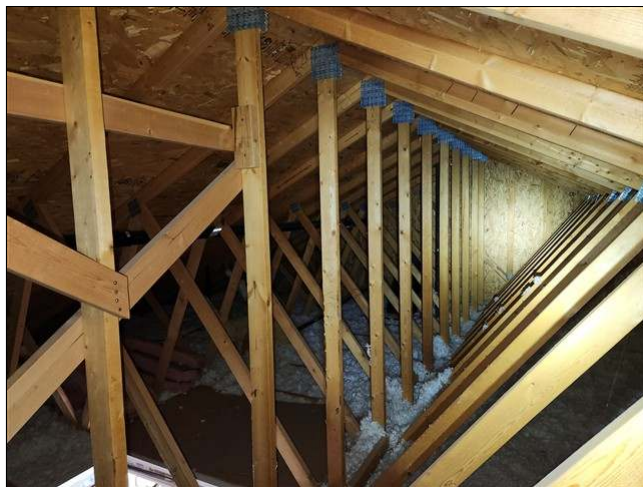
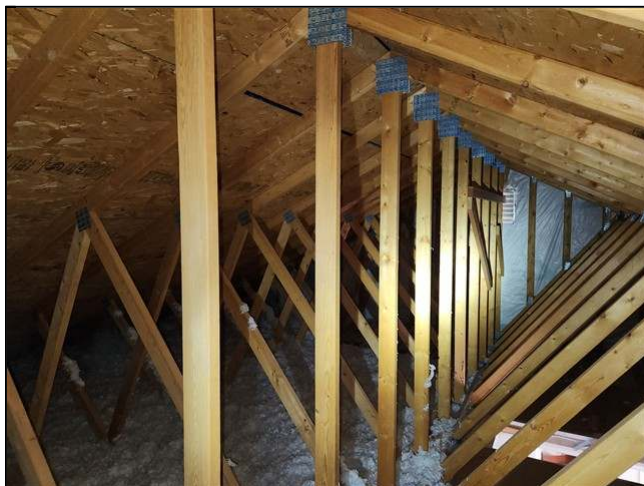
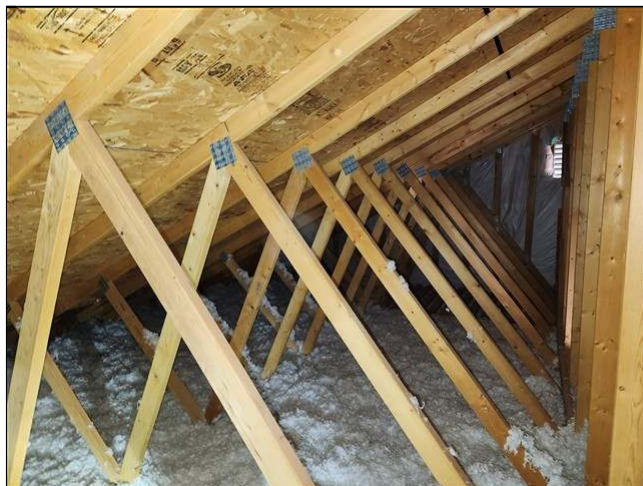
Garage attic area as seen at time of inspection. NOTE: Garage ceiling is insulated with R19 loose-fill fiberglass.

8.11 Item 1(Picture) view of garage roof structure

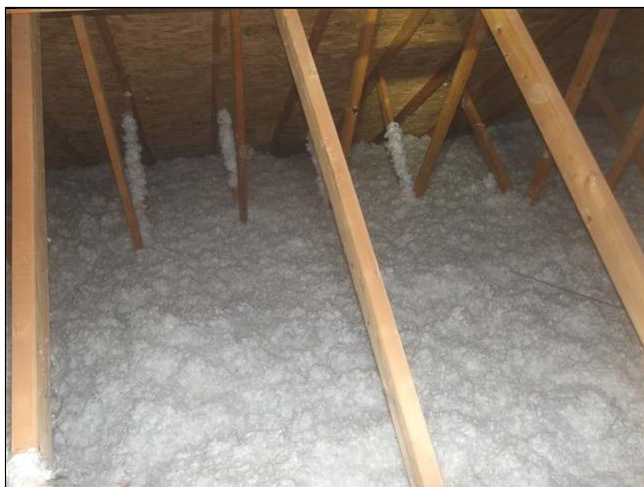
(1) The flat ceiling attic insulation is blown-in loose-fill fiberglass, and is approximately 10 to 12 inches deep (R-30), in most areas, with insulation tapering down to about R19 in a few locations. No major problems noted.

9.0 Item 1(Picture) view of attic insulation

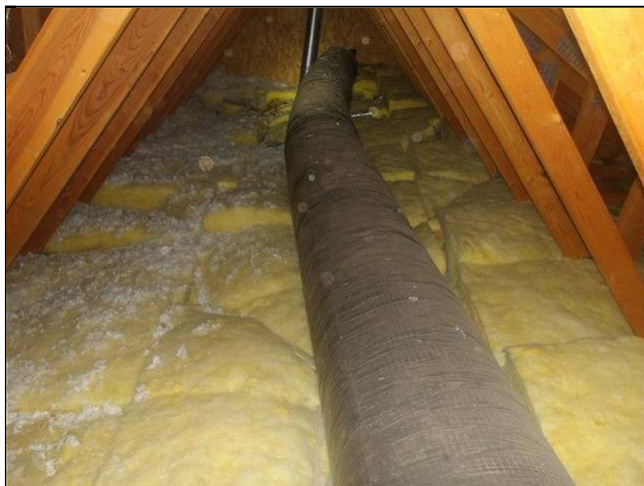
(2) Cathedral Ceiling Attic insulation is Fiberglass Batt type approximately 9 to 10 inches thick (R30). No problems noted at time of inspection.

9.0 Item 3(Picture) Cathedral Ceiling Attic insulation

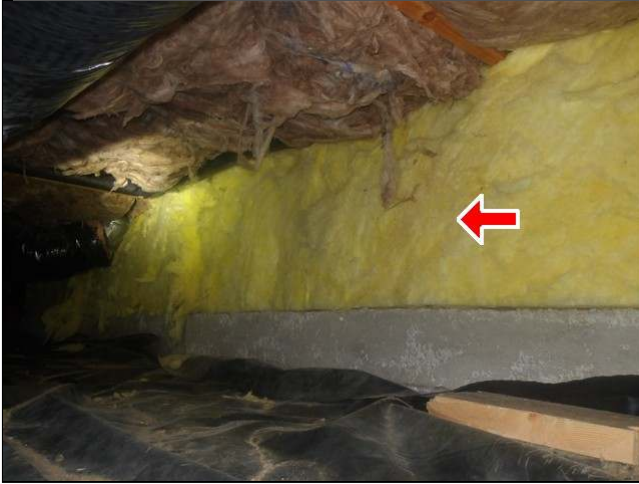
(1) The crawlspace area is insulated on the perimeter of the foundation using R13 fiberglass Batts, no problems noted.

9.1 Item 1(Picture) insulated on the perimeter of the foundation

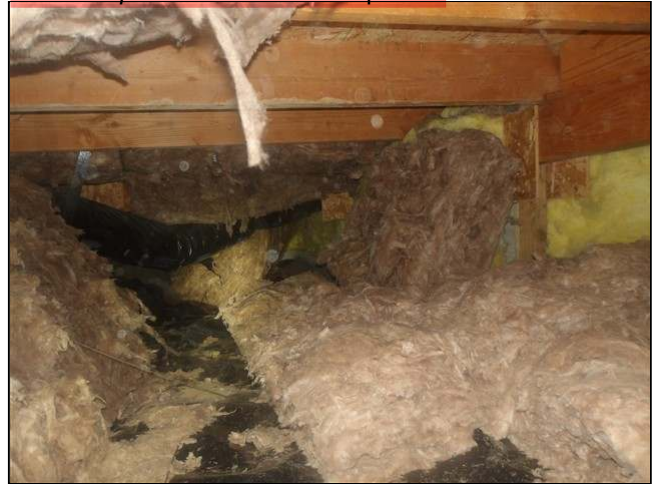
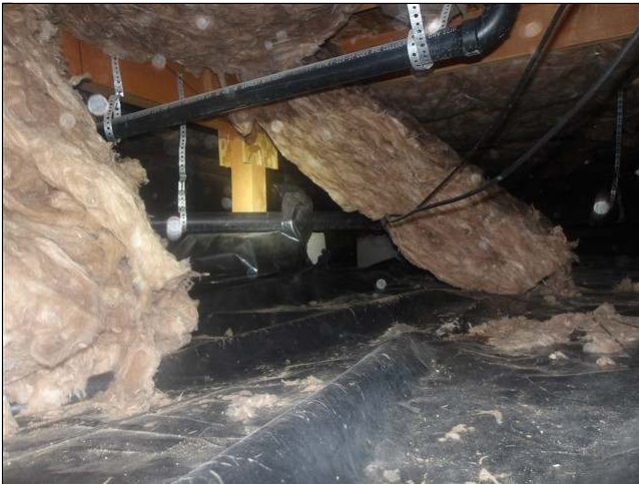
(2) The subfloor area is insulated between the floor joists using R30 fiberglass Batts. Insulation has fallen out of position or been torn down by rodent activity in several areas under the North side of building, and should be re-secured or replaced to maximize the home's efficiency.

9.1 Item 3(Picture) fallen subfloor insulation

**RE: ITEM 9.1(2)—\*\*SCHEDULED\*\*** Please see *Exhibit: Seller Repair Itemization* for Updates

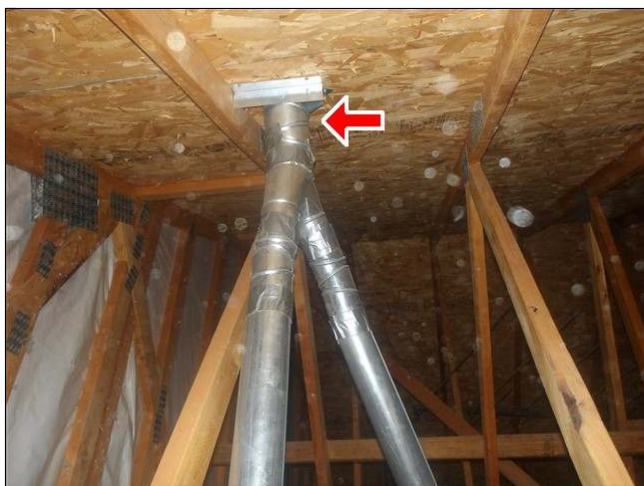
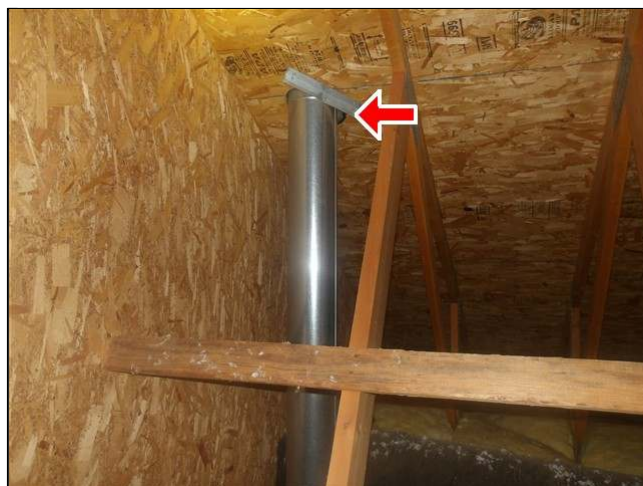
Bathrooms, Kitchen and Laundry vents are properly ducted to the exterior of the home.

9.4 Item 1(Picture) properly ducted to the exterior

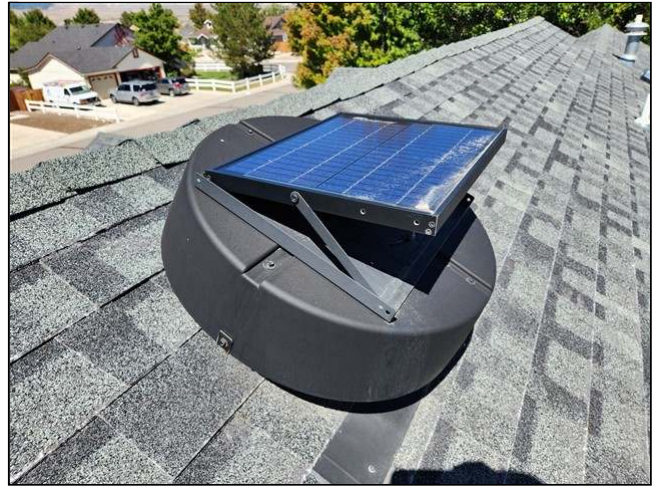
Solar powered ventilation fan noted installed at the East slope of roof, however was non-operational at time of inspection.

9.5 Item 2(Picture) Solar powered ventilation fan

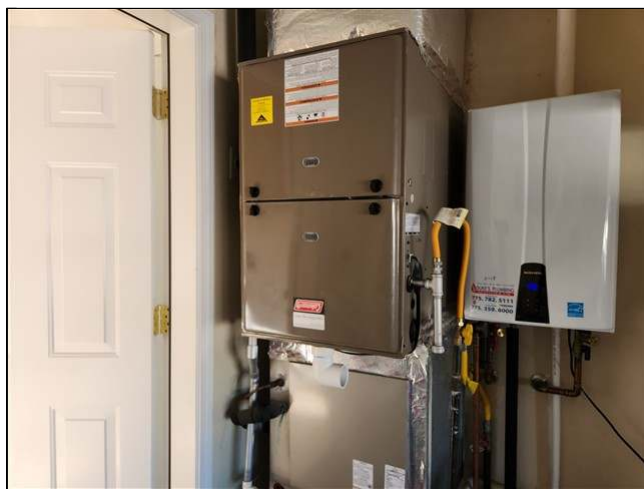
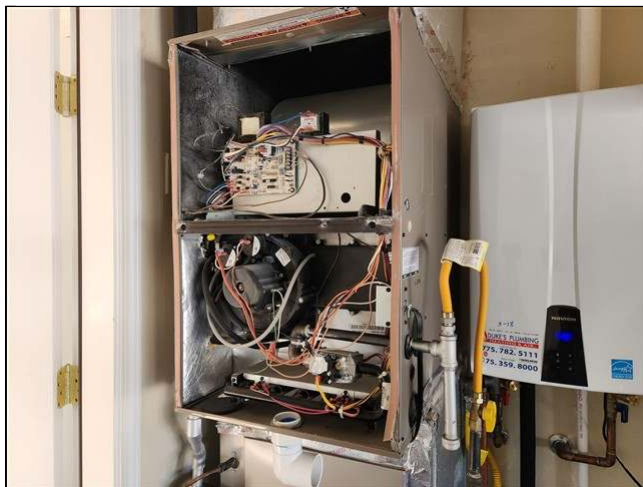
The heating equipment is NOT original (11 years). The furnace is a vertical downdraft natural gas fired forced air unit, Rated at 100,000btu's, that operated as intended with normal operating controls. The burners have an even blue flame. Manufactured in 2015 by COLEMAN heating.

10.0 Item 1(Picture) forced air furnace

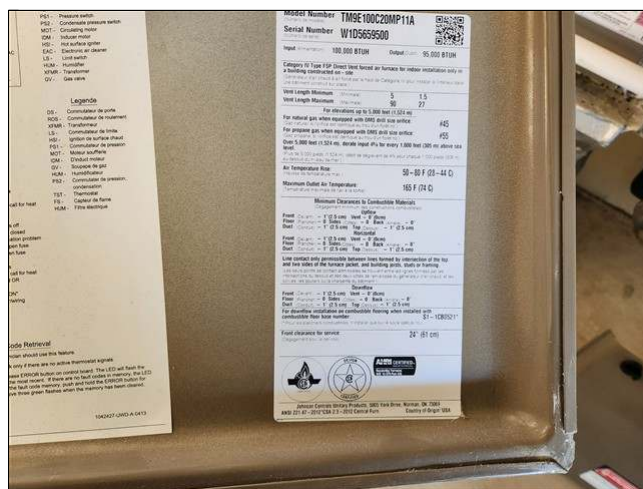
10.0 Item 2(Picture) manufacturer's label

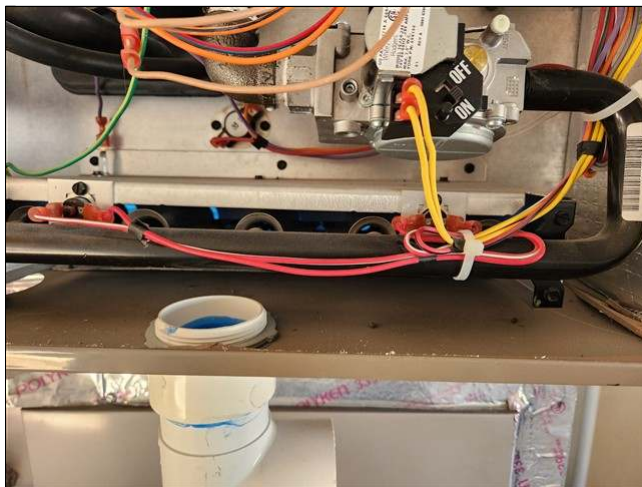
10.0 Item 4(Picture) furnace burners

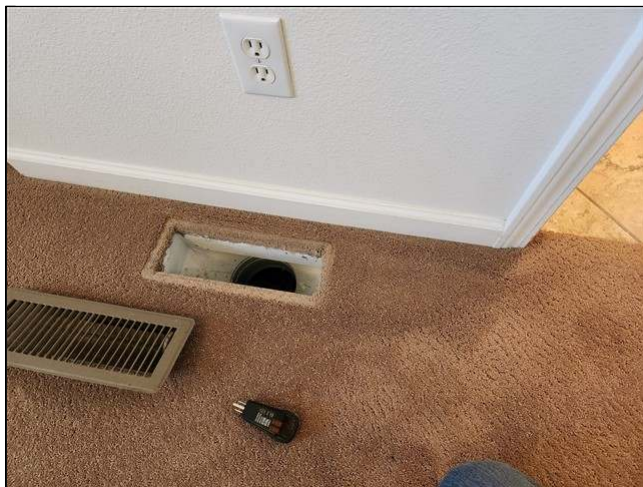
(1) The debris (and mice nest/urine odor) seen in the vents indicates the need for professional cleaning ducts for improved indoor air quality.

10.3 Item 1(Picture) debris (and mice nest/urine odor) seen in the vents

**10.1 NORMAL OPERATING CONTROLS****Comments:** Inspected**10.2 AUTOMATIC SAFETY CONTROLS****Comments:** Inspected**10.3 DISTRIBUTION SYSTEMS (including fans, pumps, ducts and piping, with supports, insulation, air filters, registers, radiators, fan coil units and convectors)****Comments:** Inspected **RE: ITEM 10.3(1)—\*\*DUCTING/RETURN REPLACED\*\* Please see *Exhibit: Seller Repair Itemization* for Invoice**

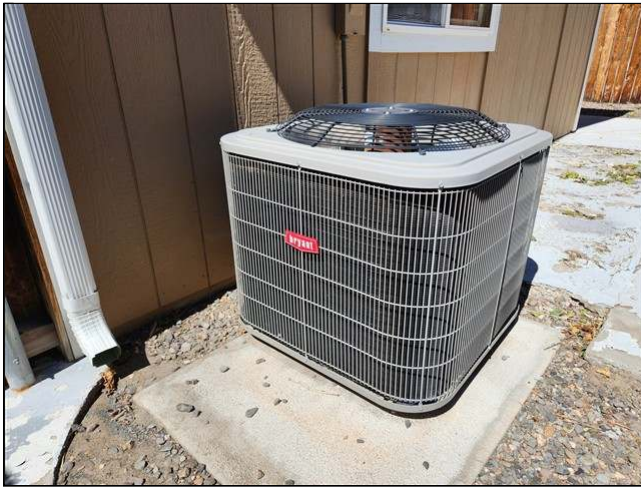
The ambient air test was performed by using thermometers on the air handler of Air conditioner to determine if the difference in temperatures of the supply and return air are between 14 degrees and 22 degrees which indicates that the unit is cooling as intended. The supply air temperature on your system read 56 degrees, and the return air temperature was 71 degrees (a/c cabinet temperature measured 82 degrees). This indicates the range in temperature

drop is normal. Condensing unit operated as intended with normal operating controls, and no abnormal noises noted. Unit was manufactured in 2018 by Bryant.

10.5 Item 1(Picture) condensing unit

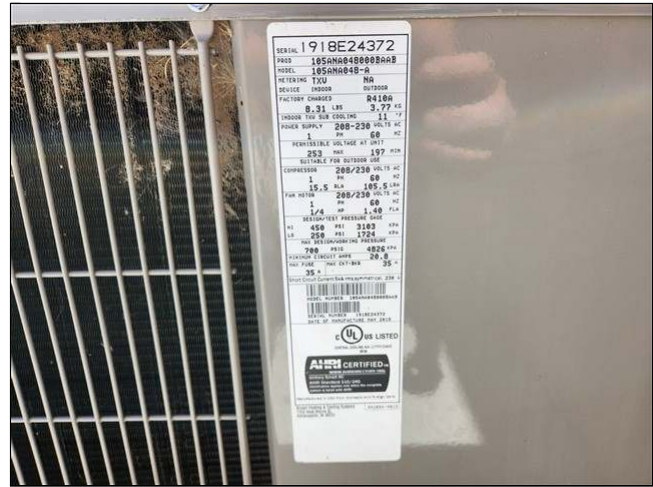
10.5 Item 2(Picture) manufacturer's label

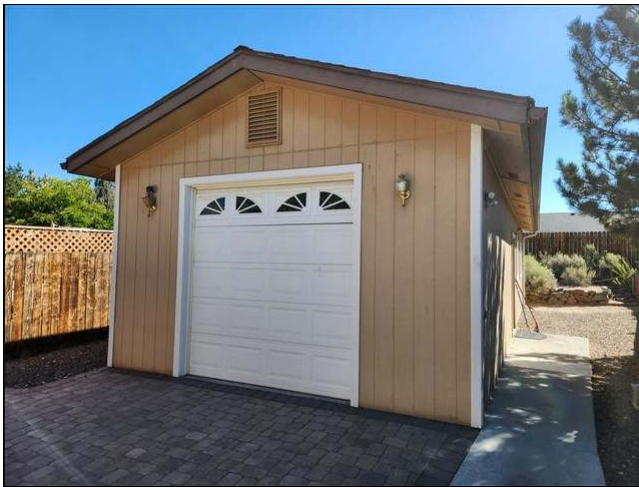
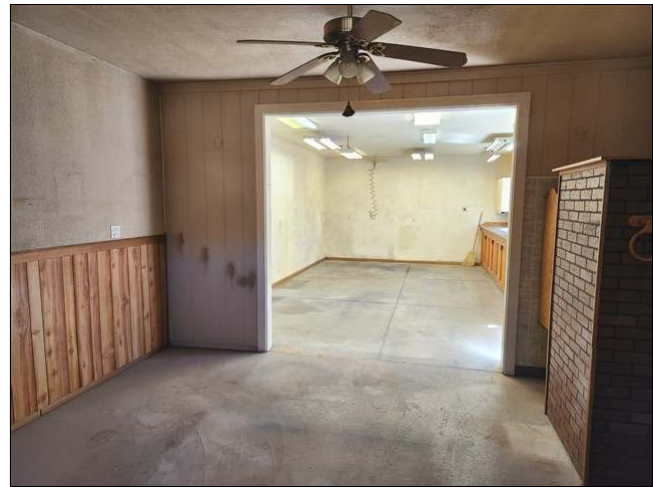
11.0 Item 1(Picture) view of workshop exterior

11.0 Item 2(Picture) view of workshop interior

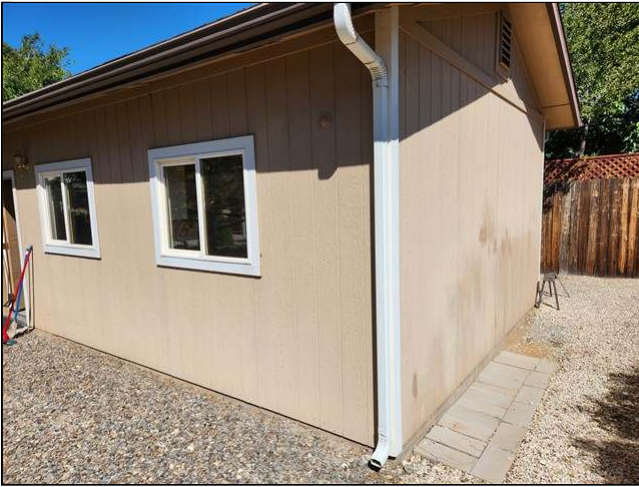
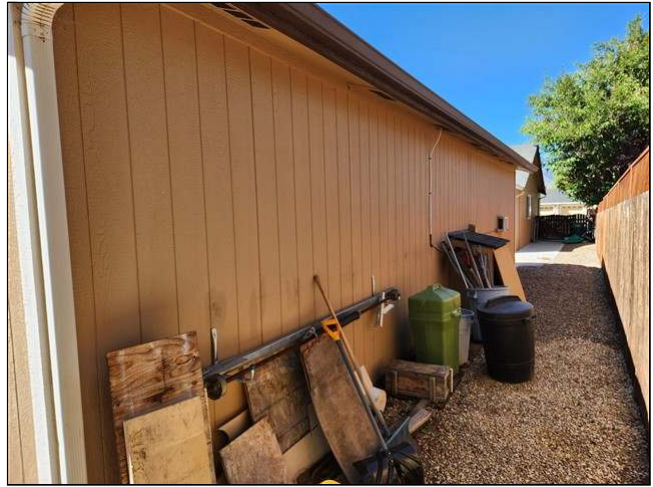
(1) Exterior wall cladding appears original to the building, and is T-111 style OSB panels that appear in good overall condition. Normal aging and wear was noted, with very slight deterioration at the lower edges, possibly from roof run-off splashing on the ground. No problems were noted with the siding materials, and appears properly secured to wall framing.

11.1 Item 1(Picture) view of exterior wall siding

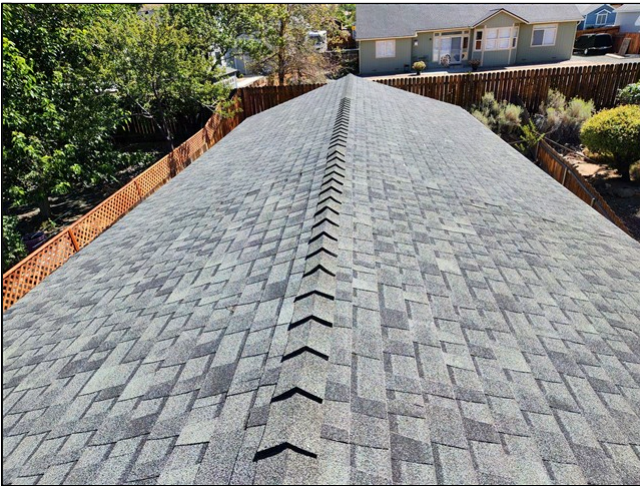
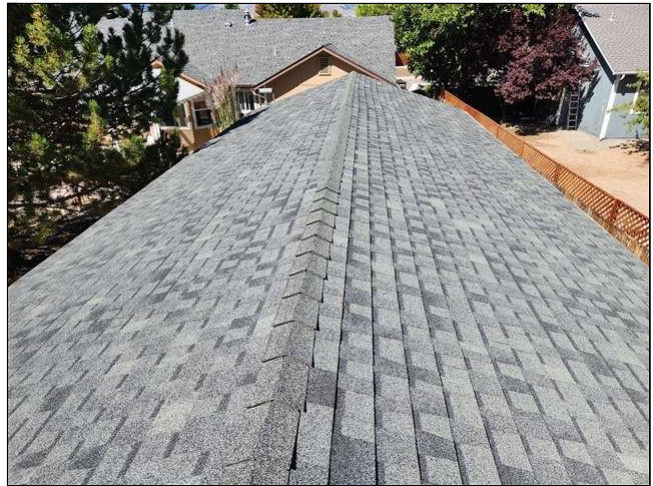
The roof covering is a 30 year architectural, asphalt/fiberglass Composition shingle with much of it's life remaining (has an appearance of roughly half of life remaining). Typical loss of granules noted from shingles, however is more advanced at the South slope of roof. No problems noted.

11.3 Item 1(Picture) view of roof

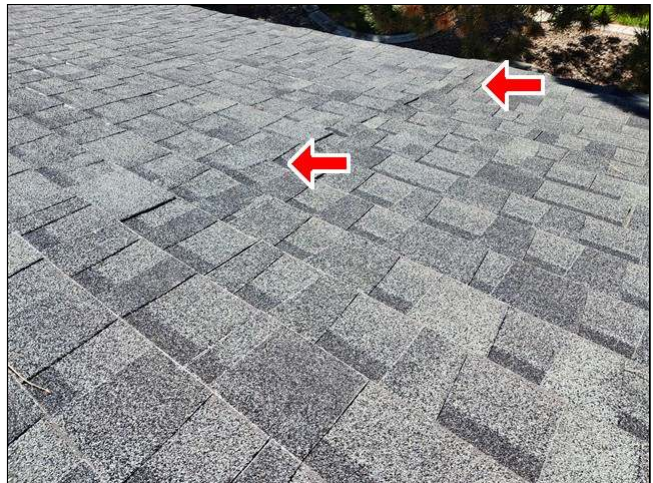
11.3 Item 4(Picture) connection of front/rear sections

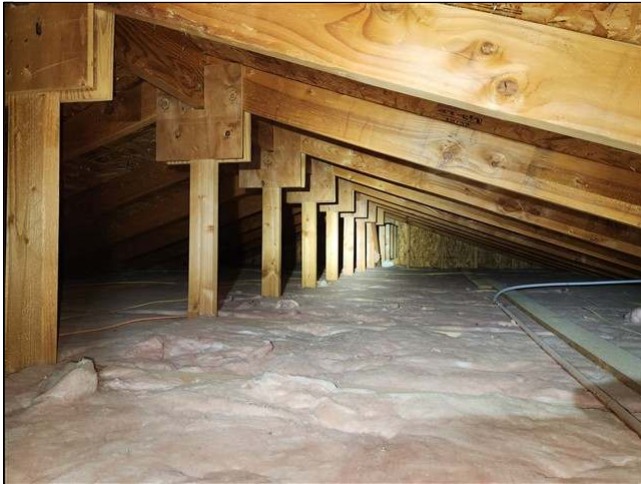
Front section of building (garage area) uses Manufactured trusses with 2x4 lumber, that appear to be in good overall condition. Rear section of building (workshop area) is site/stick built and appears to be in good overall condition. No problems noted.

11.4 Item 1(Picture) view of rear section attic

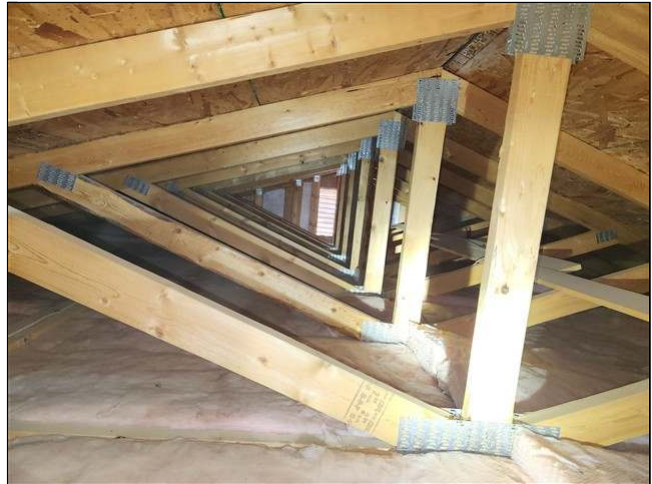
11.4 Item 2(Picture) view of front section attic

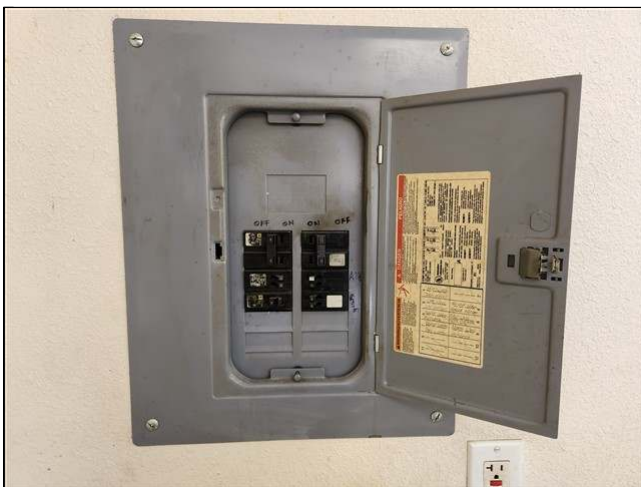
(1) Garage panel is well labeled for circuit identification, The circuit conductors appear in good condition, and are properly sized for their prospective overcurrent devices. No burned connections noted. Panel is Manufactured by Homeline.

11.6 Item 1(Picture) main garage panel
