# Inspection Report

2987 Del Rio Ln  
Minden NV 89423

## Clear Choice Home Inspection Services

| <b>Date:</b> 9/7/2026 | <b>Time:</b> 09:00 AM | <b>Report ID:</b> SPA298 |

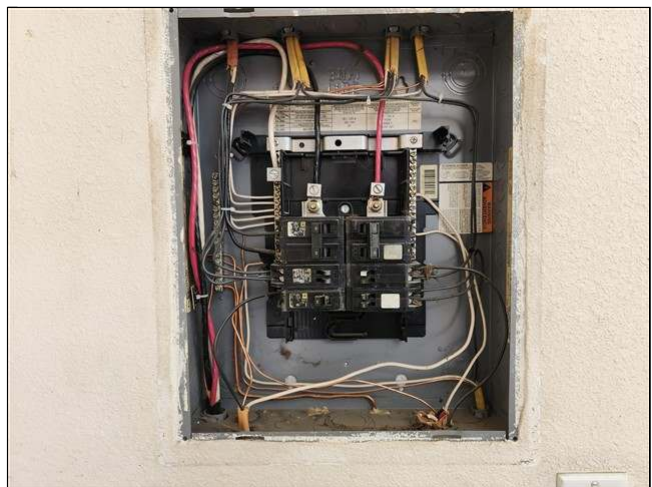
(1) Garage panel is well labeled for circuit identification, The circuit conductors appear in good condition, and are properly sized for their prospective overcurrent devices. No burned connections noted. Panel is Manufactured by Homeline.

11.6 Item 2(Picture) garage panel conductors

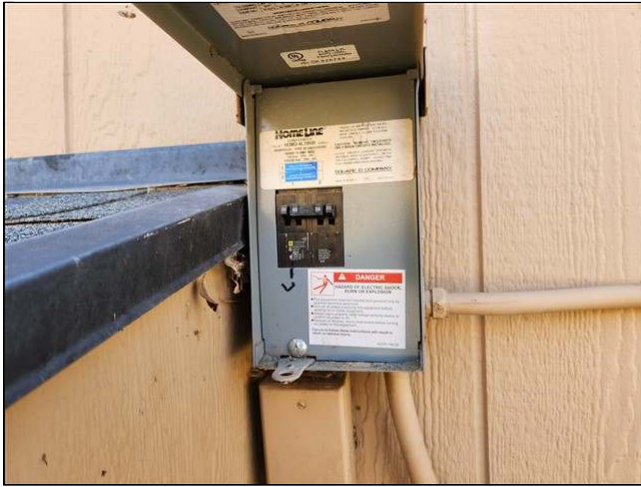
11.6 Item 3(Picture) exterior panel

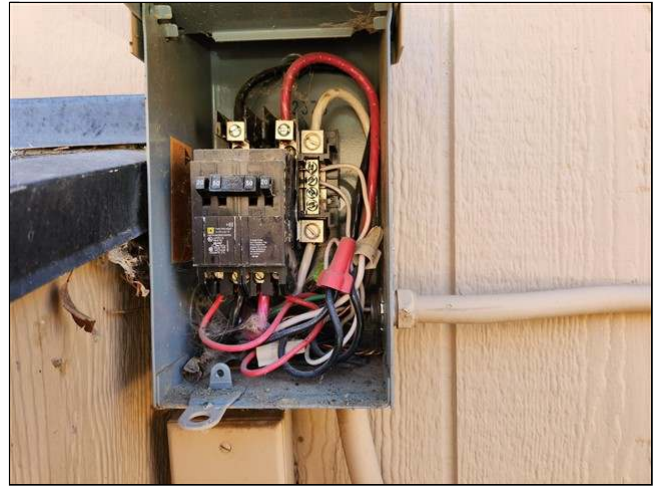
11.6 Item 4(Picture) exterior panel conductors

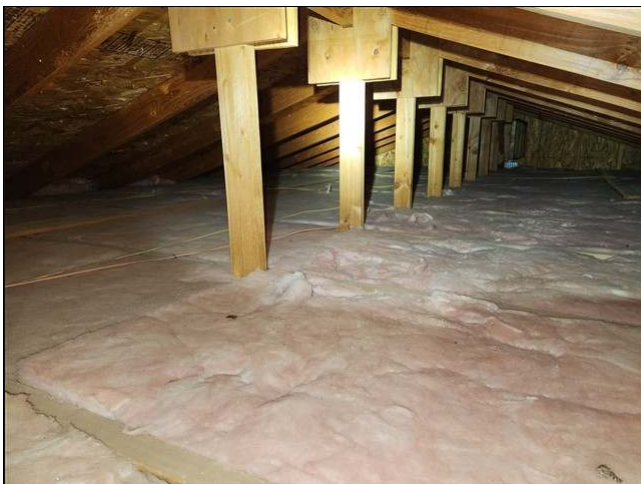
Attic insulation is Fiberglass Batt type approximately 3.5 inches thick (R13). No problems noted.

11.7 Item 1(Picture) view of attic insulation

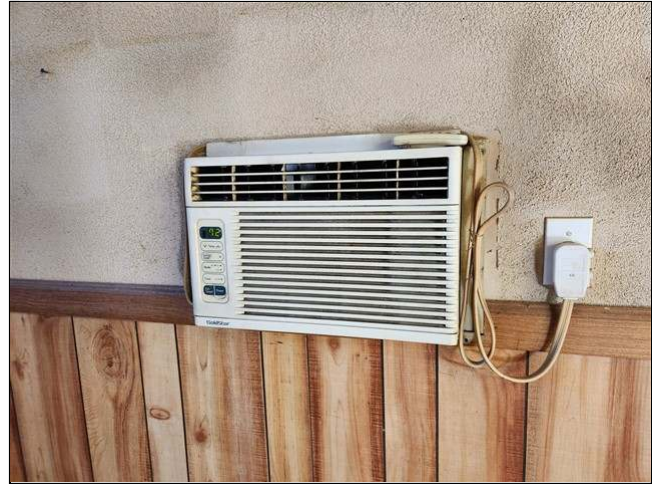
No heating source was noted. Cooling unit mounted at the North wall did not cool, and only recirculated the room air and appears needs service to function as intended.

11.9 Item 2(Picture) cooling unit at north wall
