EAGLE ROCK INSPECTIONS

## RESIDENTIAL PROPERTY INSPECTION

6040 Cielo Cir  
Sparks, NV 89436

04/08/2026

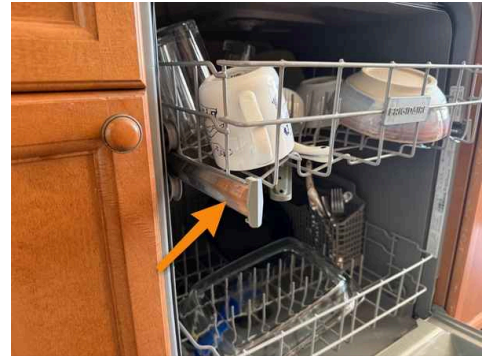
**TOP RACK ROLLER ARM - ADJUSTMENT**

The top rack roller arm needs adjustment to function properly by a qualified person.
