### Supplemental Disclosure Regarding Prior Inspections

| Inspection Type (General, Roof, etc) | Name of Inspector or Inspection Co. | Date of Inspection |
|---|---|---|
| General | Marc Bebout Armstrong Inspection Services, Inc. | 09/09/2026 |

## INSPECTION REPORT

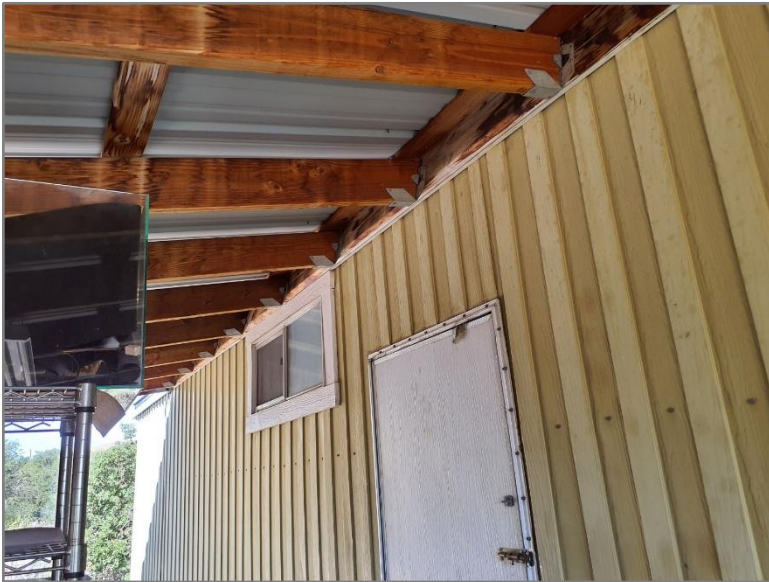
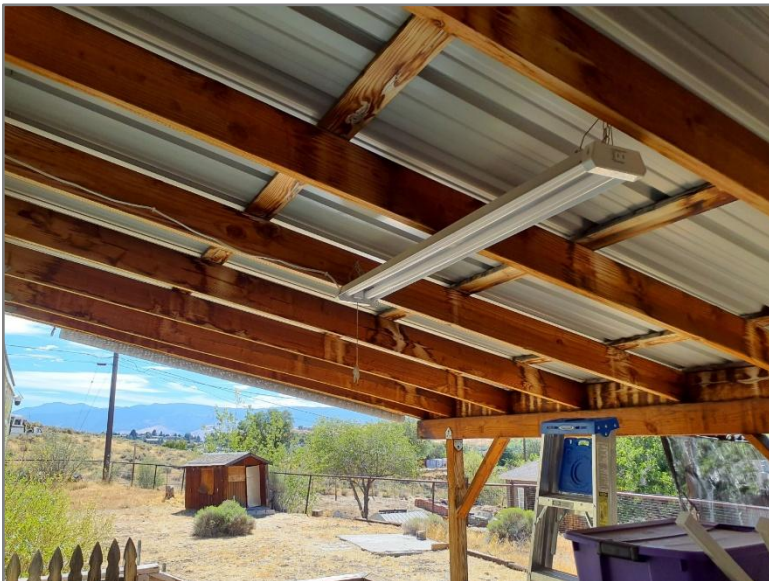
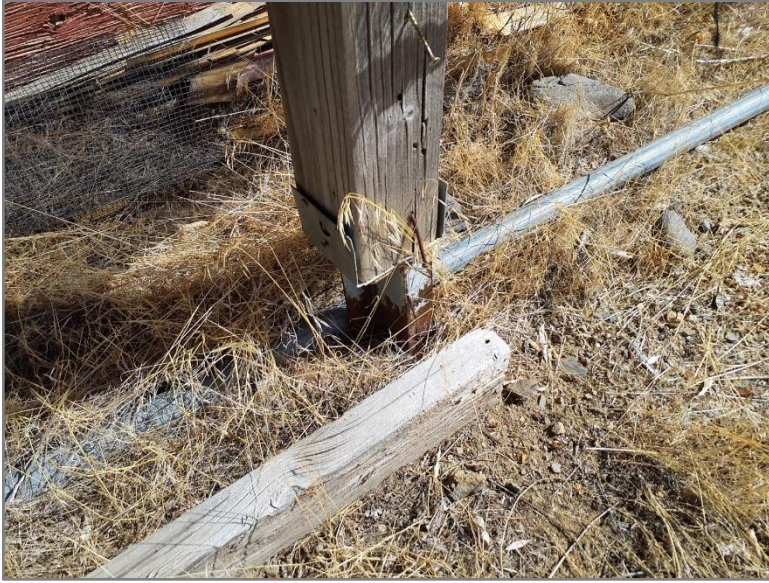
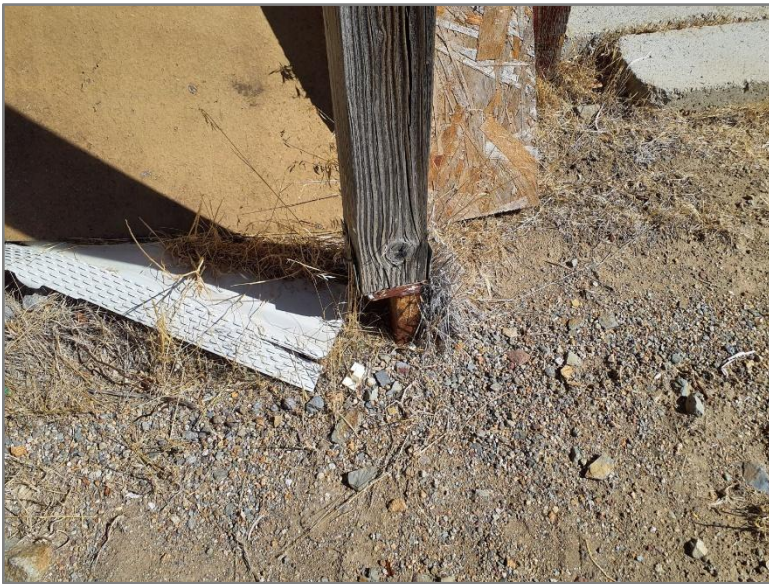
→ It's unknown how the patio cover is attached to the structure. Generally manufactured homes do not allow additional structures to be attached.

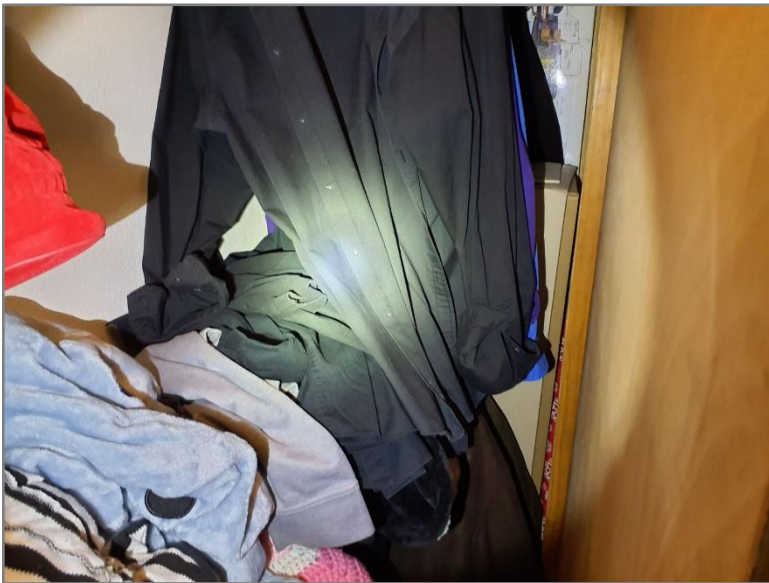
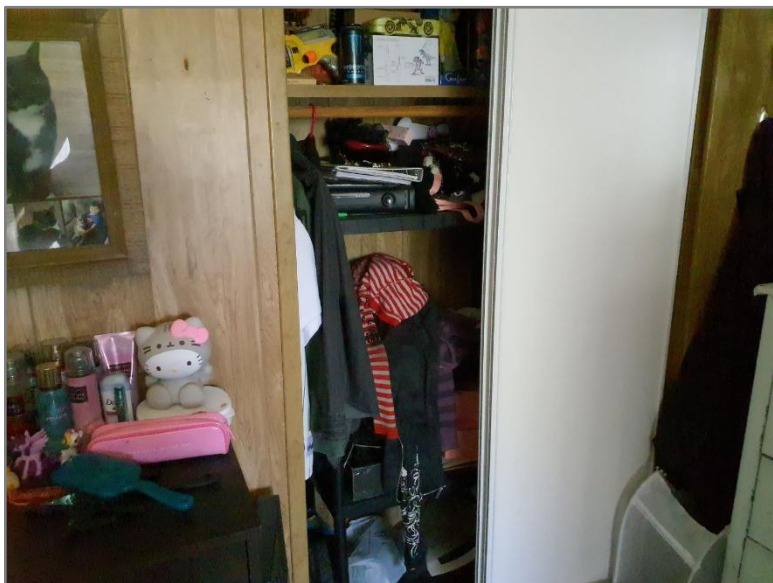
→ Personal items throughout the home block a thorough view of all wall and floor spaces.

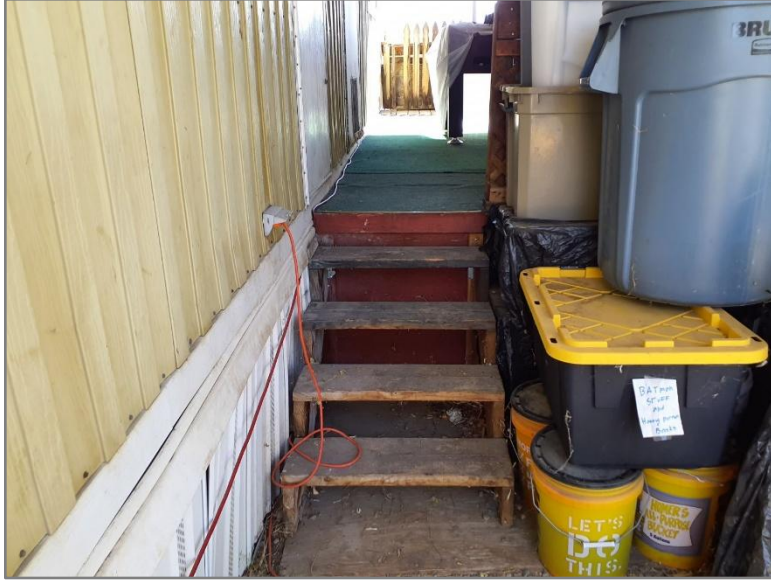
General-17

→ The front steps are rotted and should be replaced.
